ATSB TRANSPORT SAFETY INVESTIGATION REPORT
Marine Occurrence Investigation No. 236
Final

**Independent investigation into the engine
room fire on board the Bahamas registered
general cargo ship**

Baltimar Boreas

9 February 2007

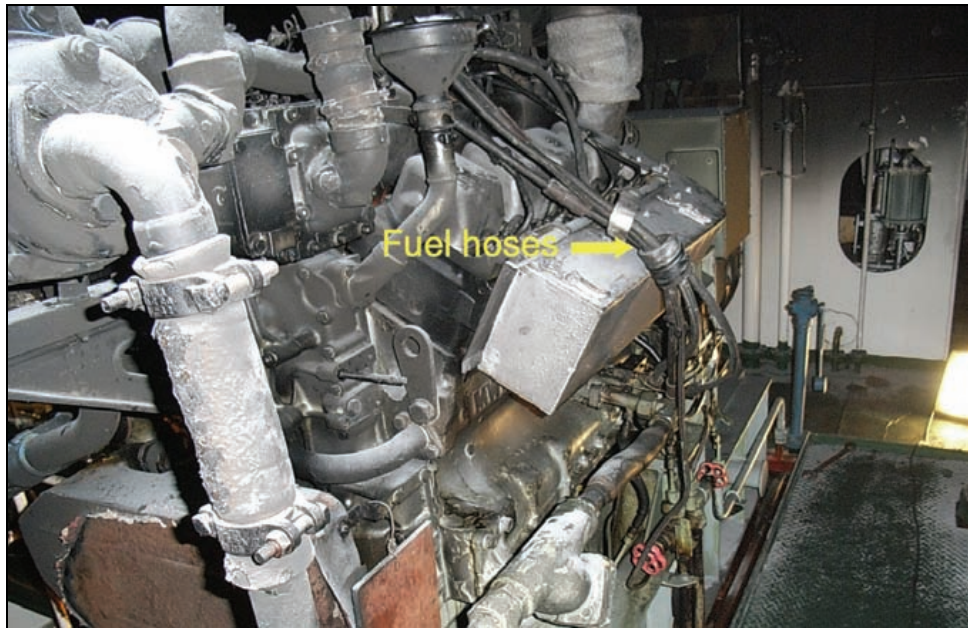
Figure 2: Number two diesel generator

Baltimar Boreas's electrical power is provided by three electrical generators, each of which is driven by a MWM (Motoren-Werke Mannheim) TBD-234 V8 turbocharged eight cylinder diesel engine (diesel generator) developing 212 kW (Figure 2).

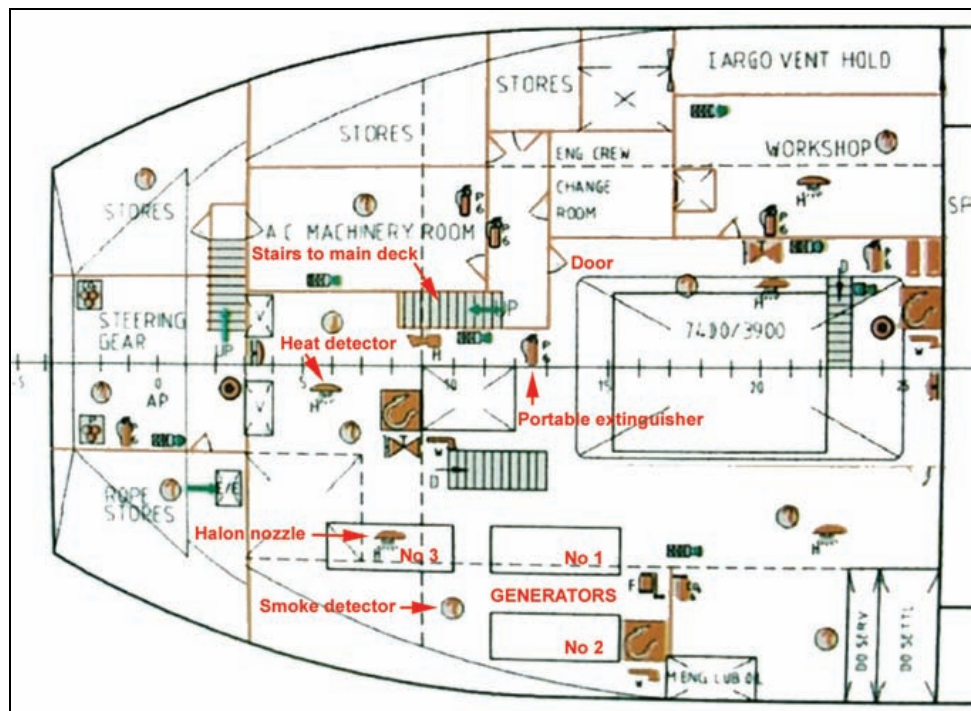
Figure 7: Elevation of engine room second deck

The fire alarm had also activated in the engineers' cabin UMS alarm panels. The alarm woke the second engineer and he went to the engine room immediately. As soon as he entered the engine room, he saw flames on top of number three generator (Figure 7). He activated the manual fire alarm button adjacent to the engine room access door, picked up a portable fire extinguisher and approached the fire. He could not get closer than about 4 m from the fire, so he discharged the fire extinguisher towards the large red and yellow flames which appeared to him as though they were being fanned by the engine room ventilation fans. He then retreated from the fire, losing his spectacles as he hurried out of the engine room. After shutting the access door, he stopped the engine room ventilation fans from the panel near the stairs.

At 0255, the second engineer used the telephone in the engine crew change room nearby and reported the fire to the second mate on the bridge. He then ran up the stairs to the main deck shouting 'Fire! Fire!'. He met the chief engineer making his way down and told him that number three generator was on fire. The second engineer then rushed up to the bridge.
