ATSB TRANSPORT SAFETY INVESTIGATION REPORT  
Marine Occurrence Investigation No. 238  
Final

Independent investigation into the boiler explosions  
on board the Panamanian registered bulk carrier

# Shirane

2 April 2007

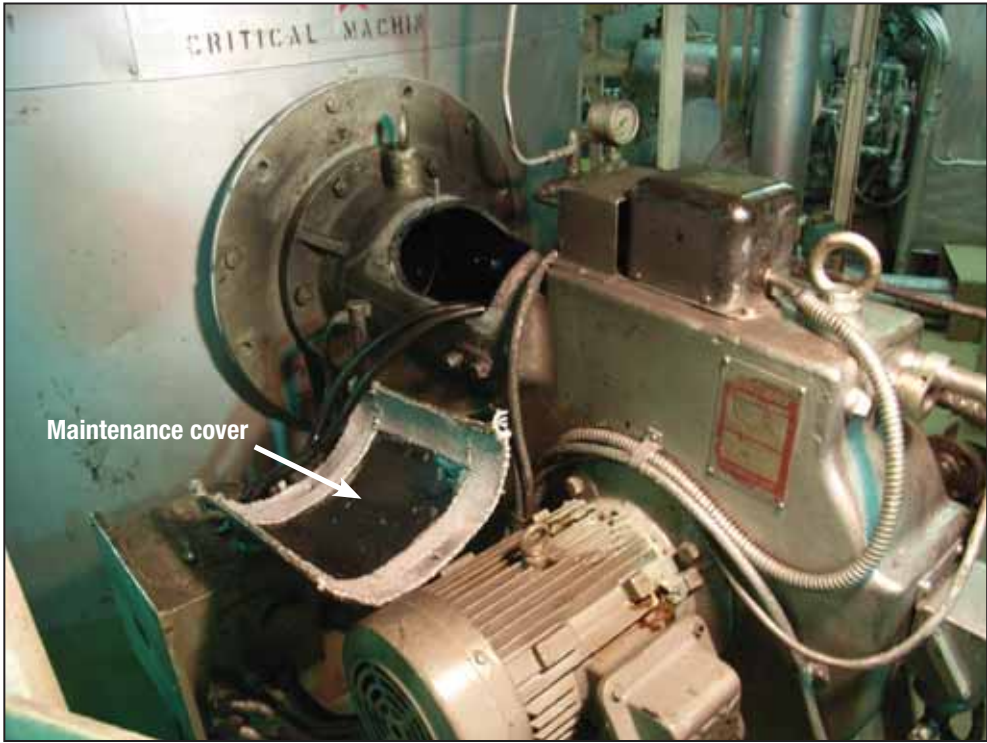
**Figure 4: Volcano VJ-140-1 oil firing unit**

When the ship's main engine is stopped, or is providing insufficient exhaust gas energy to produce enough steam to meet the demand, the boiler is fired using oil. The oil firing unit, a VJ-140-1, was manufactured by the Volcano Company of Japan (Figure 4). The unit comprises a fully automatic pressure jet oil burner, integrated with a single electric motor driving both the forced draft fan and the fuel oil feed pump. Control of combustion air flow is provided by a single, two-position, damper on the forced draft fan's air inlet housing. The oil firing unit may be fired using either diesel or heavy fuel and has an integrated electric heater for use when firing on heavy fuel. The oil firing unit's controls and monitoring system are located in a cabinet which is mounted on a bulkhead adjacent to the boiler.
