ATSB TRANSPORT SAFETY INVESTIGATION REPORT  
Marine Occurrence Investigation No. 245  
Final

Independent investigation into the fire on board  
the Antigua and Barbuda registered general cargo ship

# BBC Islander

14 August 2007

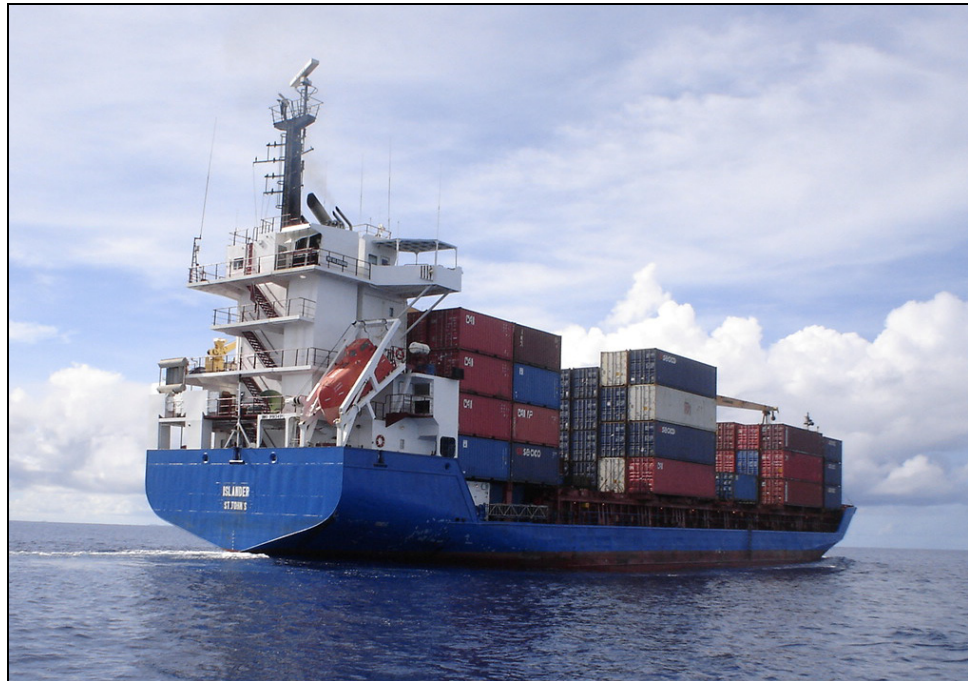
**Figure 1:** *BBC Islander*

*BBC Islander* is an Antigua and Barbuda registered general cargo/container ship (Figure 1). The ship is owned and managed by Briese Schiffahrts, Germany and classed with Germanischer Lloyd (GL). It has two cargo holds and two cargo cranes located forward of the accommodation superstructure.

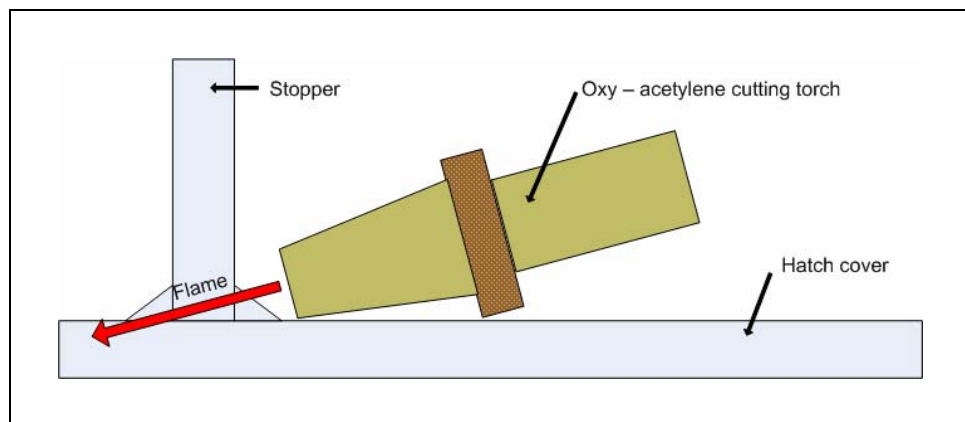
**Figure 8: Schematic diagram of the oxy-acetylene cutting torch**

The stoppers were made from sections of mild steel I-beam and were about 15 mm thick so the fitter tried to cut them off as close as possible to the hatch covers to ensure that the amount of material that was left to grind off was minimised. However, the design of the oxy-acetylene cutting torch (Figure 8) led to him directing the oxy-acetylene flame downwards, at an angle towards the hatch covers. This resulted in areas of the hatch cover material being gouged by the flame (Figure 9).

At about 1310, when the fitter removed the last stopper from the port side of the aft cargo hold hatch covers, he inadvertently cut a hole through the hatch cover. As a result, sparks and molten metal were blown into the cargo hold and onto the cargo stowed below.
