Collision between *Namhae Gas* and *Rexandra*

30 November 2007

ABSTRACT

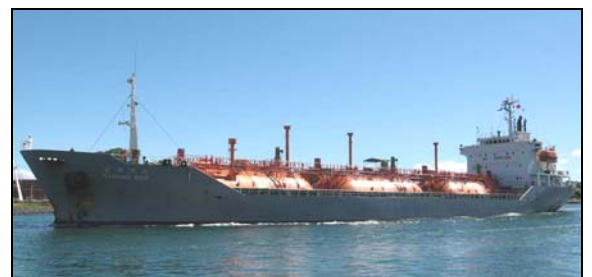
Figure 1: *Namhae Gas*

Namhae Gas is a Korean registered LPG tanker (Figure 1). It has an overall length of 110 m, a beam of 17.6 m, a depth of 7.8 m and a deadweight of 3676 tonnes at its summer draught of 4.96 m. It has an LPG cargo capacity of 4521 m³, which is carried in three refrigerated tanks located forward of the accommodation. The

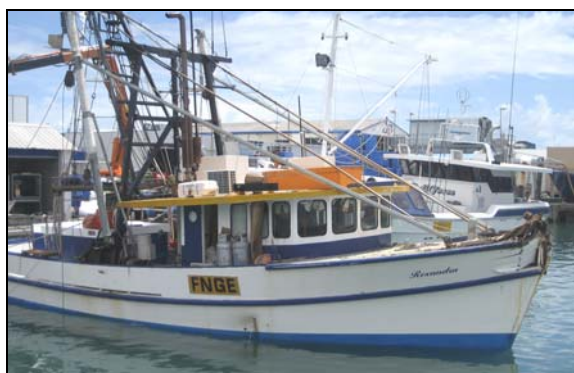
Figure 2: *Rexandra*

Rexandra (Figure 2) was a 15.24 m timber fishing vessel which operated out of Mooloolaba, Queensland. It had a beam of 5.56 m, a depth of 2.29 m and a gross tonnage of 48.1.

The fishing vessel's bow and surrounding structure was damaged. It was taking on a small amount of water, but its bilge pumps were able to cope with the water ingress. The skipper and

The damage to *Rexandra's* bow was consistent with the fishing vessel hitting something nearly head on, then moving to port.
