ATSB TRANSPORT SAFETY REPORT  
Marine Occurrence Investigation No. 248  
Final

Independent investigation into the grounding of the  
Australian registered bulk carrier

# Endeavour River

at Gladstone, Queensland  
2 December 2007

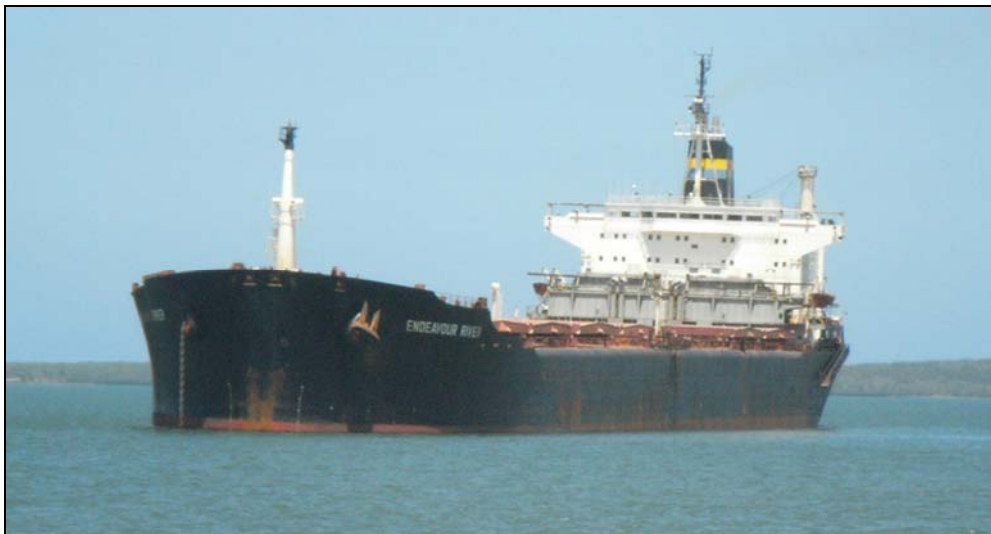
**Figure 1:** *Endeavour River*

*Endeavour River* (Figure 1) is an Australian registered bulk carrier engaged in carrying bauxite between the Queensland ports of Weipa and Gladstone, through the Great Barrier Reef Inner Route.

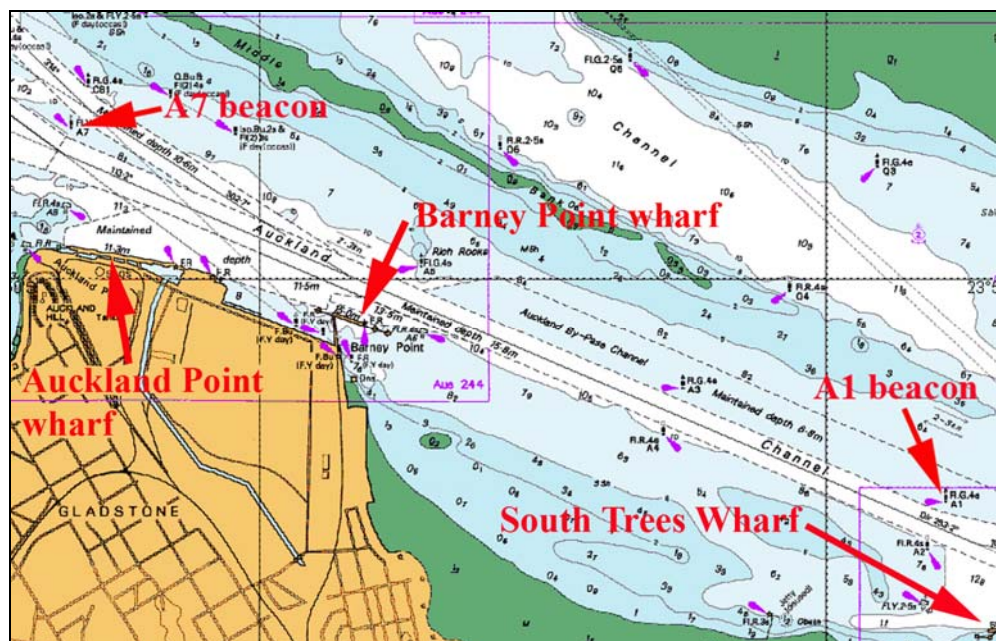
**Figure 3: Section of navigational chart Aus 244 showing Auckland Channel**

Auckland Channel (Figure 3) is the main shipping channel leading from Gatcombe Channel and the South Trees Point area to the main port of Gladstone berths. It is approximately three miles in length, 182 m wide and has a charted depth of 15.8 m. Auckland channel starts at A1 and A2 beacons (northwest of South Trees Point) and runs in a direction of approximately 293° (T). It ends at A7 beacon, just to the north of Auckland Point. To facilitate passing, a smaller by-pass channel, which has a charted depth of 6.8 m, is dredged alongside the Auckland Channel for part of its length.

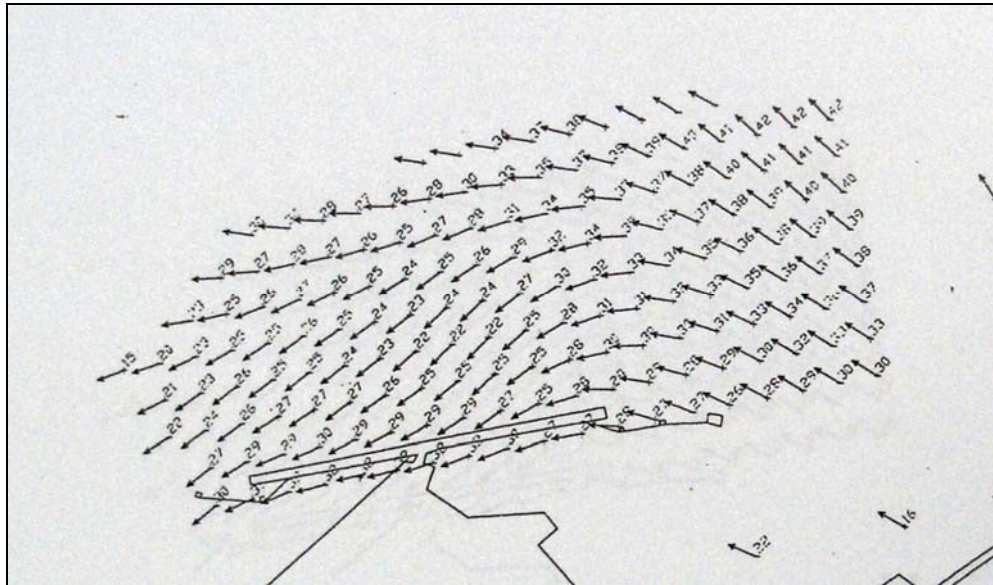
**Figure 4: Recorded tidal flows (flooding) at South Trees Wharf**

Tidal streams passing South Trees Wharf can be up to three knots (without wind influence) and therefore can have a major influence on the ability to safely handle a ship in this area. This is particularly important on a flood tide, when a ship can be pushed up towards the shallow area of the harbour if its entire length is presented to the full effects of the tidal stream.

The results of surveys conducted in the vicinity of South Trees Wharf by the Central Queensland University for Maritime Safety Queensland (MSQ) are shown in Figure 4. The data was collected three hours before high water on a 2.1 m tidal range and at a depth of six metres, about half the draught of *Endeavour River*. The arrows indicate direction of flow and the figures are in cm/s (50 cm/s equals about 1 knot).

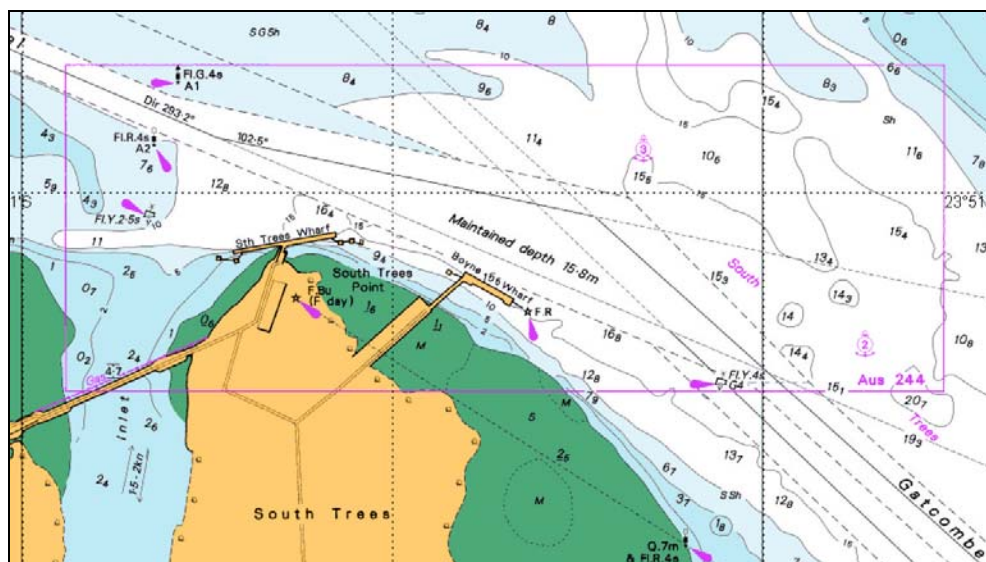
**Figure 5: South Trees Point area**

Mid-tide berthing, on either an ebb or flood tide, was introduced at South Trees Wharf (Figure 5) to increase vessel throughput and the resultant supply of bauxite for the Queensland Alumina processing plant. Mid-tide berthing also reduces the impact of other harbour movements on fully laden coal ships that can only sail on high tide.

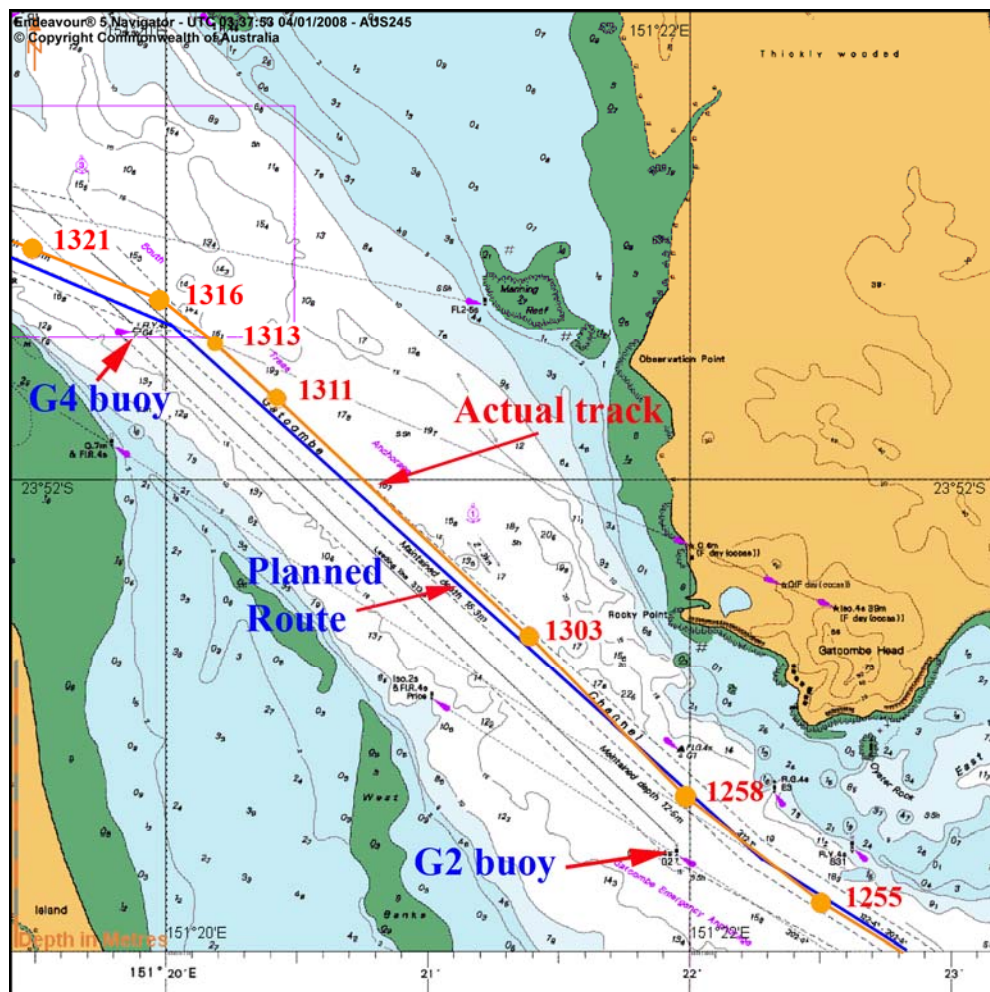
**Figure 6: Section of navigational chart Aus 245 showing *Endeavour River's* passage through Gatcombe Channel**

At 1303, while transiting the Gatcombe Channel (Figure 6), the ship's speed was 9.7 knots, with the shaft speed at 30 rpm. The master was satisfied with the ship's progress.

At 1313 (Figure 6), the master ordered hard-to-port when he wanted to start the turn from Gatcombe Channel onto the leads of the Auckland Channel. At that time, the ship was well to starboard of the planned route and was actually on the leads of the Auckland Channel. The S-VDR data shows that the ship was slow to respond to the rudder movement, indicated on the bridge by the sound of the gyro compass 'ticking' as the ship turned. Two minutes later the helm was ordered midships and then hard-to-starboard. By 1316, the ship had travelled 460 m from the 1313 position and, following the turn, was 100 m to starboard of the planned route – the Auckland Channel leads. Following the turn, the master settled the ship onto the new heading of about 290°.

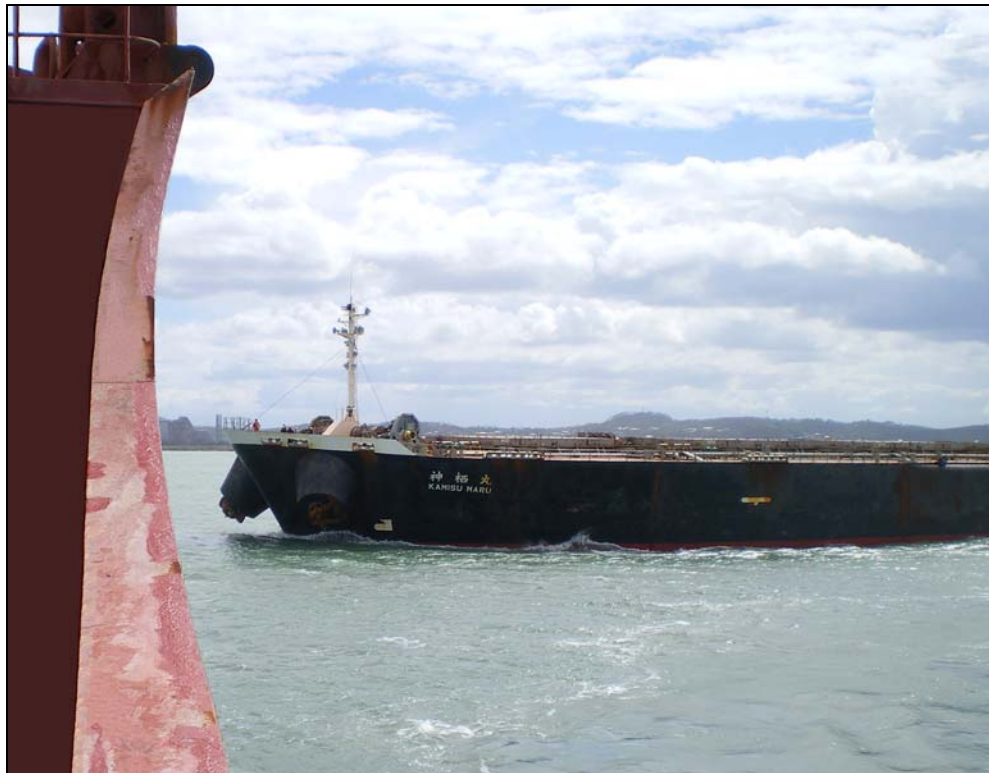
**Figure 11: Photo of *Kamisu Maru* passing ahead of *Endeavour River*, taken from the break of the raised forecastle**

At 1420, *Kamisu Maru* passed about 20 m ahead of *Endeavour River*'s bow (Figure 11), and the same distance from A2 beacon. When clear, the ship's pilot increased engine speed to harbour full ahead, altered course to 102° (T) and continued outbound.
