OUTLINE OF INCIDENT

At 0505 hours local time on 21 February 1990 the Australian flag bulk carrier IRON KEMBLA, whilst on passage from Newcastle NSW to Tobata, Japan, collided with the Japanese fishing vessel KASUGA MARU in a position approximately 4 miles WSW of Hino Misaki lighthouse in Kii Suido. The fishing vessel capsized and one of the two crew members lost his life.

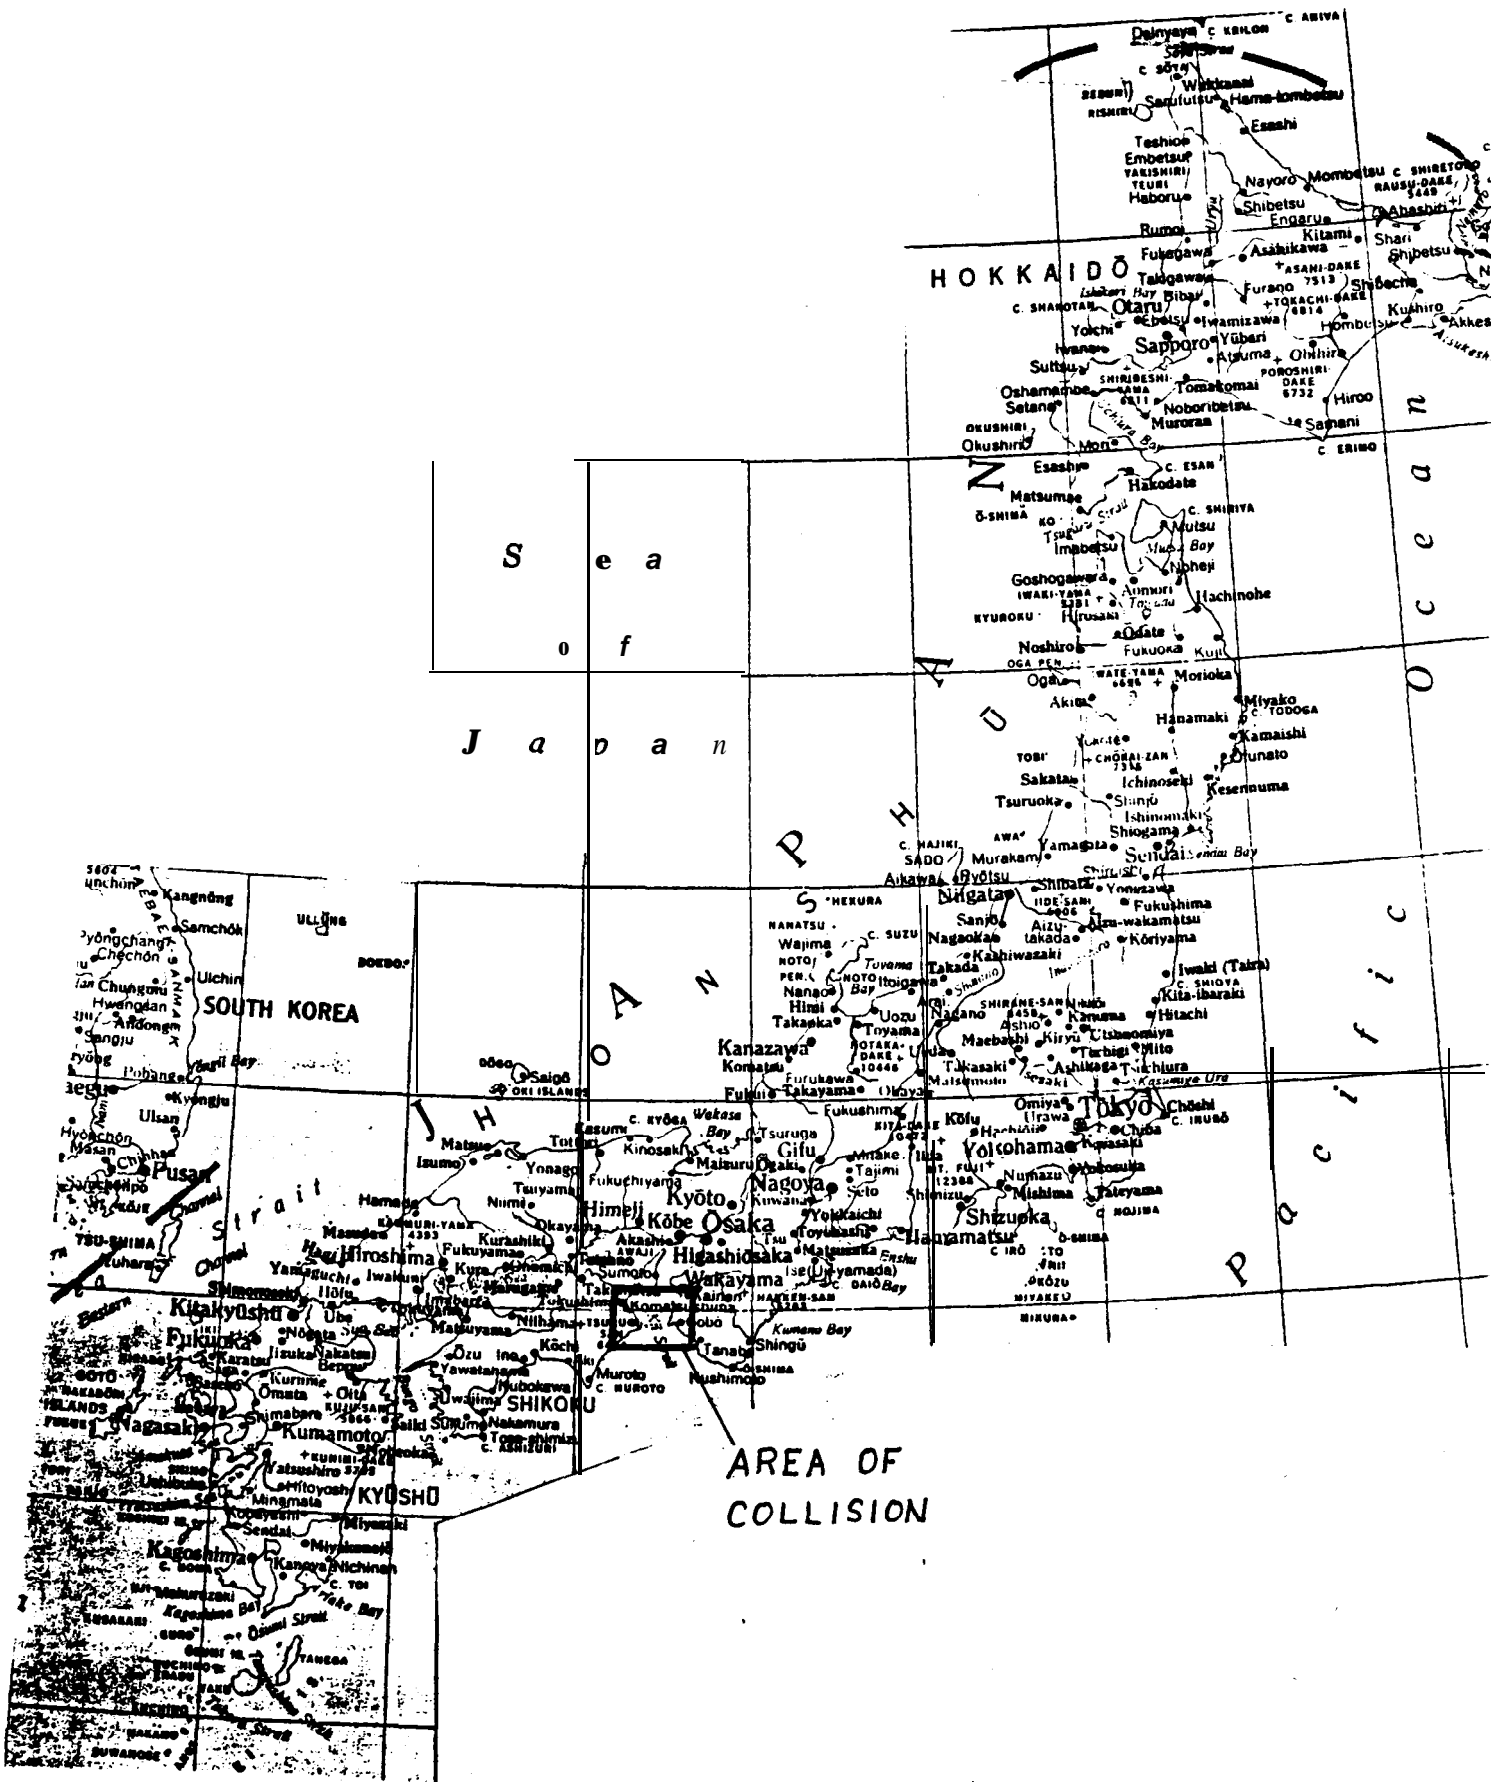
DIAGRAM OF RELATIVE POSITION OF THE TWO VESSELS

The KASUGA MARU was observed to alter course to a northerly heading, a large alteration from its original easterly heading, and may therefore be assumed to have been taking, albeit rather late, avoiding action. Why the KASUGA MARU then altered back to starboard is difficult to explain. However, on hearing the whistle signal from the IRON KEMBLA the fisherman may have taken this to be a warning, rather than a manoeuvring signal. On looking astern the fisherman at this stage may well have been able to see both sidelights of the IRON KEMBLA and so have considered himself to be right ahead of this other ship. If so, expecting the IRON KEMBLA to maintain its course, he may then have decided to alter back onto his original course. What-ever the fisherman's reasons, his alteration to starboard, back to an easterly heading, must have quickly followed the commencement of IRON KEMBLA's swing to starboard under hard a starboard helm, thus making collision inevitable.

- 4 The Master of the IRON KEMBLA was correct in ordering an alteration of course to starboard when the KASUGA MARU was observed to alter course to port to run on a parallel course.
