At 0320 West Australian time, 14 February 1991, the Panama registered bulk carrier *Sanko Harvest* grounded in shoal water between Hastings Island and Hood Island, in position 34° 07.4' South, 122° 05.1' East, approximately 19 miles south south east of Esperance, while on passage from Tampa, USA, via Cristobal, Panama, to Esperance, West Australia, loaded with 30,791 tonnes of fertiliser.

Captain C W Filor, Inspector of Marine Accidents, undertook an investigation into the circumstances leading to the incident with the object of identifying the cause.

# SANKO HARVEST

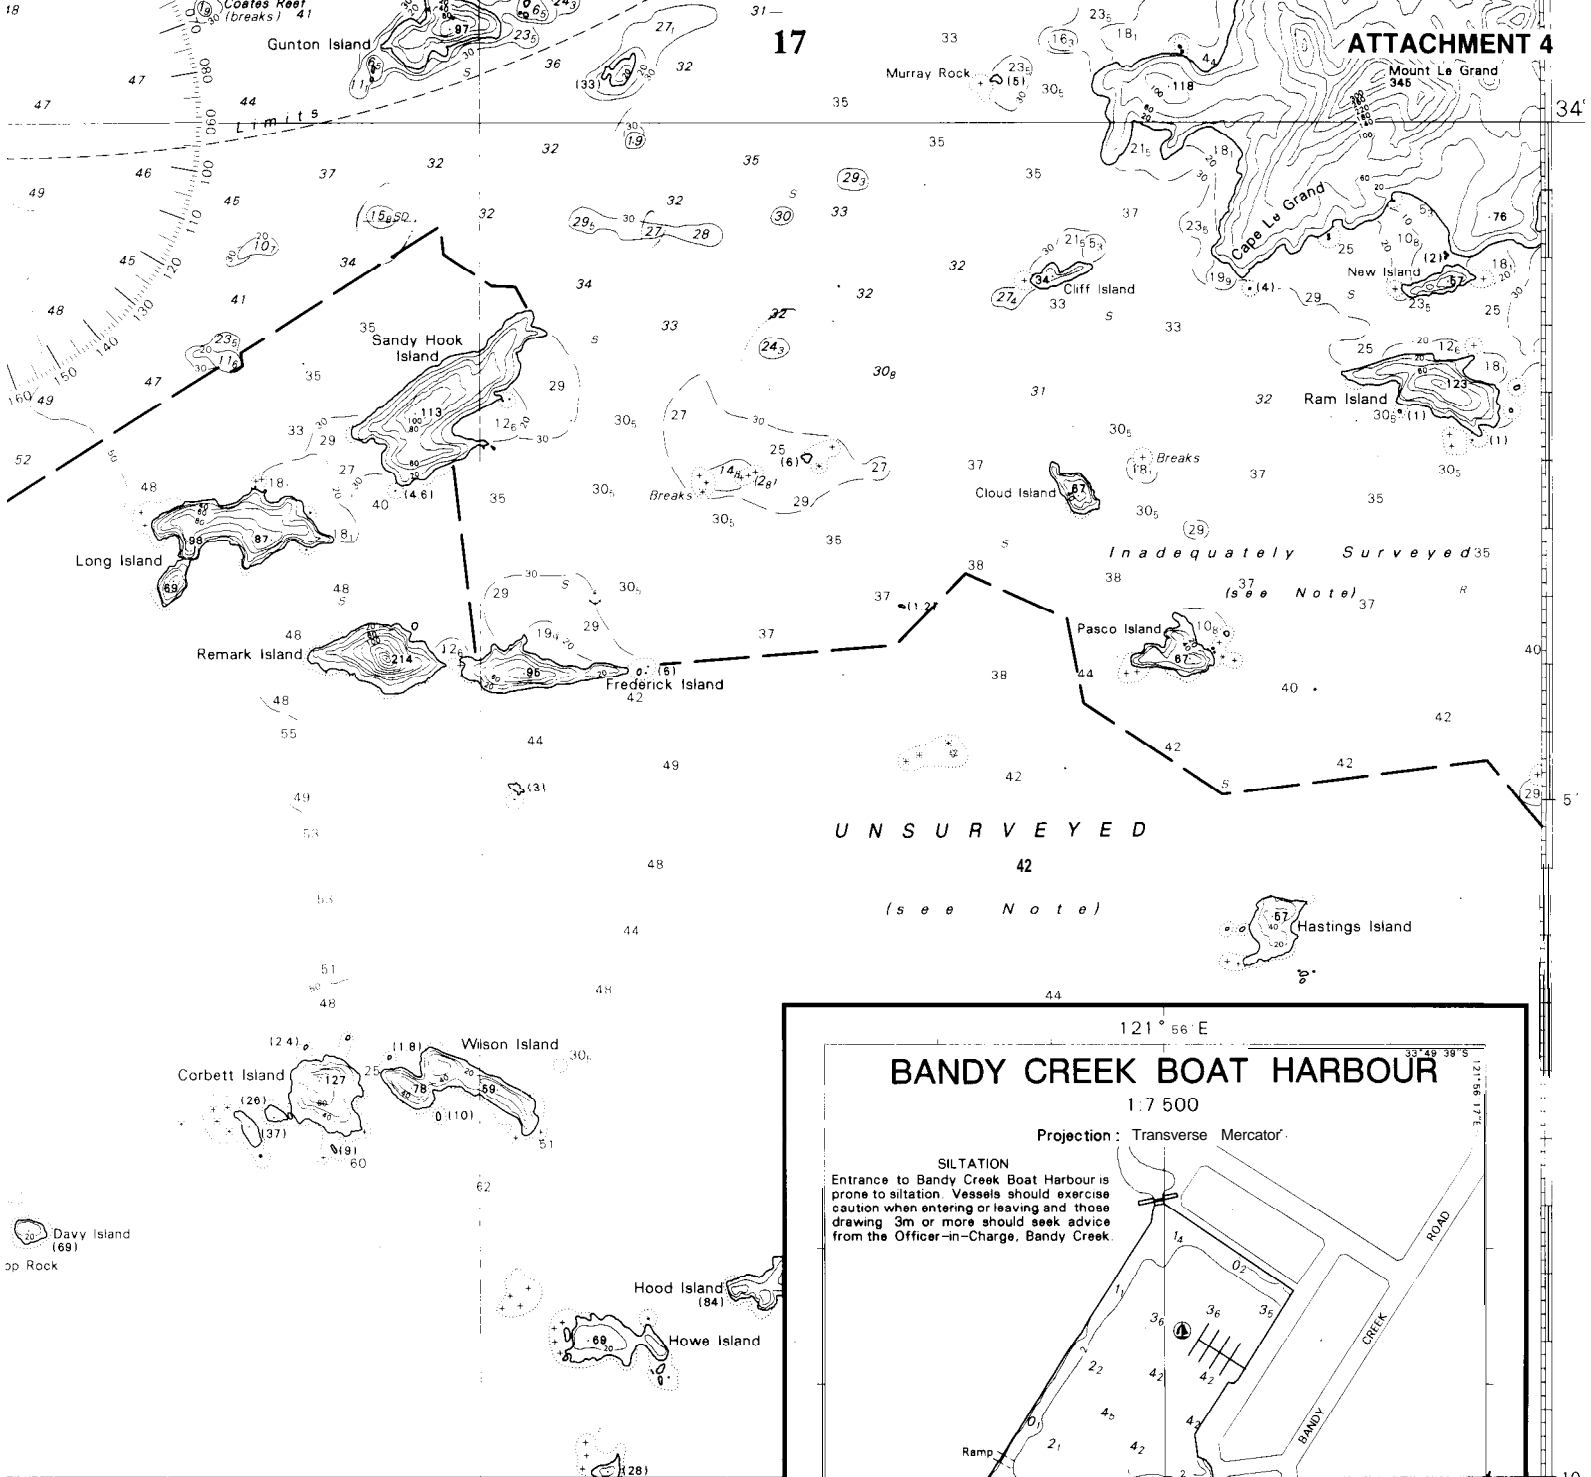
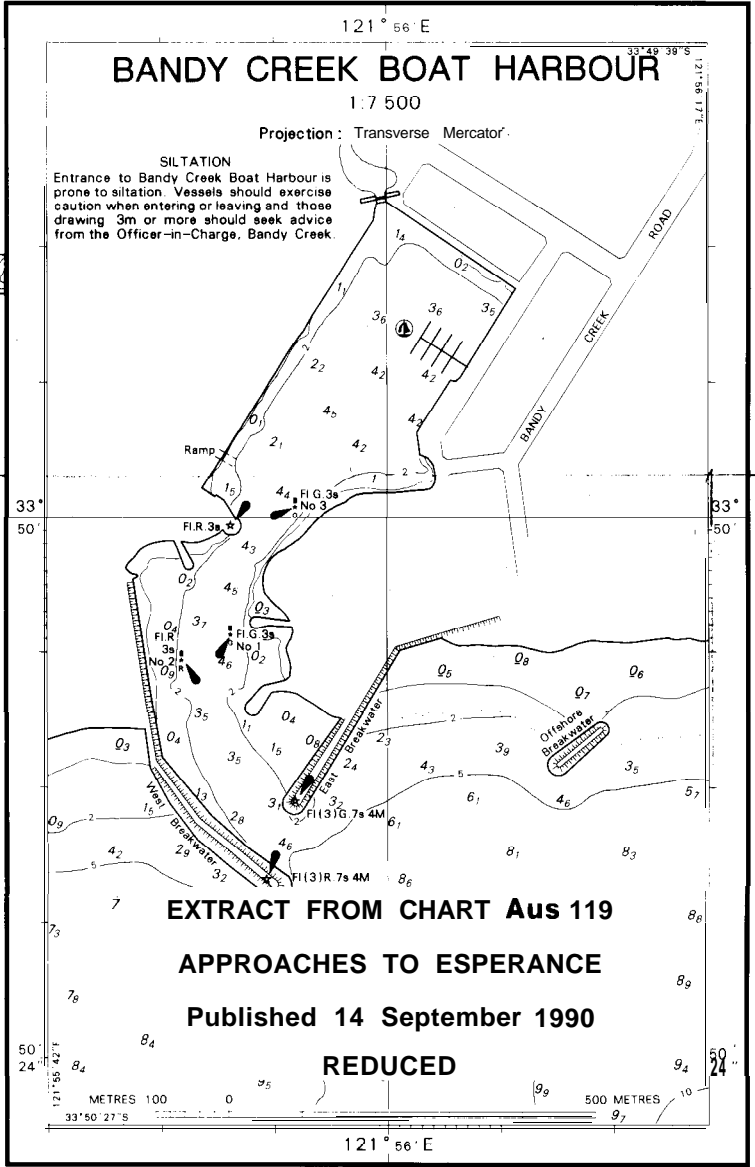
BA 3 189 (reduced) Cape Le Grande to Cape Pasley Copy of chart on board Sanko Harvest at 14 February 1991

Captain Harrod arrived on board the *Sanko Harvest* at 0800. He examined the ship's chart in use at the time (AUS 119) and observed that the last small correction noted in the bottom left hand corner was Aus 500. He stated that he told Captain Kim that the chart in use was not the latest edition. The ship's staff then referred to the notices to mariners on board and found Aus notice 577 notifying mariners that a new edition of the chart would be published shortly. Captain Harrod also stated that there was no suggestion that alcohol or drugs were a factor in the grounding.
