Summary

At about 1830 local time on 1 September 1992, the Australian yacht *Champers*, while on a voyage from Gladstone to Tweed Heads, was involved in a collision with a ship in a position 18.5 miles east of Bustard Head.

Photographs: yacht "Champers" and MV "Antares"

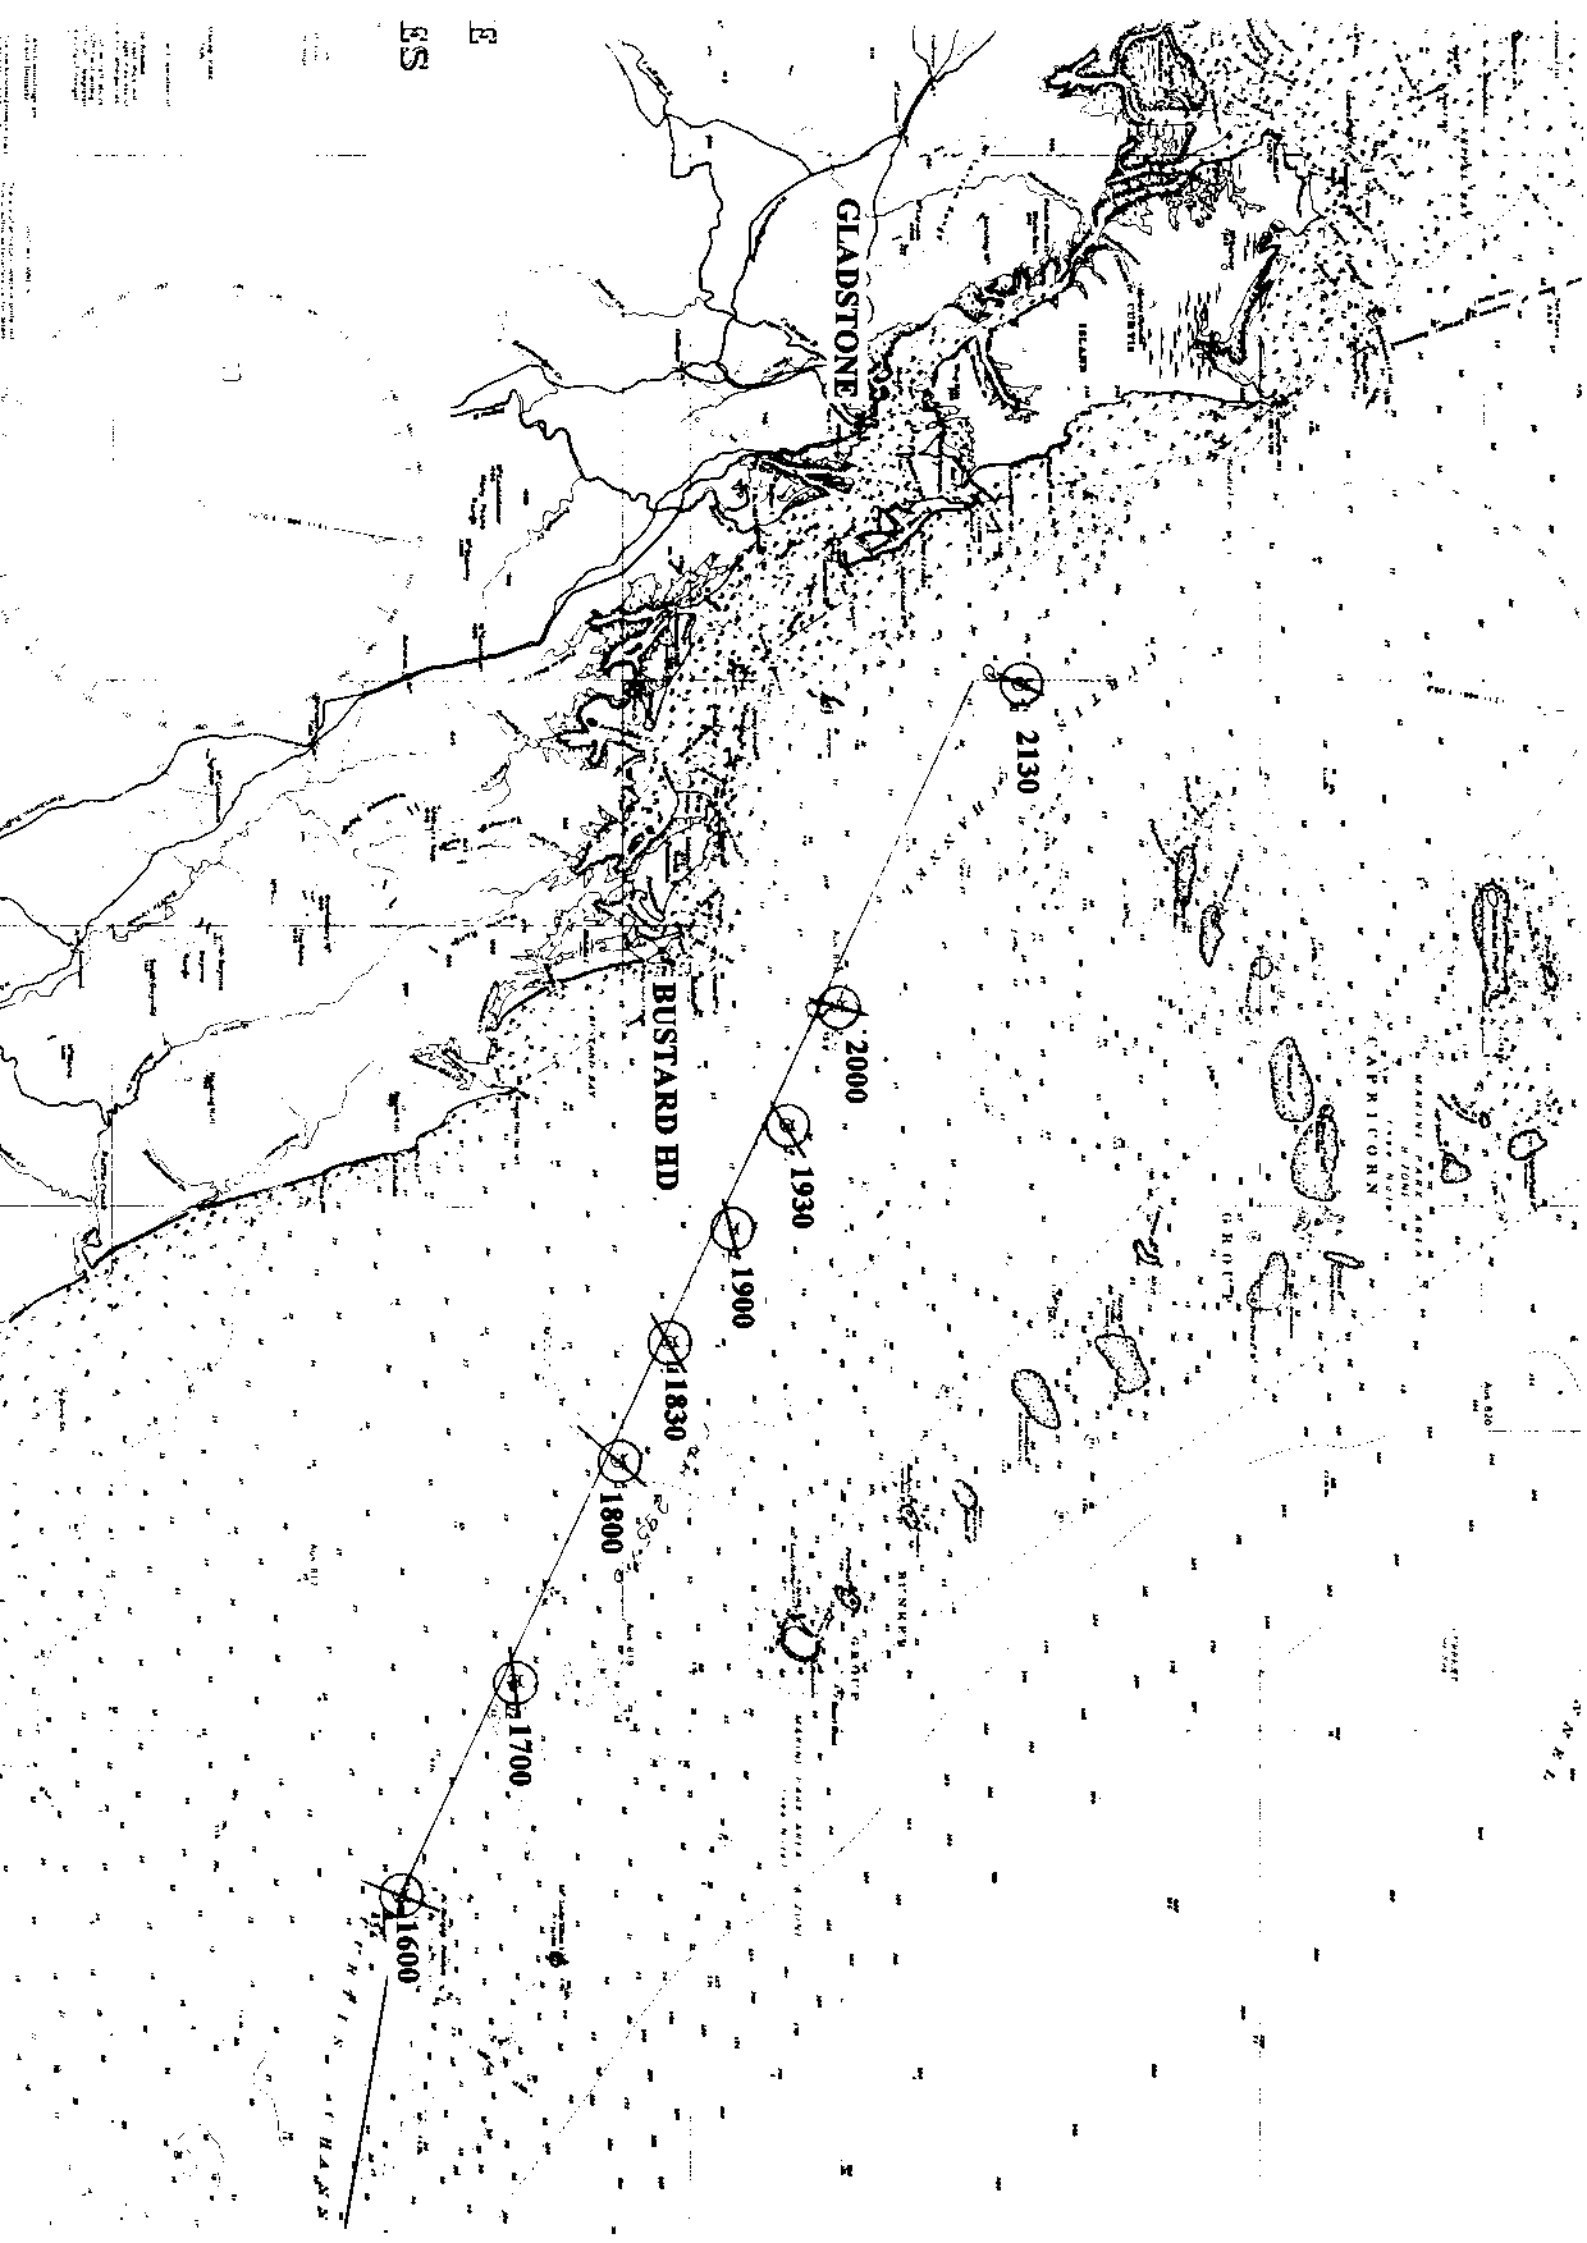
At 1800, the Chief Mate plotted the ship's position on the chart - Lady Musgrave Island bearing 042 degrees at 12.1 miles. A number of fishing vessels were in the area, both to port and starboard, observed both visually and on the radar.
