**Departmental investigation  
into the  
capsize of the crane barge  
TITAN  
off Smoky Cape, on the 25 December 1992  
and  
the subsequent sinking of the barge  
off Camden Head, on 29 December 1992**

into the capsizing of the crane barge

TITAN

Published: 18 October 1993

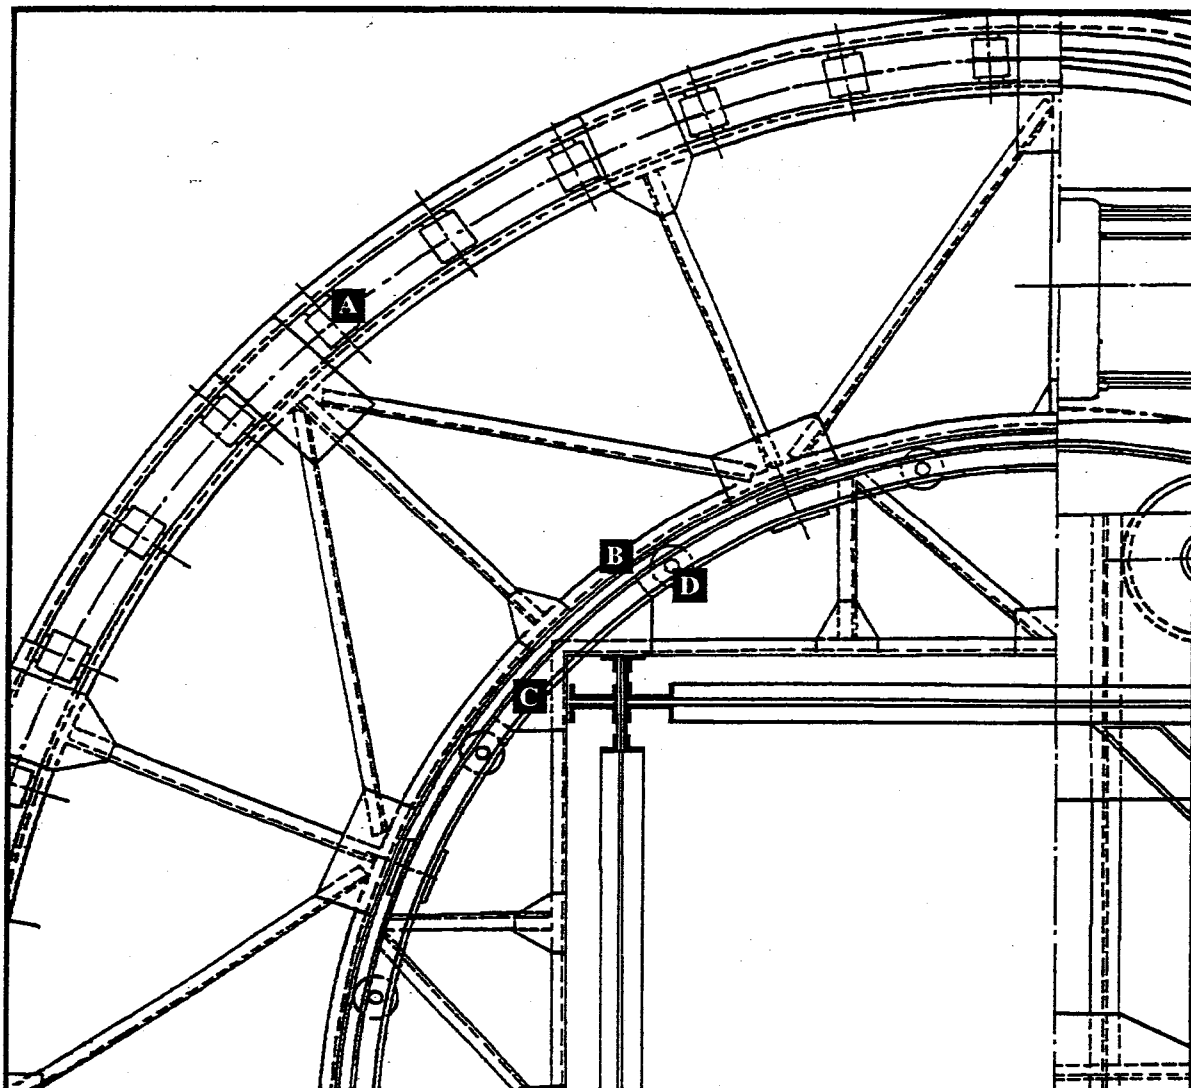
Diagram of live ring  
Plan View

- A. 48- Rollers 203mm dia x 254mm
- B. Live Roller Part
- C. Curcular girder (part of Mast)
- D. 16 Rollers 203mm dia x 102mm

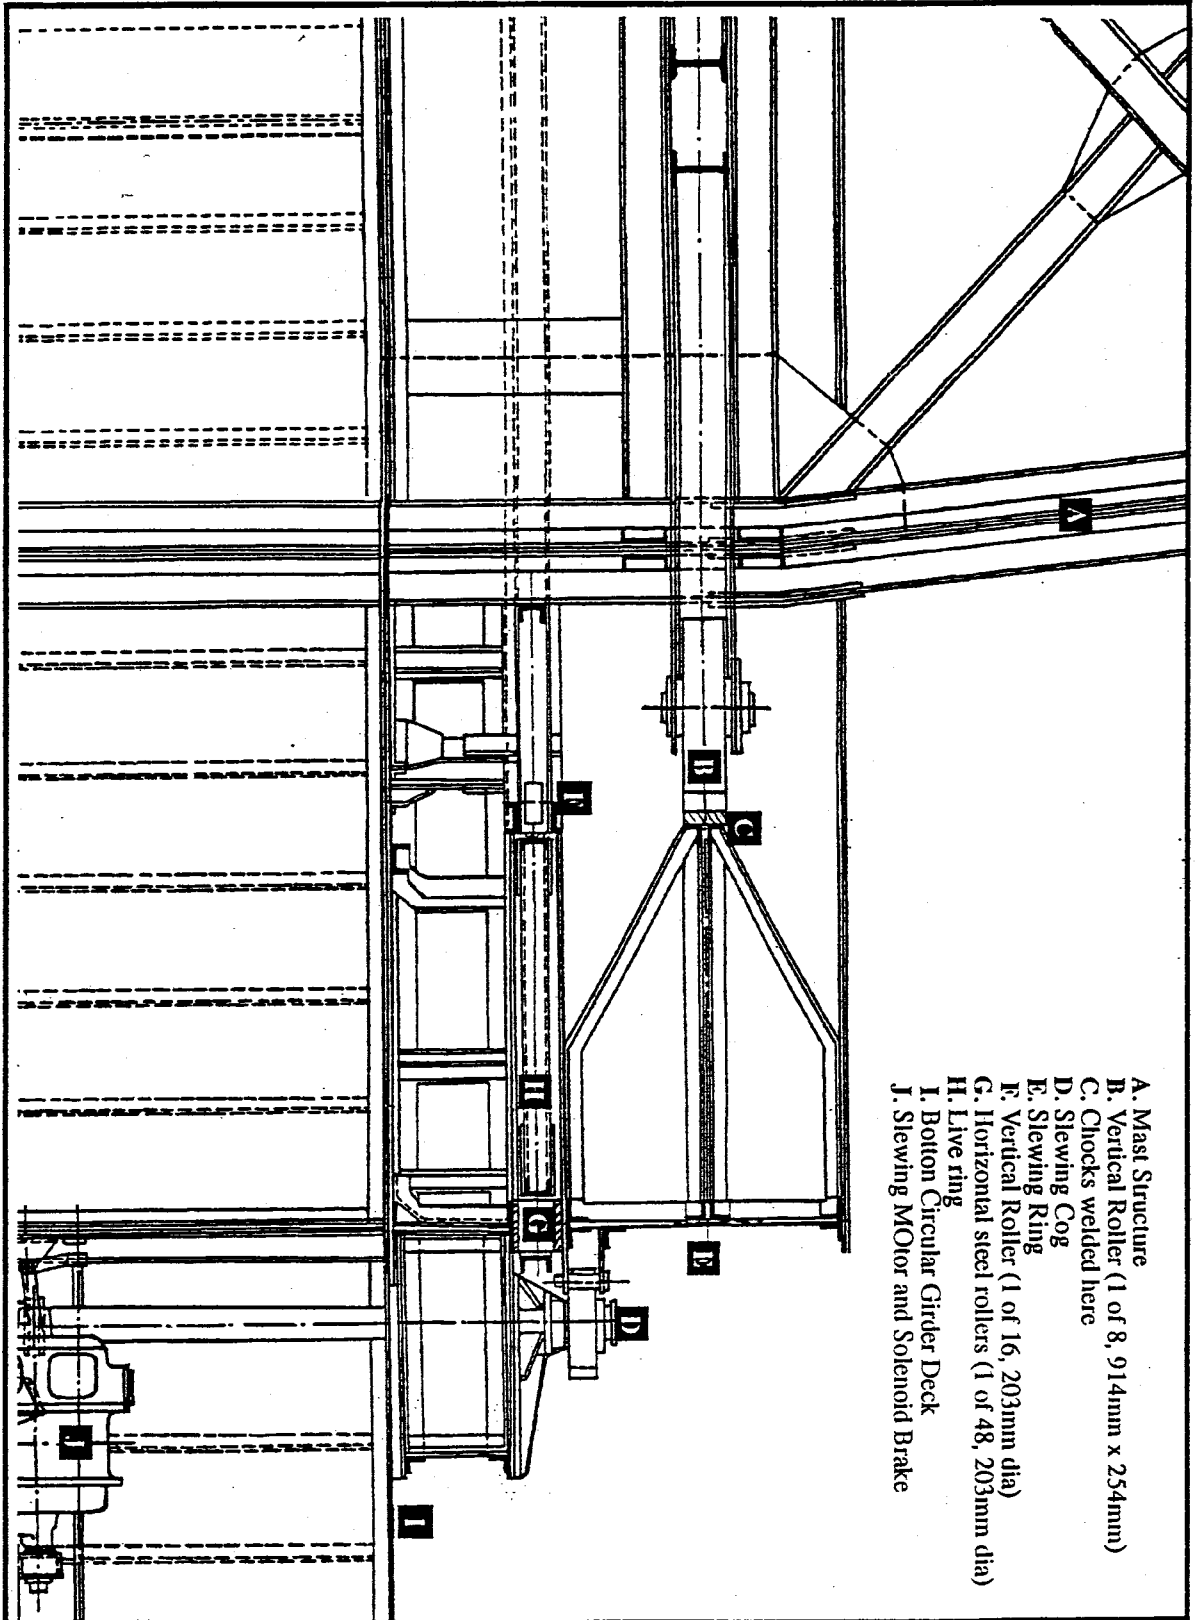
Titan Roller Path  
 Elevation of live ring and slewing ring

The mast was square, constructed of rolled steel plate and sections with a circular channel bar, about 7.2m in diameter, designed so the mast would resist the horizontal forces imposed on it by the crane, without undue deflection. The main horizontal forces were taken by the eight vertical rollers, and the associated bracing of the mast. Each roller was a little more than 914mm in diameter and 254mm deep.

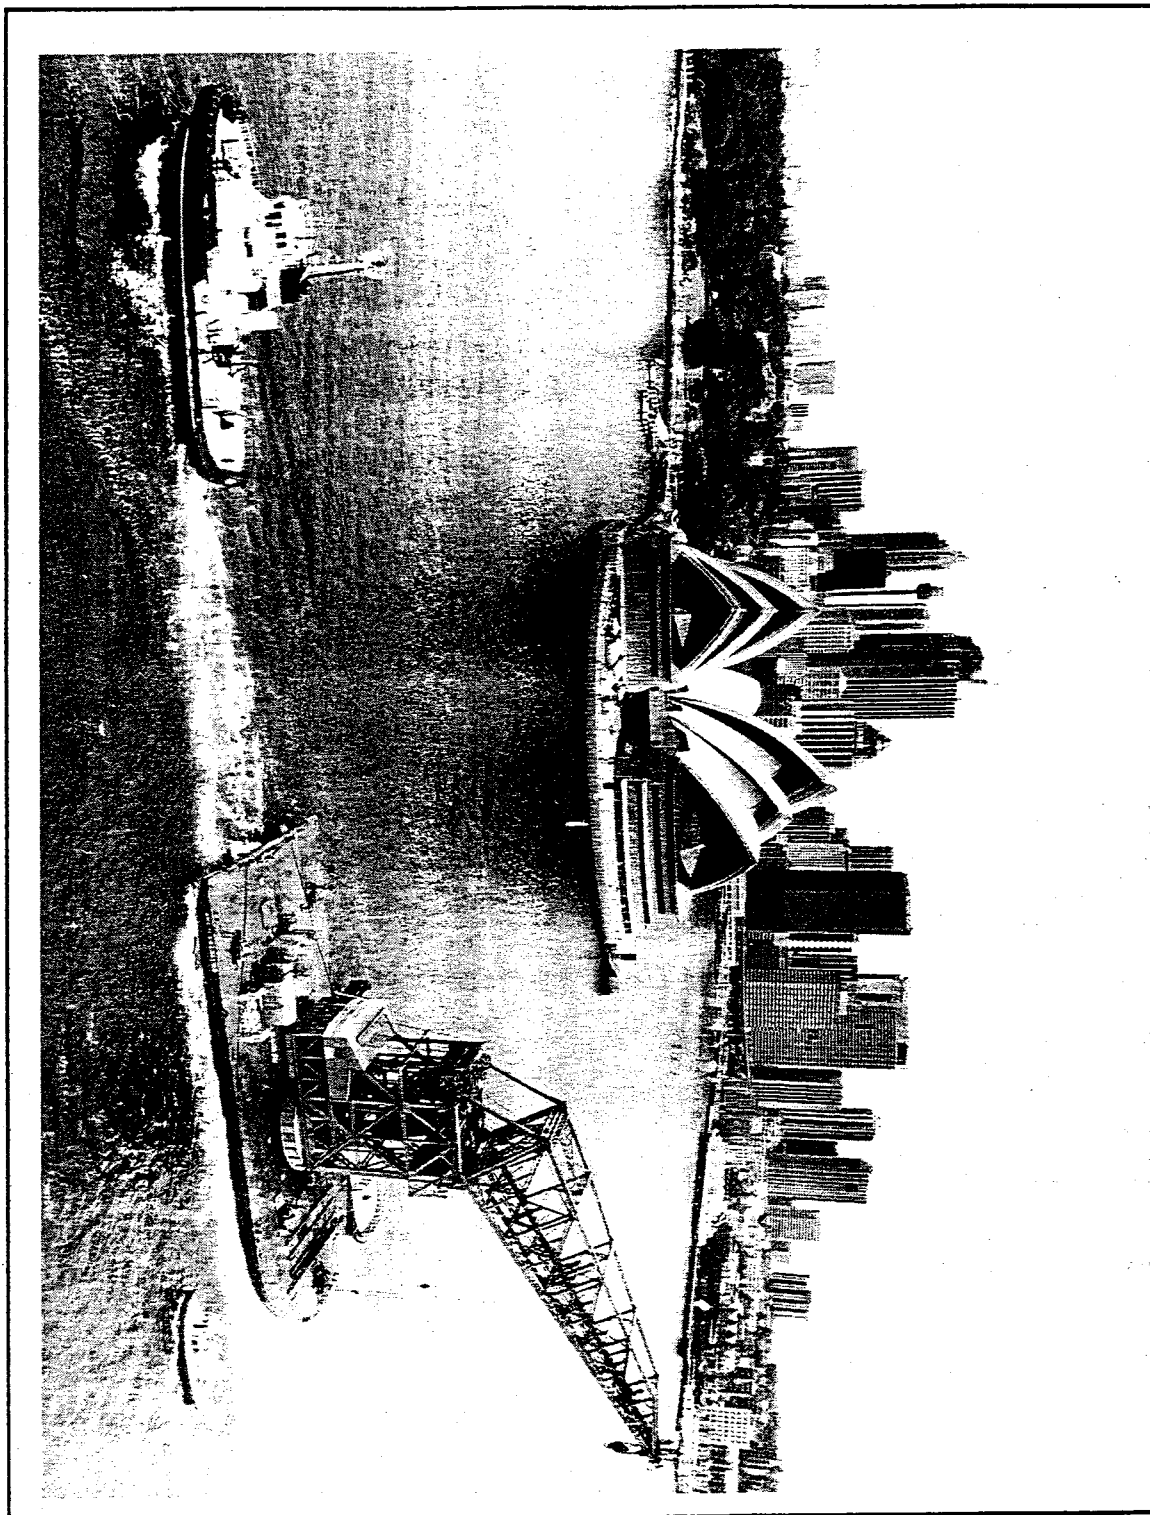
Crane Barge Titan  
Photograph courtesy of John Fairfax Group Pty Ltd.  
Photographer: Robert Pearce

AMSA conducted a final inspection of the barge and its towing arrangement on 21 December. The surveyor satisfied himself that all safety requirements had been met and noted that all the openings to the interior of the barge had been made weather tight. The crane jib had been lowered to its lowest operating

angle, to conform to the barge's condition when inclined and on which the stability data had been calculated. He noted also that the crane had been secured to prevent it from slewing. Experience in towing the Titan within Sydney Harbour had shown that it was difficult to maintain directional stability if towed bow first. The practice had evolved of towing it stern first, which overcame the problem. It was, therefore, decided that the Titan would be towed stern first to Singapore.

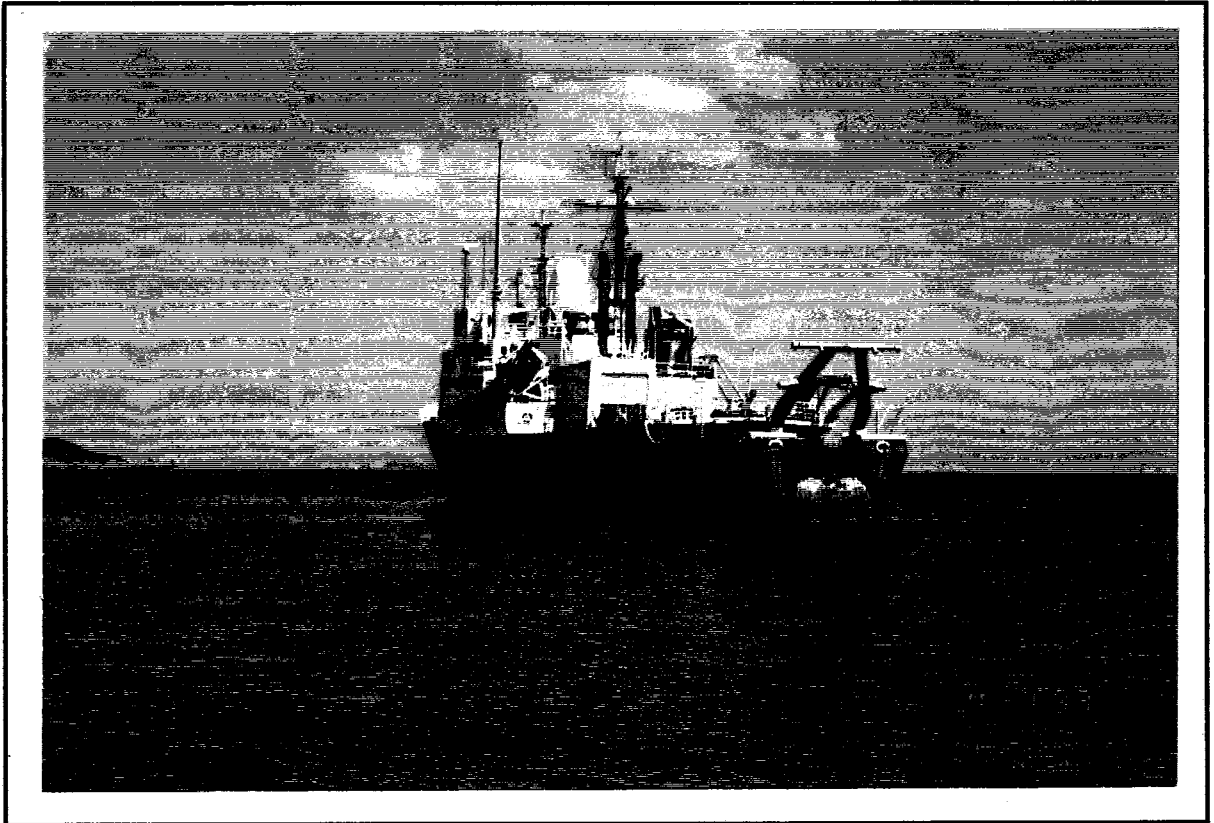
**Photograph Rapuhia**

Under the Port State Control provisions of the Safety of Life At Sea Convention, 1974, Rapuhia was inspected by an AMSA surveyor on 13 December 1992. The general condition of the ship was found to be of a high order. All safety certificates and certificates of competency appeared to be in order and valid, and were accepted at face value, in accordance with the provisions of international Port State Control provisions.

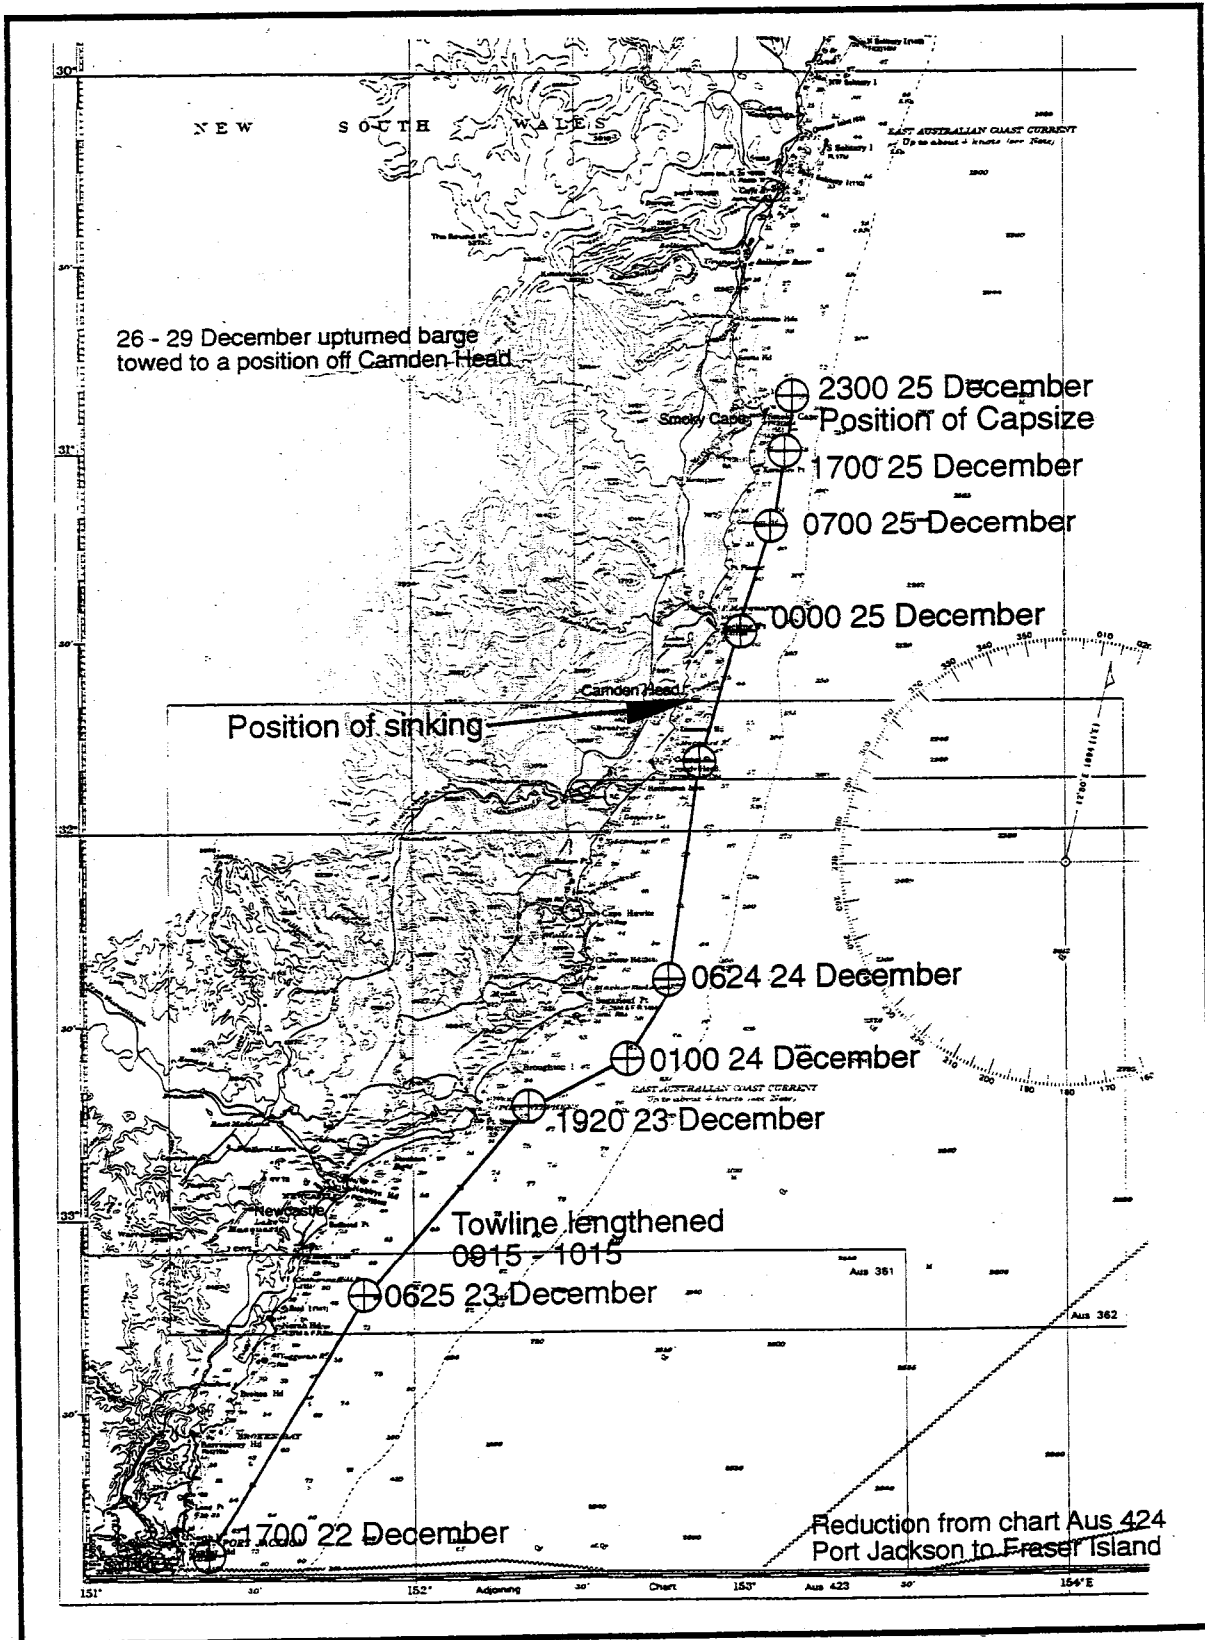
Voyage of the Titan  
22 December 1992 to 29 December 1992

At noon, Titan was in position  $31^{\circ} 04.7'$  South,  $153^{\circ} 10'$  East. Rapuhia was steering  $005$  degrees to make good a course of  $014$  degrees allowing for a nine degree easterly set. A drop in barometric pressure from  $1009$  hectapascals to  $1005$  hectapascals was noted together with an increase in wind force to  $26$  knots from the north and a swell approaching  $2m$ . The log book entry for noon stated :

*"... v/l moving slowly to rough head sea. Drop in barometric pressure noted"*.
