Summary

On 10 December 1993, the Australian flag tanker Osco Star was loading a cargo of petroleum products at the Shell refinery Geelong (Corio). A little after midnight, as the officer of the off-going watch was checking the deck, he opened the sighting port to no.4 port cargo tank and heard the rush of liquid falling into what should have been an empty tank. On checking he found that the gas oil cargo in no.3 centre tank was flowing into no.4 port.

Oscos Star -

10/11 December 1993

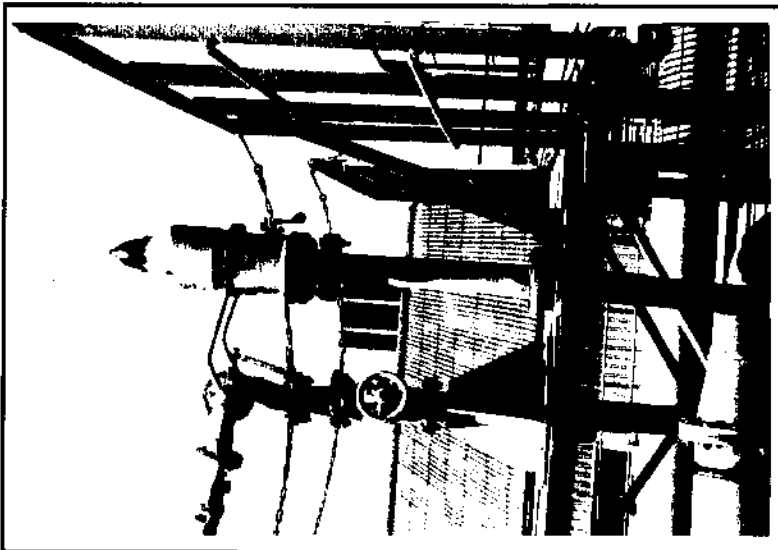
on the 11th, it was accepted that the tank structure had suffered damage due to over-pressurisation, caused by the failure of the pressure/vacuum relief valve on no.3 centre cargo tank, a valve which is designed to vent the displaced gas in the tank when loading, or to relieve vacuum when discharging.

Typical pressure
release valve in
situ
