**Departmental investigation
into a fatality
aboard the offshore supply vessel
SHELF SUPPORTER
off the north-west coast of Australia
on 29 December 1993**

Navigation Act 1912
Navigation (Marine Casualty) Regulations
investigation into a fatality
aboard the offshore supply vessel
SHELF SUPPORTER
off the north-west coast of Australia
on 29 December 1993

No 62

Published: 28 September 1994

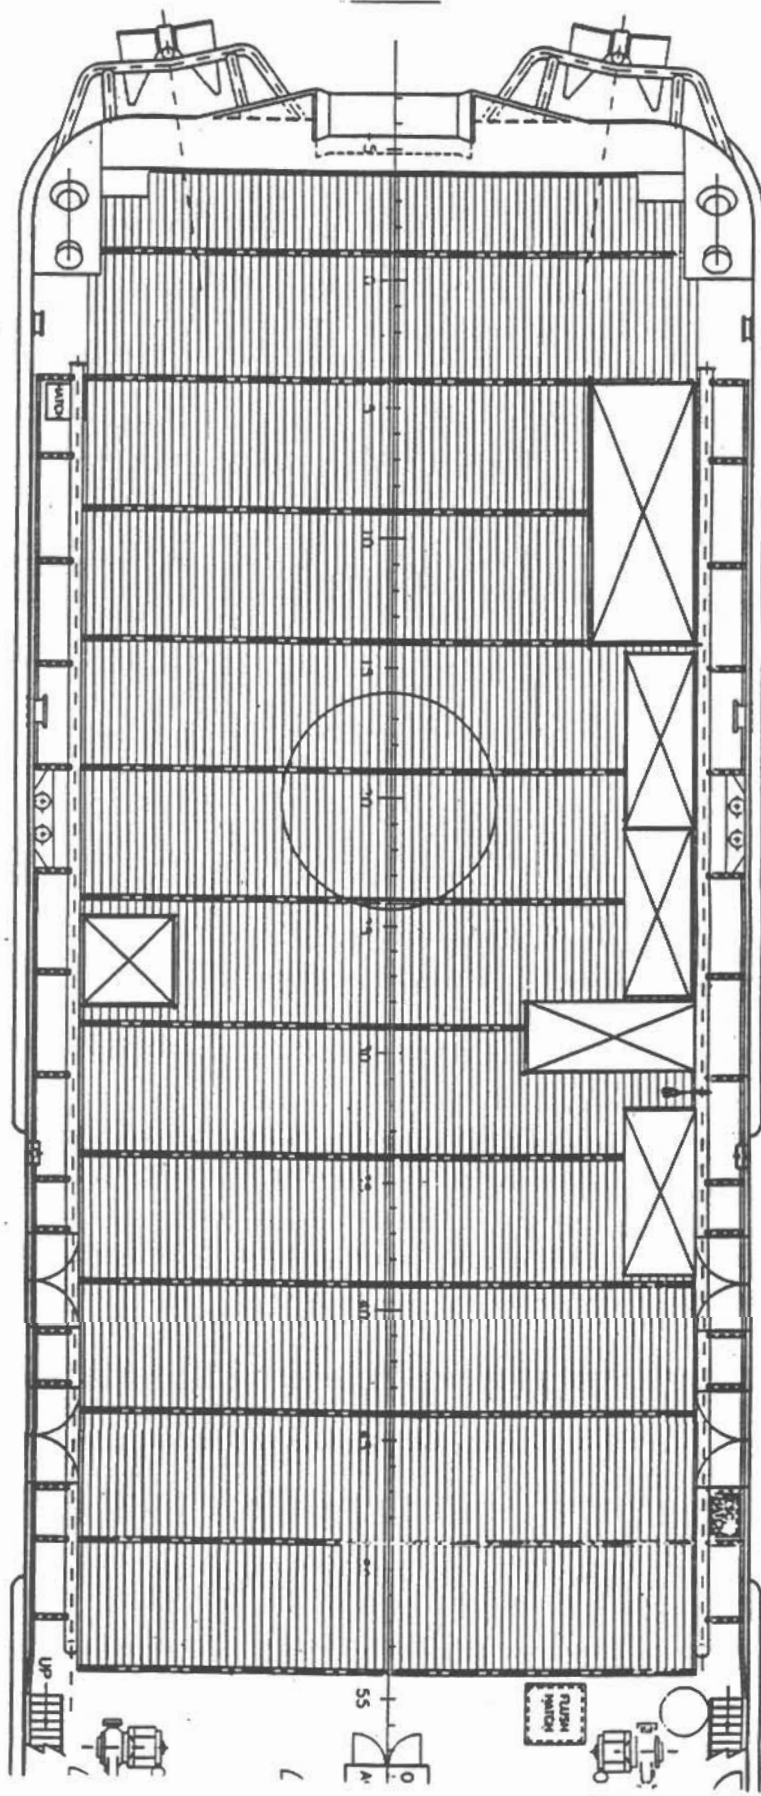
Deck cargo stowage plan immediately prior incident.

Whatever the AB's movements were, the movement and speed of movement of the skip forward on the deck, caused by the seawater travelling up the deck, apparently caught him unawares and pinned him with his back against the after inboard corner of the vessel's skip.

than estimated by the Master, and that the skip was probably close to being afloat.

It is also possible that the sloshing, or free surface effect of the water in the skip may have aided the skip's movement.
