Navigation Act 1912  
Navigation (Marine Casualty) Regulations  
investigation into the capsizing of the  
landing barge

KEPPEL TRADER

and the subsequent fatality  
off the mouth of the Victoria River

7 August 1995

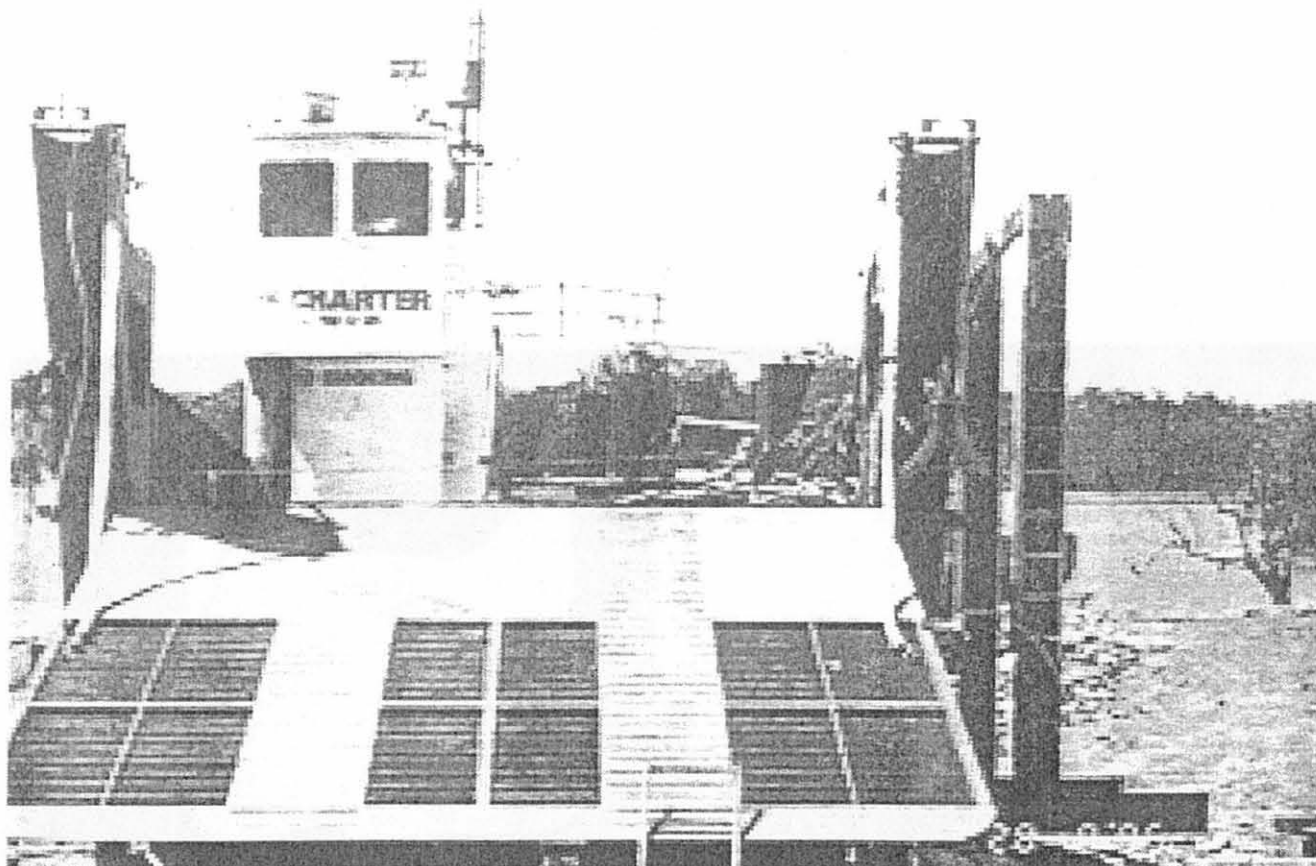
'Keppel Trader' view from forward

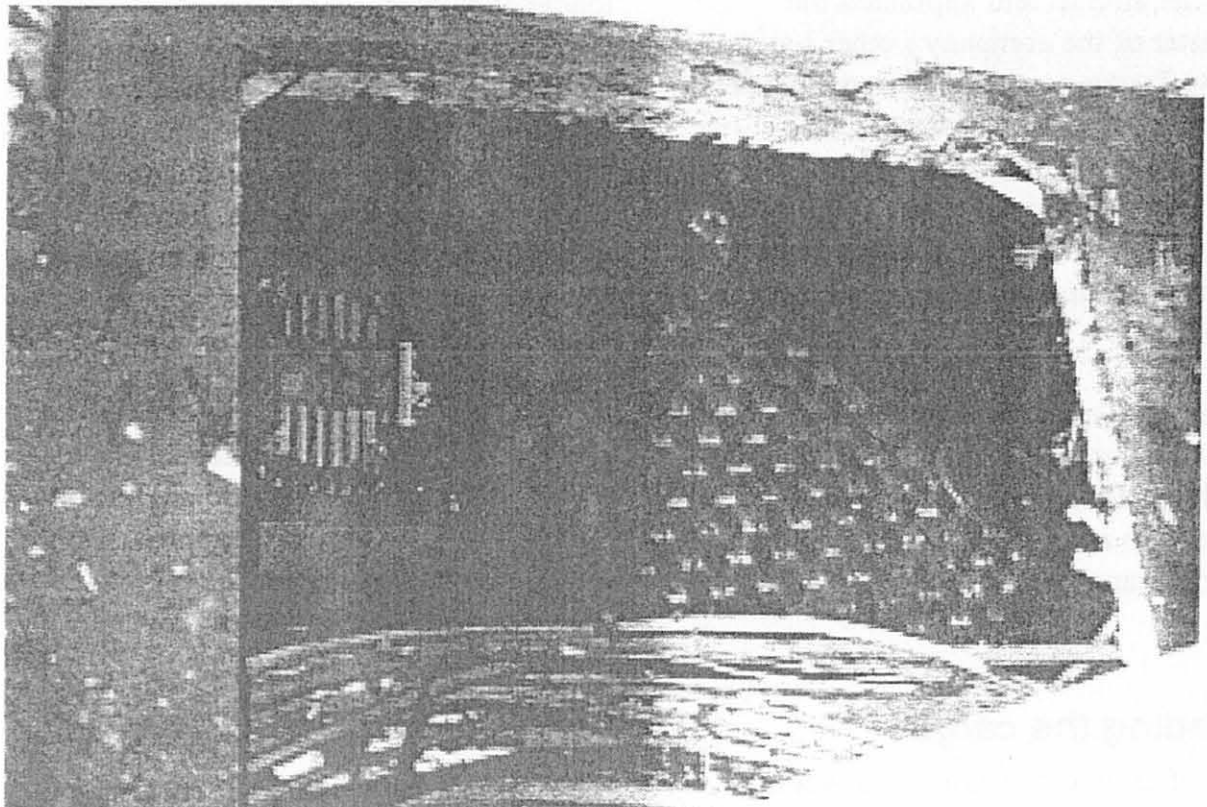
Internal access to engine room showing compressor and cable runs

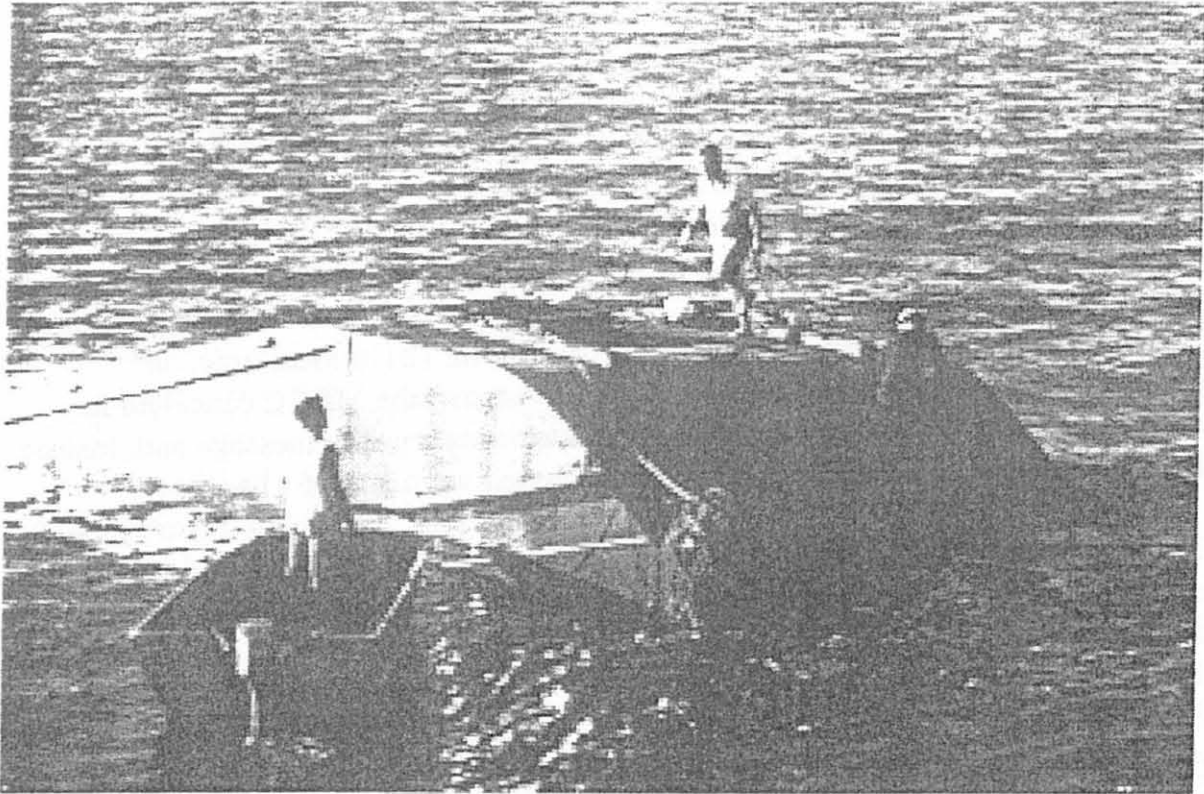
On 11 August, the tug Valali left Wyndham to search for the upturned Keppel Trader and to attempt salvage. It located the barge on the morning of the following day (12 August), 43 miles to the north-west of the position where the Master had been rescued, and commenced towing it to the mouth of the King George River in Western Australia, this having been considered a suitable anchorage at which to attempt to right it.

Upturned Keppel Trader before salvage

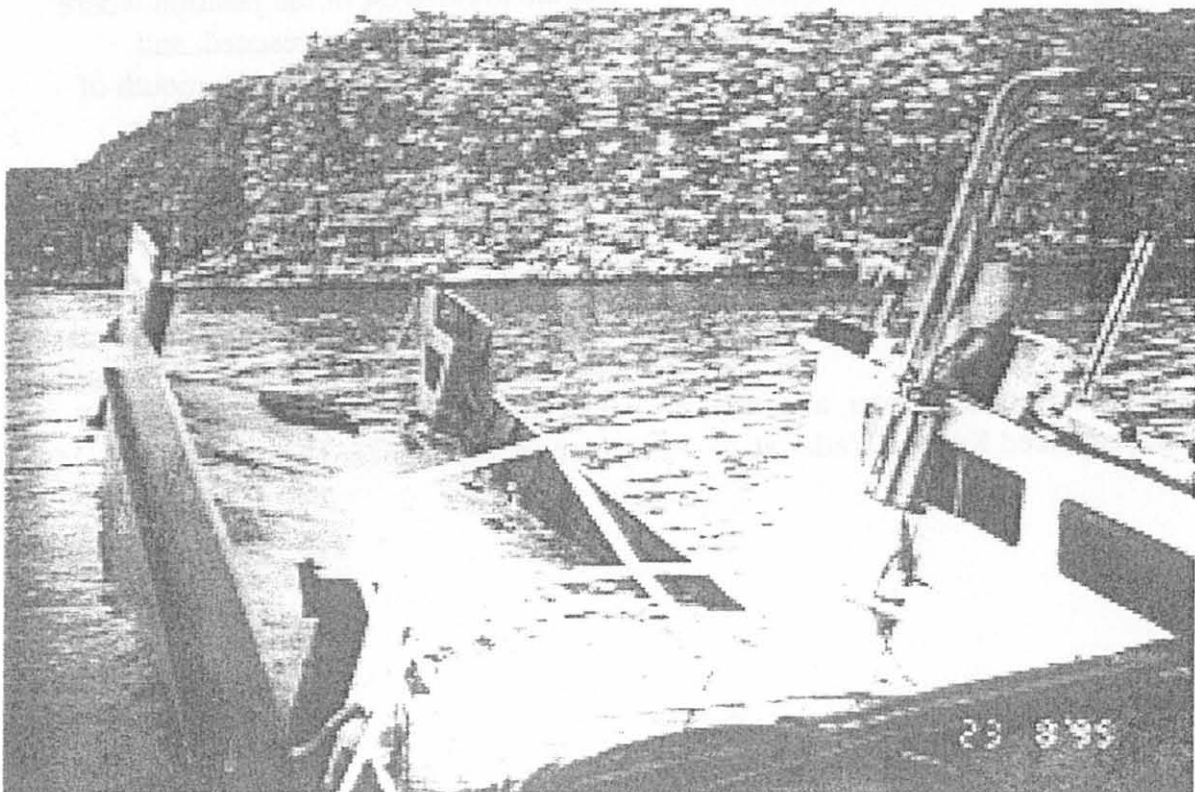
About two weeks later, the barge was successfully righted and towed back to Darwin where it was returned to the owners slipway for repairs and refit.

Keppel Trader being righted during salvage

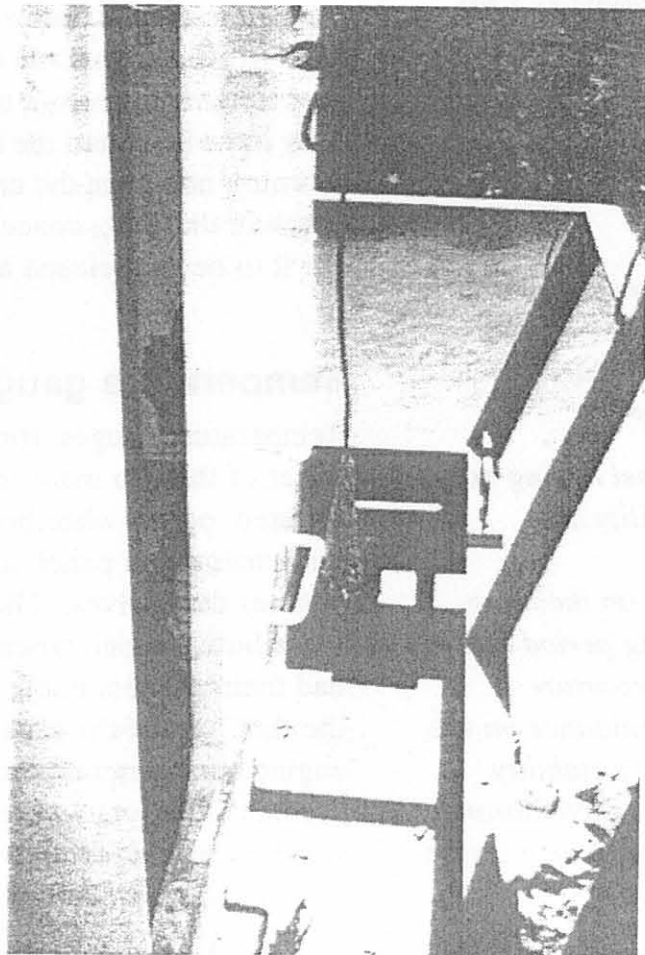
The upturned barge was being carried further out to sea by both the south-easterly winds and the current running from the mouth of the Victoria River. During the morning of Monday 7 August, the Master was battling to retain his hold on the upturned hull, frequently being submerged as the seas washed over him. In an attempt to gain body warmth without becoming totally exhausted, he alternated between being on top of the hull and being in the water, secured to the hull by his strop made from the plastic fuel pipe. He was wearing only a T-shirt and a pair of shorts. So quickly had the vessel capsized, he had no chance to grab either a life-jacket, warm clothes or the EPIRB, stowed in a bracket inside the wheelhouse.

Wheelhouse access showing stowed EPIRB
