Goonzaran

New Noble

# Summary

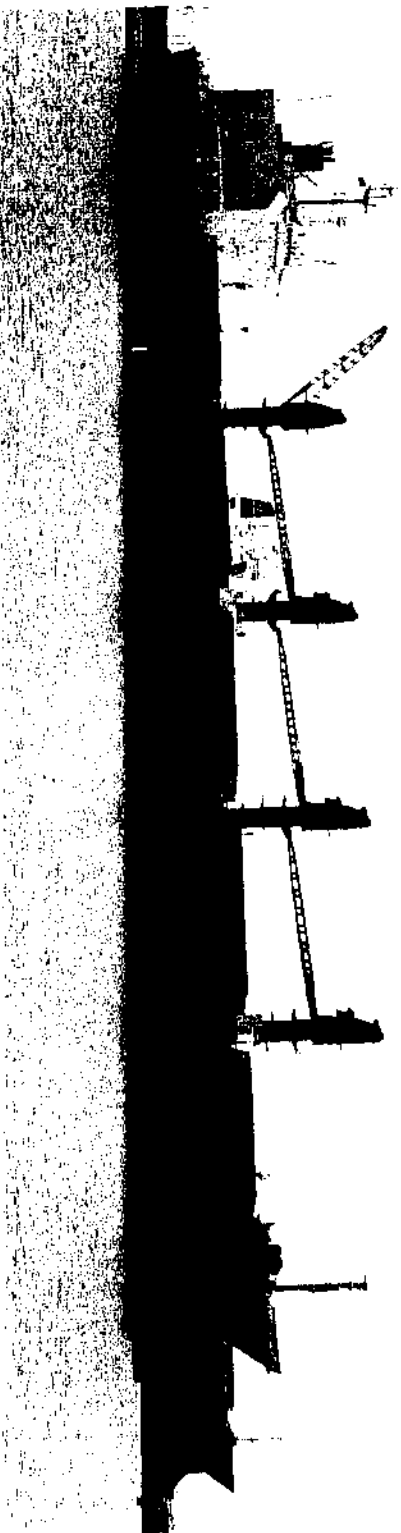
The damage to New Noble was not serious and the classification society imposed a thirty day 'condition of class'. The ship subsequently loaded its cargo and sailed, the necessary repairs having to be made within 30 days.
