Departmental investigation  
into the accommodation fire aboard the  
bulk carrier  
**DOCEBAY**  
off the coast of Queensland  
on  
13 May 1996

**Navigation Act 1912  
Navigation (Marine Casualty) Regulations  
investigation into the into the  
accommodation fire aboard the  
bulk carrier  
DOCEBAY  
off the coast of Queensland  
on  
13 May 1996**

**Report No 92**

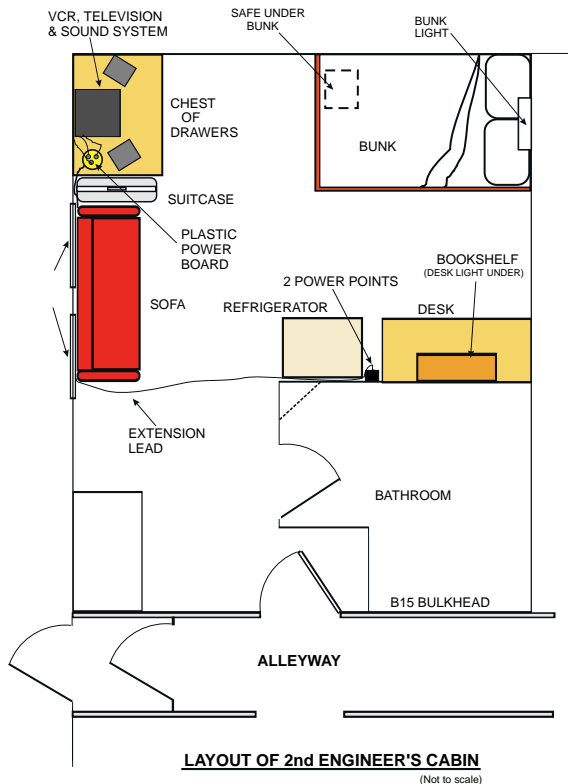
Although the lack of available evidence prevented any conclusion being reached on the cause of the fire, an extension lead used in the Second Engineer's cabin, the construction of which would not meet Australian Standards, was suspected.

**Extension lead and power board as used in 2nd Engineers' cabin**
