**Departmental investigation
into the death of the Master of the
Danish flag vessel
ARKTIS GRACE
at Townsville on
12 October 1996**

Report No. 99

Navigation Act 1912
Navigation (Marine Casualty) Regulations
investigation into the death of the Master of the
Danish flag vessel
ARKTIS GRACE
at Townsville on 12 October 1996

Published: May 1998

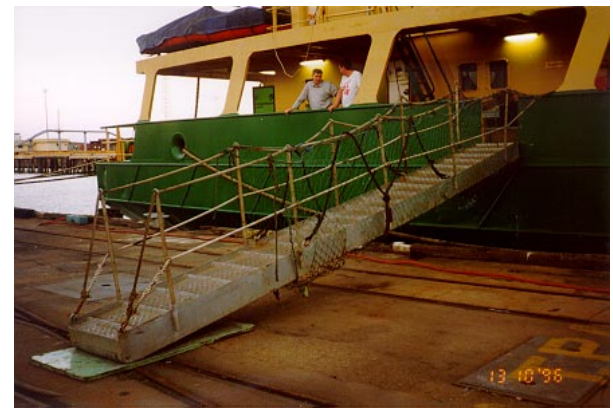
Above the main deck at the aft end of the ship there is an "upper deck" upon which is situated the ship's superstructure. At the port of Townsville, the level

Gangway arrangement of Arktis Grace
