ATSB TRANSPORT SAFETY REPORT  
Marine Occurrence Investigation No. 268  
MO-2009-008  
Final

Independent investigation into the collision between  
the Australian registered yacht

**Ella's Pink Lady**

**Silver Yang**

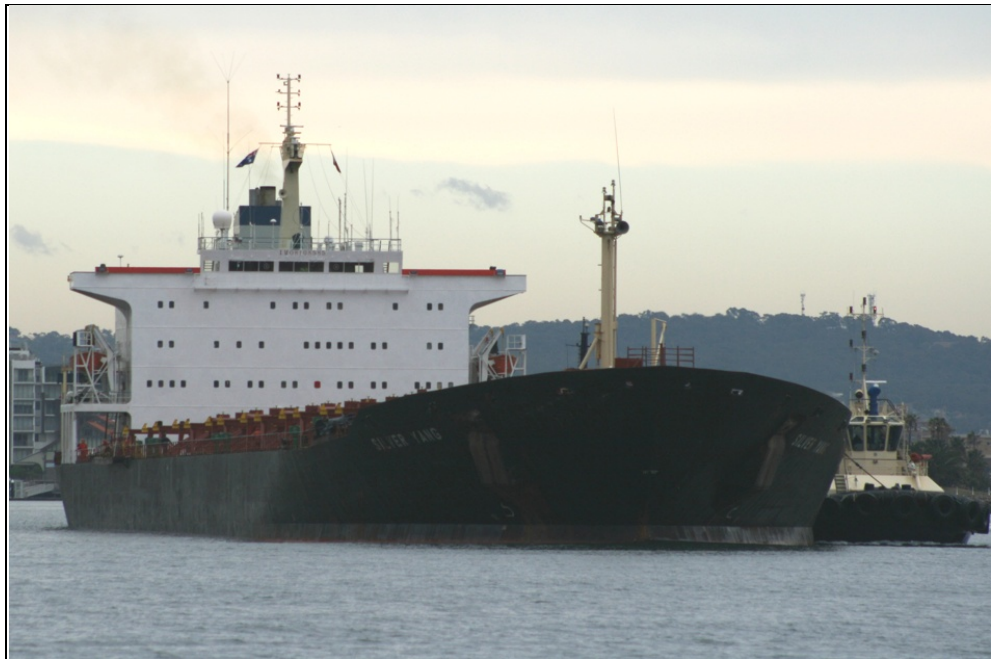
**Figure 1: *Silver Yang***

*Silver Yang* is a conventional ‘Panamax’<sup>3</sup> bulk carrier with seven cargo holds located forward of the ship’s accommodation superstructure (Figure 1). The ship was built in 1982 in Copenhagen, Denmark. It has an overall length of 225.03 m, a moulded breadth of 32.31 m, a moulded depth of 18.01 m and a deadweight of 63,800 t at its summer draught of 13.08 m.

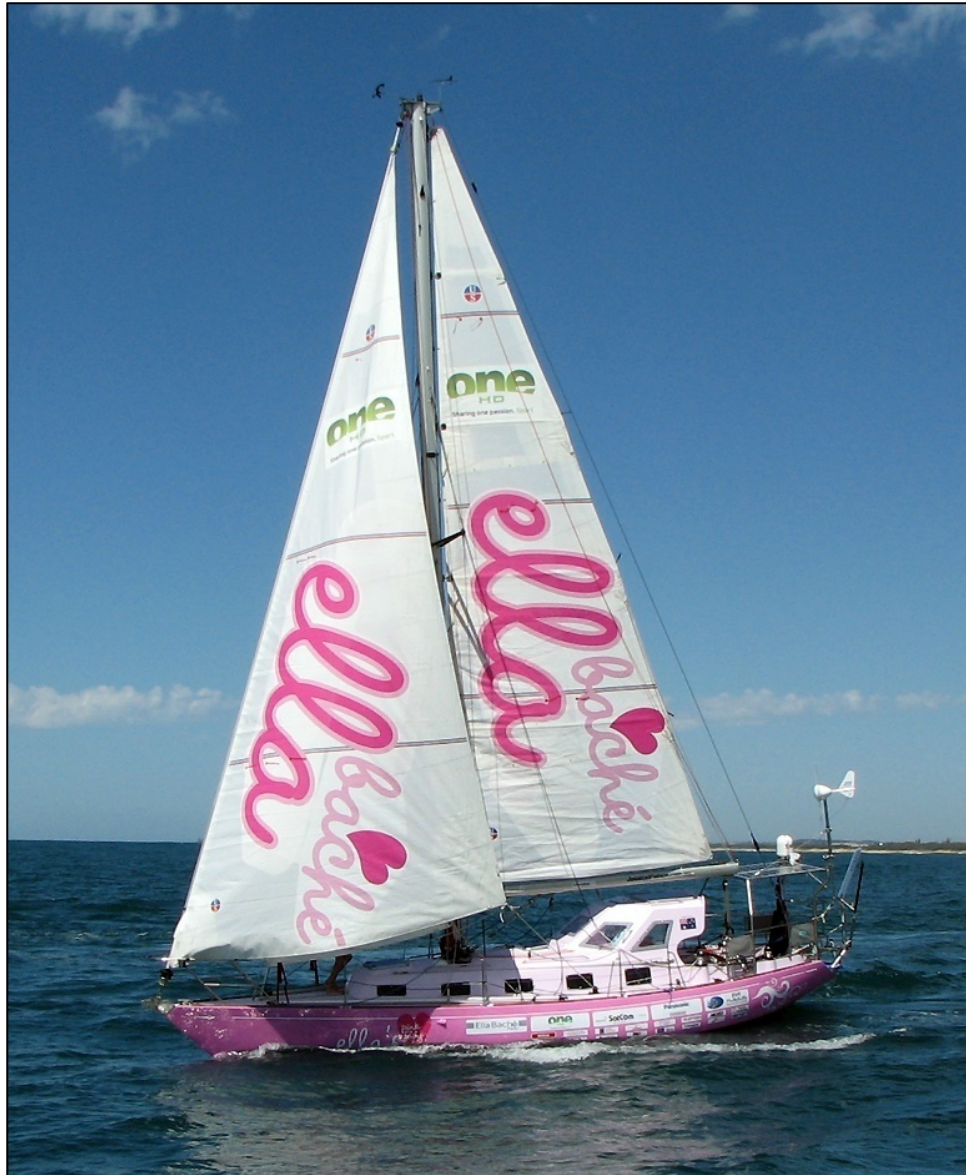
**Figure 2: *Ella's Pink Lady***

At the time of the incident, the yacht was privately owned and registered under the name *McIntyre Adventure*. It had been loaned to its current skipper to enable her to attempt an unassisted, solo, round-the-world voyage. During the previous year, the yacht had undergone an extensive refit and re-named *Ella's Pink Lady* (Figure 2).

Port and starboard navigation sidelights (separate units) were mounted on the yacht's bow (pulpit) railing, about 1.5 m above the waterline. A stern light was mounted at about the same height on the stern. A tri-colour navigation light<sup>6</sup> was also fitted to the masthead. The navigation lights met the statutory requirement for a vessel of this size, hence the sidelights should be visible at a range of at least 1 mile.

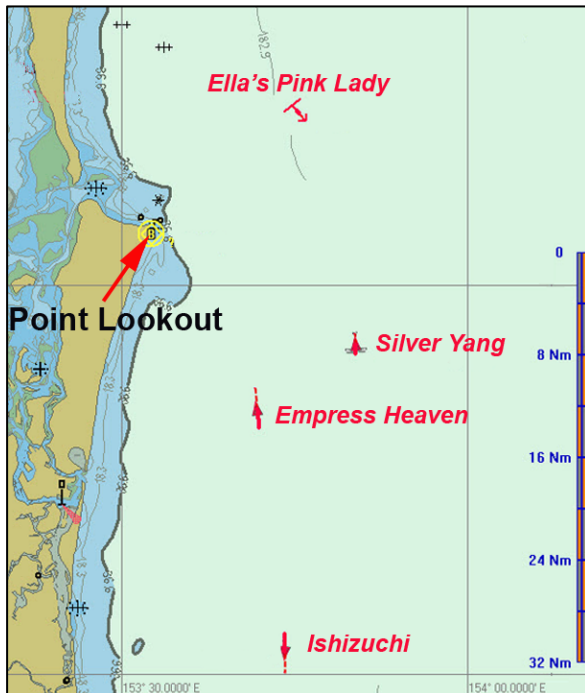
By 0030 on 9 September, *Ella's Pink Lady* was about 15 miles northeast of Point Lookout (Figure 3) and making good a course of about 140°(T) at a speed of 4 knots. The yacht was near the 100 fathom<sup>10</sup> line and in the south-setting East Australia Current. *Silver Yang* was about 17 miles east-southeast of Point Lookout, on a northerly heading and travelling at a speed of 8.7 knots.

Figure 3: AIS image derived from the Point Lookout AIS base station showing the vessels in the vicinity at 0030

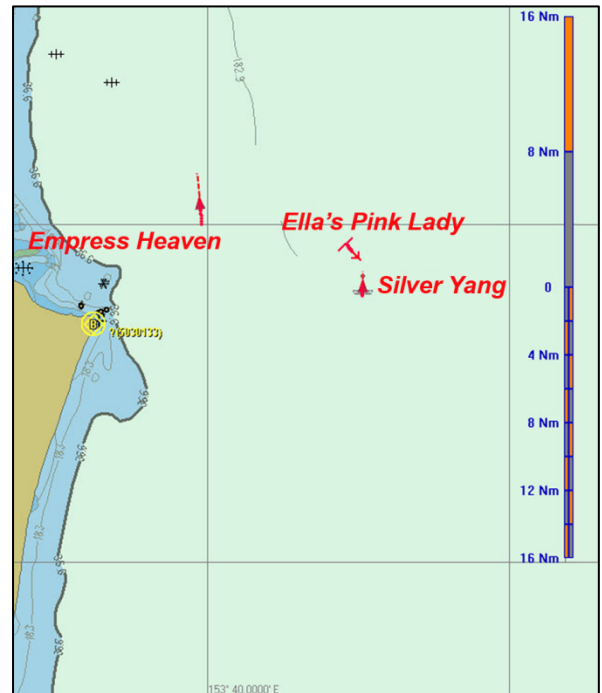
At about 0146, *Ella's Pink Lady's* skipper prepared for another catnap. The yacht was now making good a course of 144°(T) at a speed of 6.8 knots. The skipper checked the radar and noted that there was a vessel about 6 miles off the starboard quarter<sup>11</sup> (Figure 4). She could not see it visually, but she monitored its progress on the radar for about 1 minute. Once she had determined that it did not present a collision risk, she again set the radar guard-rings and alarm clocks before going to bed. By this time, *Silver Yang* was about 1 mile to the south-southeast of *Ella's Pink Lady's* position (Figure 5). However, the yacht's skipper had not detected the ship's presence.

Figure 4: AIS image derived from the Point Lookout AIS base station showing the vessels in the vicinity at 0146
