Crew member fatality on board the bulk carrier *Nireas*

Gladstone anchorage, Qld | 20 March 2013

ATSB Transport Safety Report
Marine Occurrence Investigation
299-MO-2013-005
Final – 4 March 2014

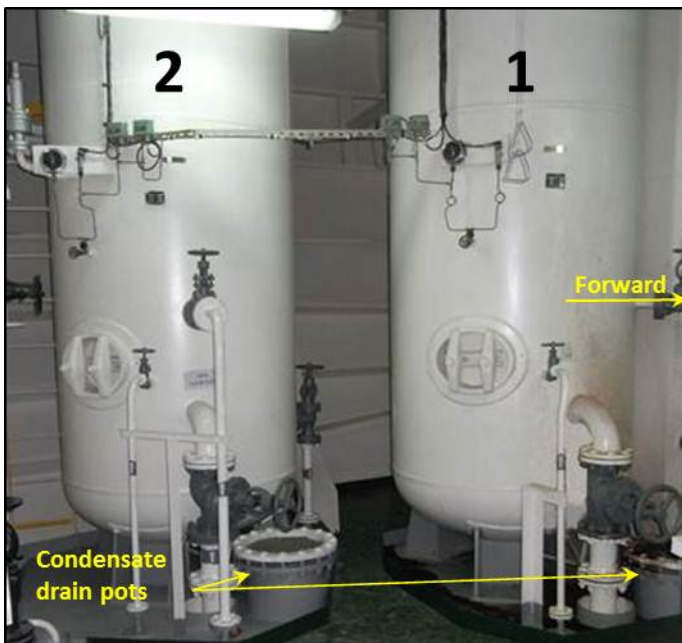
Figure 3: Main air receivers in *Nireas*

Two main air compressors and an emergency air compressor supplied 30 bar air, while a working air compressor supplied 7 bar air for deck requirements. The air was stored in two 5.5 m³ 30 bar main air receivers (Figure 3), a 30 bar auxiliary air receiver and two 7 bar control and working air receivers.

The main air receiver condensate drainage pots were heavy steel cylinders about 600 mm high and 426 mm in diameter mounted into the deck adjacent to the air receivers (Figure 3). The top of each consisted of a toughened glass inspection cover clamped to the steel cylinder by a steel flange plate (Figure 4). The drain from the air receiver entered the cylinder from the side and was then directed toward the bottom. The outlet drain line was fitted in the centre of the bottom of the pot.
