Engine room fire on board the bulk carrier *Marigold*

Port Hedland, Western Australia | 13 July 2014

ATSB Transport Safety Report
Marine Occurrence Investigation
312-MO-2014-008
Final – 20 April 2016

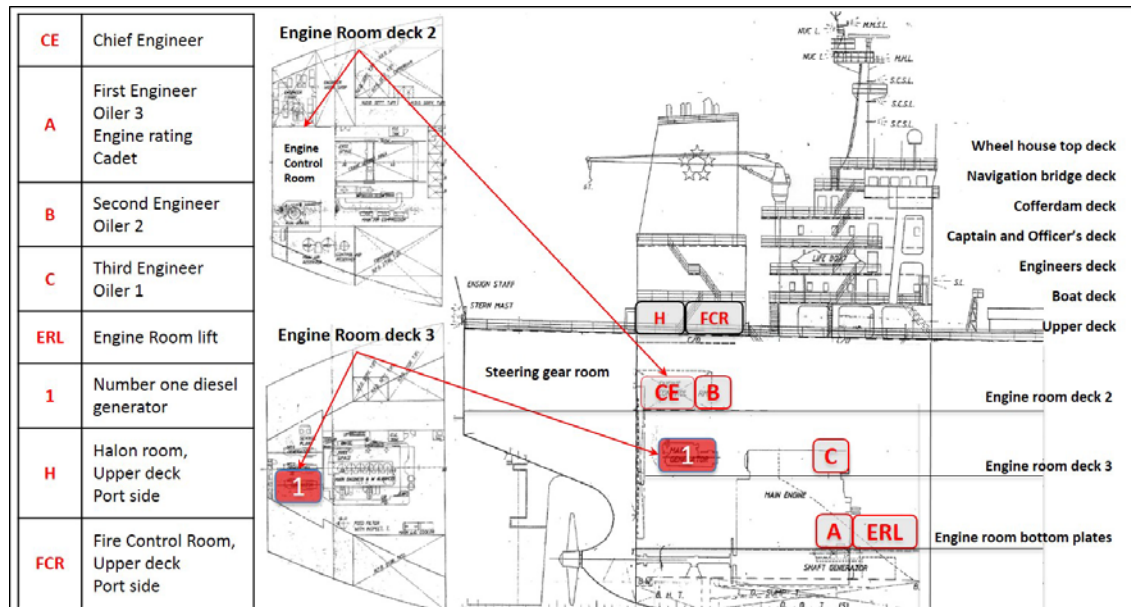
Figure 2: Plan showing crewmembers locations in the engine room when the fire started

Shortly after 1200, the third mate handed over the cargo watch to the second mate. At about 1300, *Marigold's* engineers and engine room ratings met in the engine control room (ECR). The chief engineer assigned them work, which included routine checks in preparation for the ship's departure from port. To progress the work, they split into three separate work teams (Figure 2).

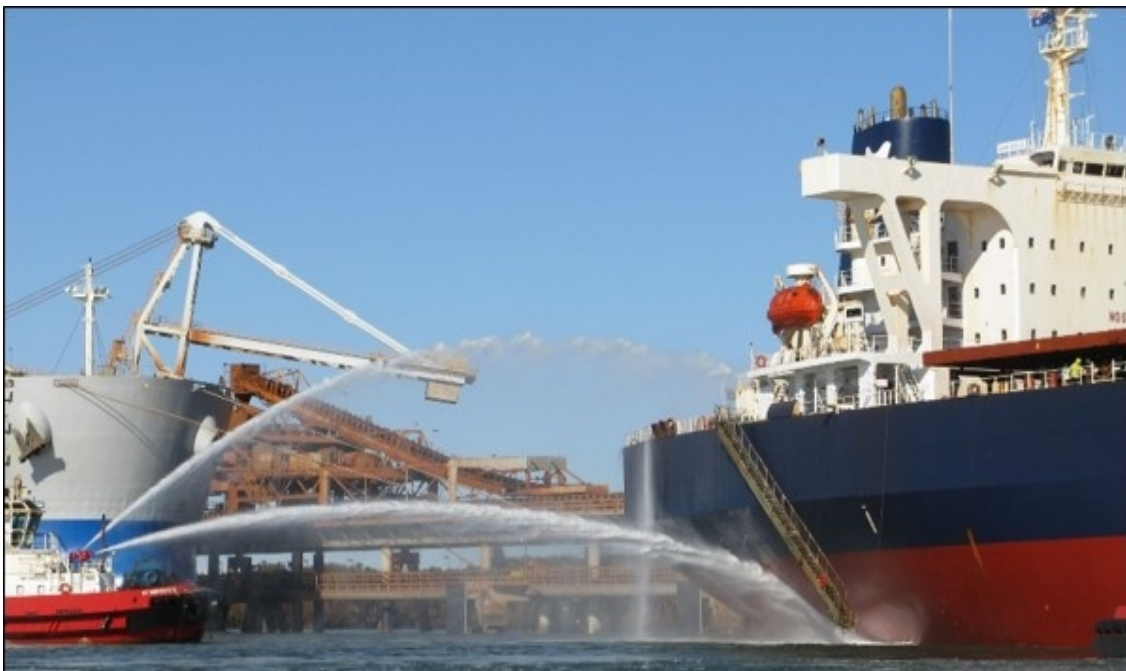
Figure 4: Harbour tug boundary cooling the engine room

At 1525, one harbour tug (Figure 4) started boundary cooling and another tug started pushing the ship onto the wharf. Consequently, the master informed the chief engineer to stop the emergency generator and close its dampers to prevent water spray from entering its air intakes.

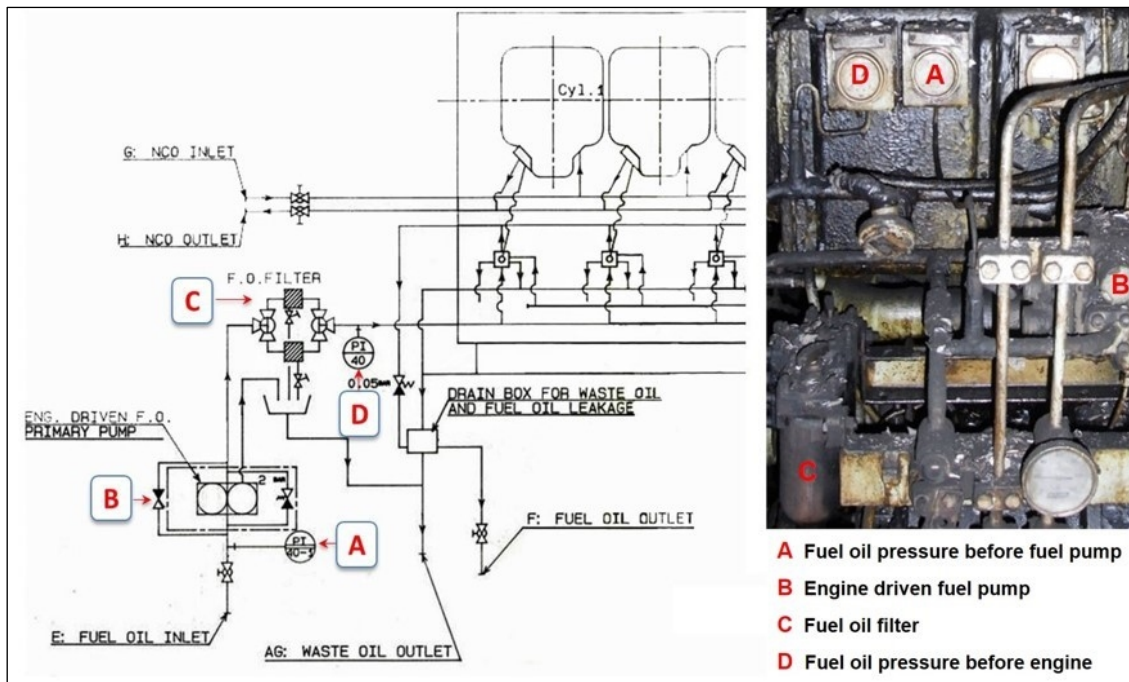
Figure 6: Diesel generator fuel oil supply system

At the engine, a low-pressure gear pump circulated fuel through a fuel filter to the main fuel oil injection pumps. Two pressure gauges (marked 'A' and 'D' in Figure 6) indicated the fuel oil pressure before the fuel pump and fuel oil pressure before the engine.
