ATSB TRANSPORT SAFETY REPORT
Marine Occurrence Investigation No. 261
MO-2008-013
Final

Independent investigation into the fatality on board the
Australian registered floating storage and offloading tanker

Karratha Spirit

24 December 2008

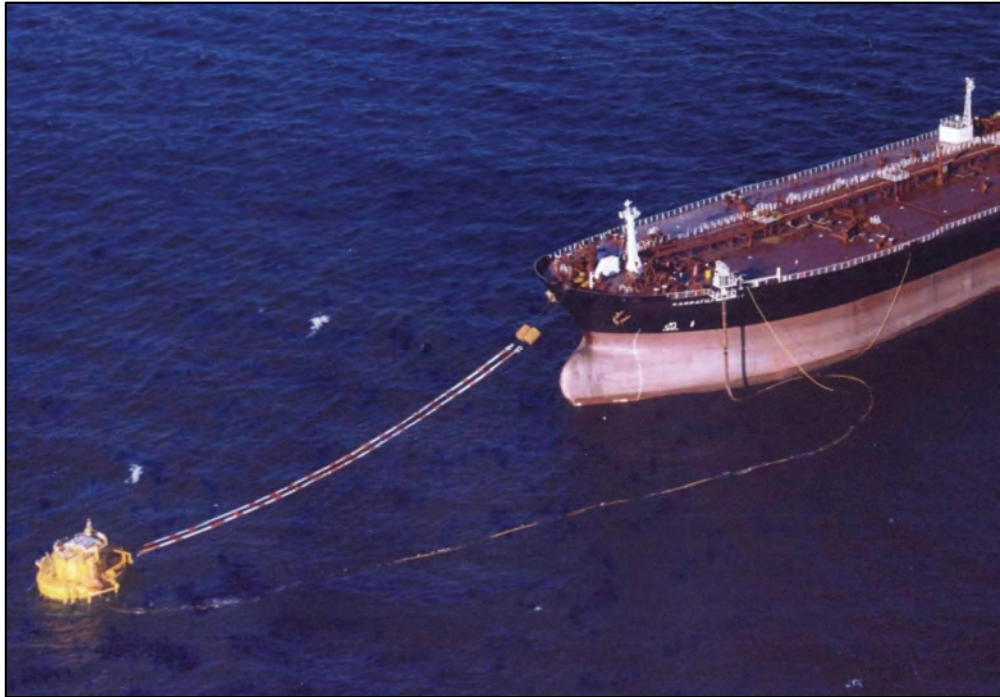
Figure 3: *Karratha Spirit's* hawsers and import hose at the CALM buoy

The import hose is held in place by two 'preventers', which are run off the forward spring winch. The preventers hold the import hose in a bight. This stops any longitudinal torsional loading of the import hose manifold structure from load on the import hose and restricts the hose from moving across the bow and potentially fouling the mooring hawsers (Figure 3).

When on station, *Karratha Spirit* is moored to the Legendre CALM buoy by two hawsers (Figure 3). Each of the hawsers is a 60 m long, 19 inch circumference, double braided nylon grommet⁶ with a safe working load (SWL) of 840 t⁷. The mooring load is shared between the two hawsers but each of the hawsers is capable of handling the full design load.

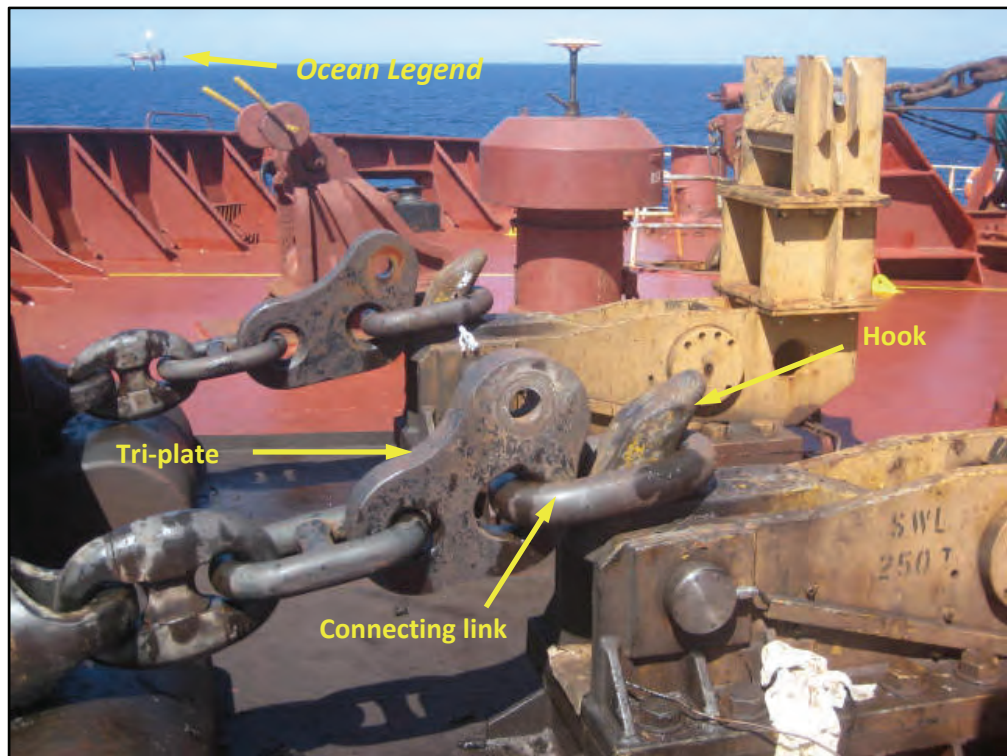
Figure 4: Quick release hooks

Each of the hawsers is shackled to a 10 m length of 76 mm diameter chafe chain that is attached to a 250 t SWL quick release hook mounted on the ship’s forecastle deck using a tri-plate and connecting link (Figure 4). The chains are in place to prevent the hawsers from chafing on the bow of the ship.

The quick release hooks can be tripped manually using a removable bar or remotely using a hydraulic system which has an actuating cylinder within the hook that operates the tripping mechanism. The hooks are remotely released from a control stand at the base of the foremast. The safety case facility description states that, ‘Simultaneous release is provided for both bow hawsers⁸’. However, the quick release hooks cannot be released together.

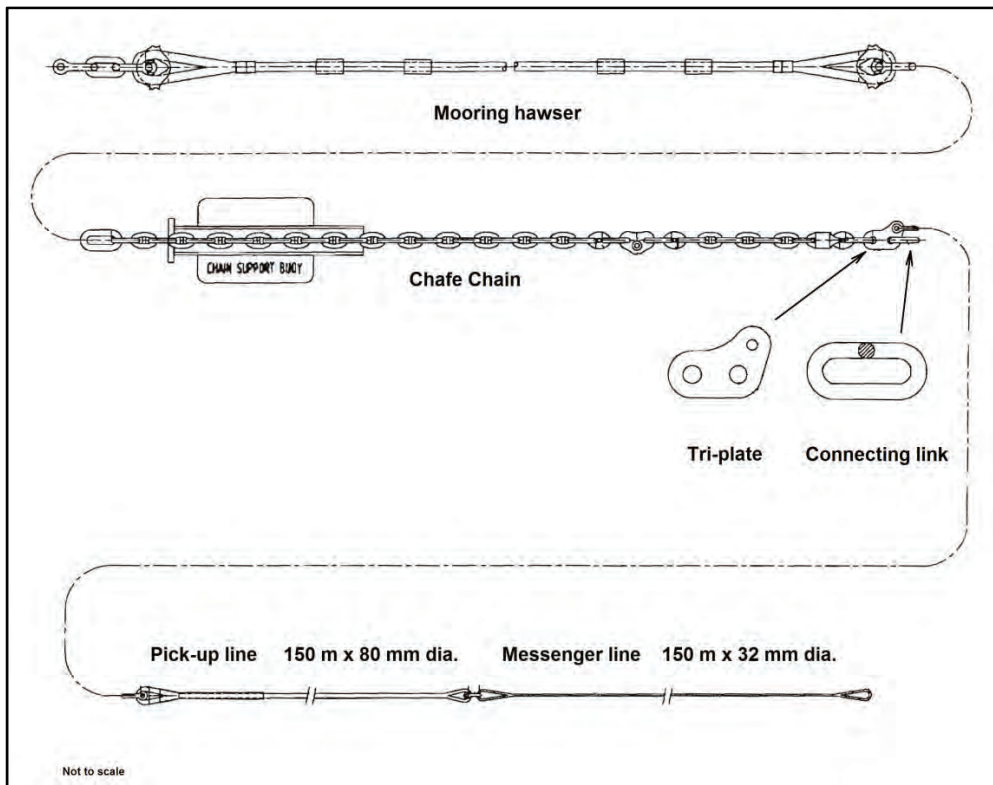
Figure 5: Mooring hawser arrangement drawing

While *Karratha Spirit* is not connected to the CALM buoy, a hawser pickup line, made up of 150 m of 80 mm diameter polypropylene rope, is attached to the end of each chafe chain (Figure 5). These pickup lines are left floating near the CALM buoy ready for re-connection (Figure 6).

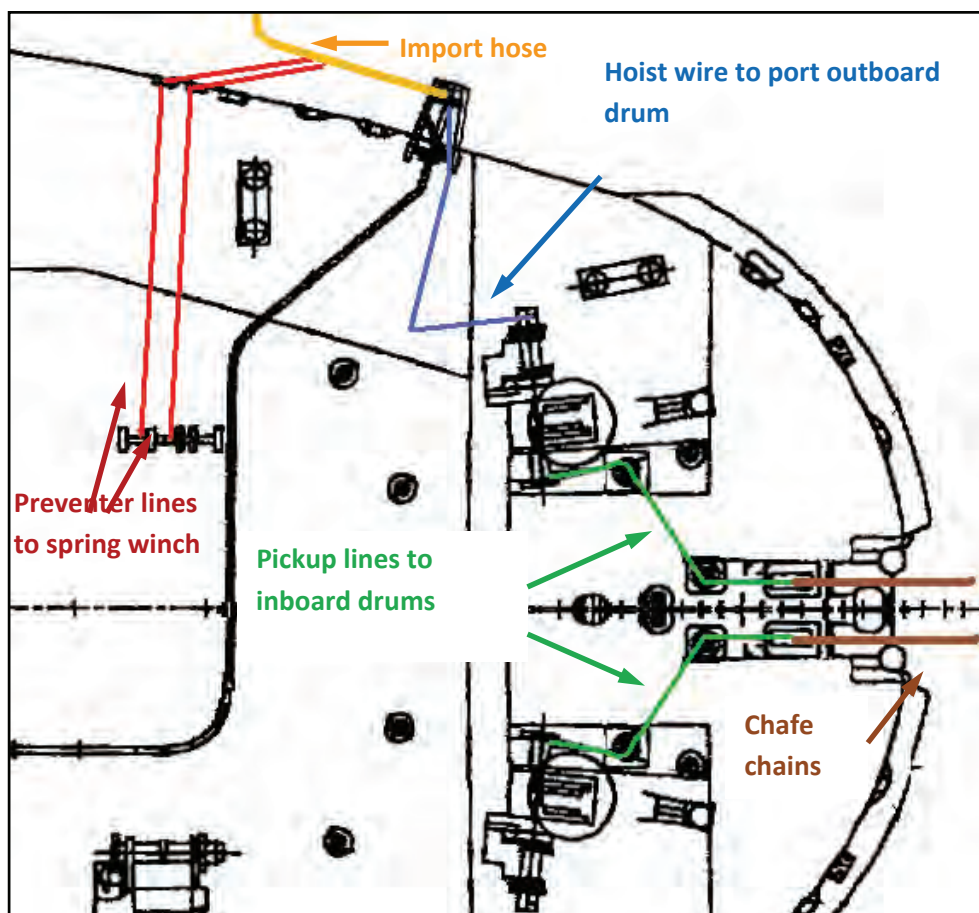
Figure 7: Forecastle deck layout showing hoist wire and pickup lines

The heaving lines are used to heave the messenger lines up to *Karratha Spirit's* forecastle deck. Each messenger line is then led around two pedestal roller fairleads (Figure 7) and onto the appropriate inboard windlass winch drum (i.e. port or starboard) and heaved in to bring the pickup lines onto the forecastle deck.

While the chief mate and the crew were fitting the blank flange, the master instructed CIR B to release the two hose preventer lines (Figure 7). The preventers

At 1920, the hoisting wire had been run from the port outboard drum (Figure 7) and it was attached to the end of the import hose using a 'suitcase hook'¹¹. The chain blocks were then removed.

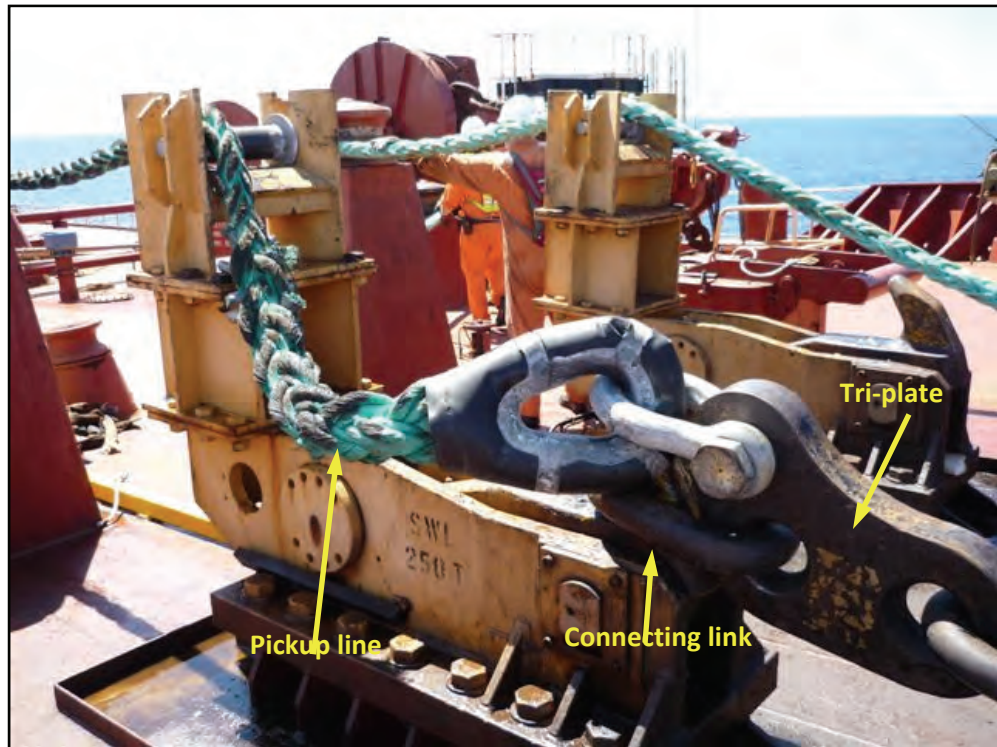
Figure 8: Tri-plate and pickup line connected to quick release hook

When *Karratha Spirit* commences a controlled disconnection from the CALM buoy, the crew run the pickup lines from the winch drums, around the pedestal roller fairleads and connect them to the tri-plates using 55 tonne shackles (Figure 8).
