ATSB TRANSPORT SAFETY REPORT
Marine Occurrence Investigation No. 288
MO-2011-007
Final

Breathing apparatus air compressor explosion on board the woodchip carrier *Universal Gloria* off Eden, New South Wales

11 October 2011

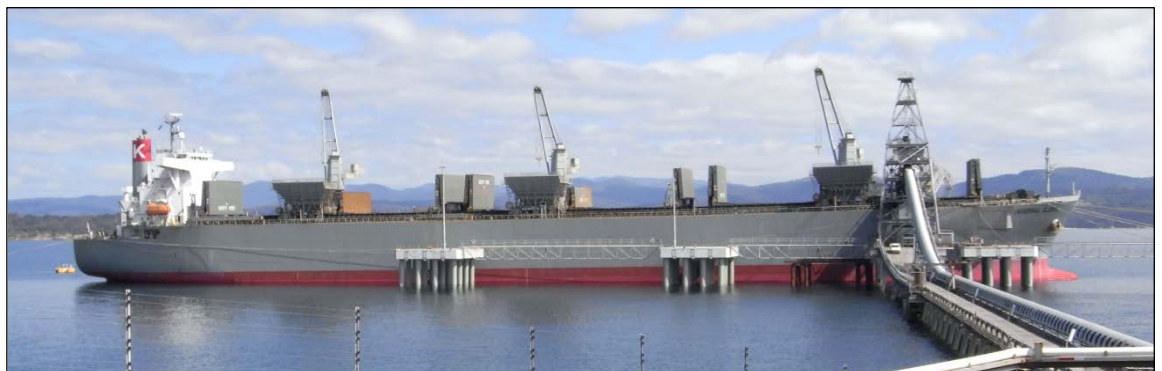
Figure 1: *Universal Gloria*

Universal Gloria (IMO No. 9286877) is a woodchip carrier (Figure 1) that was built in 2004 by Imabari Shipbuilding, Japan. It has an overall length of 228.93 m, a beam of 35.4 m and a deadweight of 62,716 tonnes at a summer draught of 11.418 m.

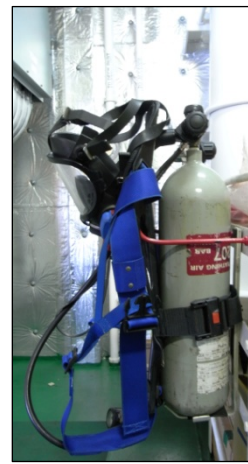
Figure 2: BA set

The mandatory equipment included two Sabre self contained air breathing apparatus (BA sets) (Figure 2), four spare BA cylinders and a portable air compressor (compressor) that was used to re-fill the BA cylinders (Figure 4). The compressor was oil lubricated and its discharge tube was

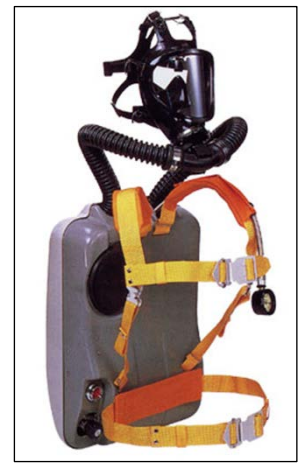
Figure 3: OBA set

In addition to the mandatory BA sets, 'K' Line had equipped the ship with four Kawasaki Safety Service⁴ (Kawasaki) OXY GEM closed circuit oxygen breathing apparatus (OBA sets) (Figure 3). Three of these sets were for operational purposes with one reserved for training and drills.
