Australian Government
Australian Transport Safety Bureau

Collision between the bulk carrier *Furness Melbourne* and the yacht *Riga II*

North of Bowen, Queensland | 26 May 2012

ATSB Transport Safety Report
Marine Occurrence Investigation
295-MO-2012-006
Final – 12 December 2013

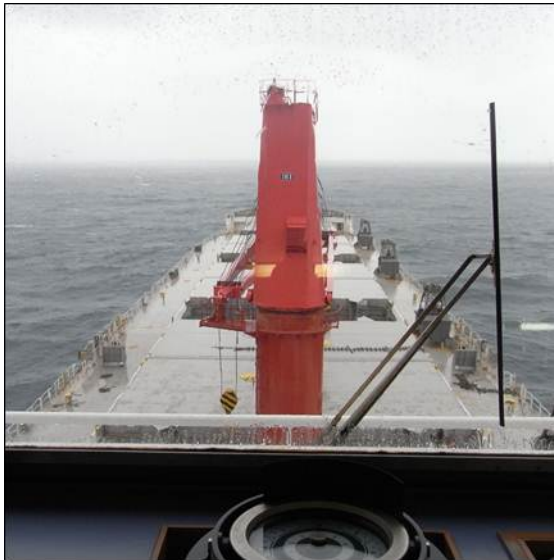
Figure 8: View looking from the centre of *Furness Melbourne’s* bridge

Just after 2153, the lookout alerted the third mate to the fact that he thought the green light he had been watching to port was now very close. However, it was not until *Riga II’s* VHF radio call at 2155¼ that the third mate realised the light was probably that of the calling yacht. At about the same time, the third mate lost sight of the yacht, probably because it had entered the blind sector created by the ship’s cargo cranes (Figures 8 and 9).
