ATSB TRANSPORT SAFETY INVESTIGATION REPORT
Rail Occurrence Investigation 2004/008
Final

Derailment of Pacific National Train 7MP5 Glenalta, South Australia

21 November 2004

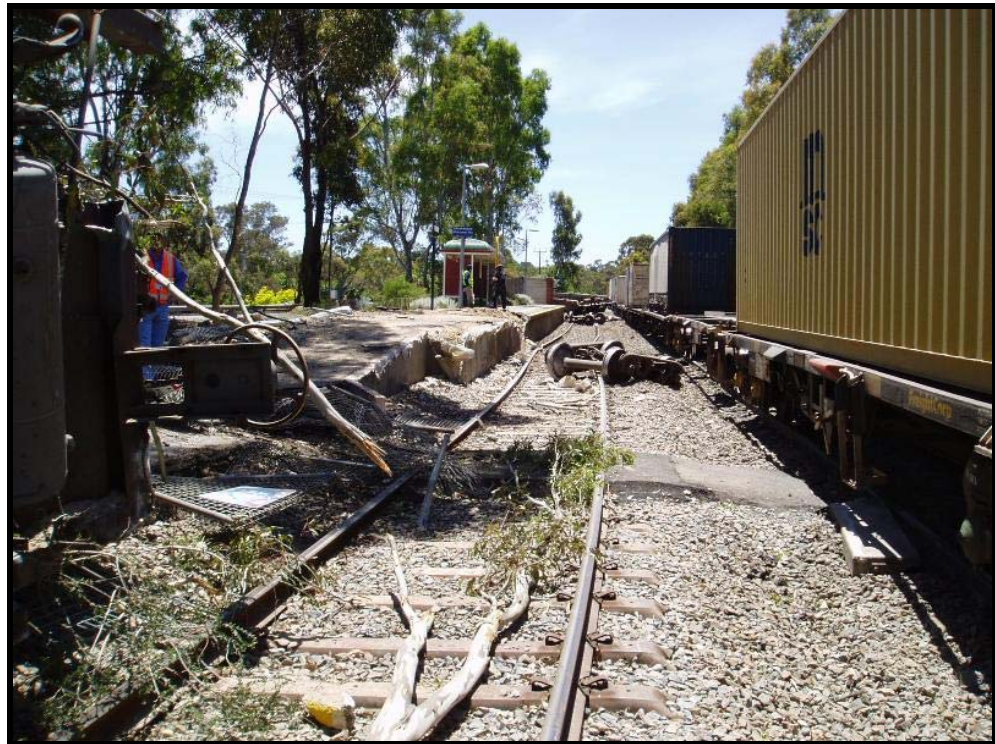
Figure 1: View of TransAdelaide track and Glenalta Railway Station platform

Train 7MP5 consisted of four locomotives leading 72 freight platforms and wagons. The total train length was 1474m, with approximately 2960 tonnes trailing the locomotives. A total of 10 platforms² and wagons were derailed, with five obstructing the TransAdelaide track and four coming to rest down an embankment in private residential properties.

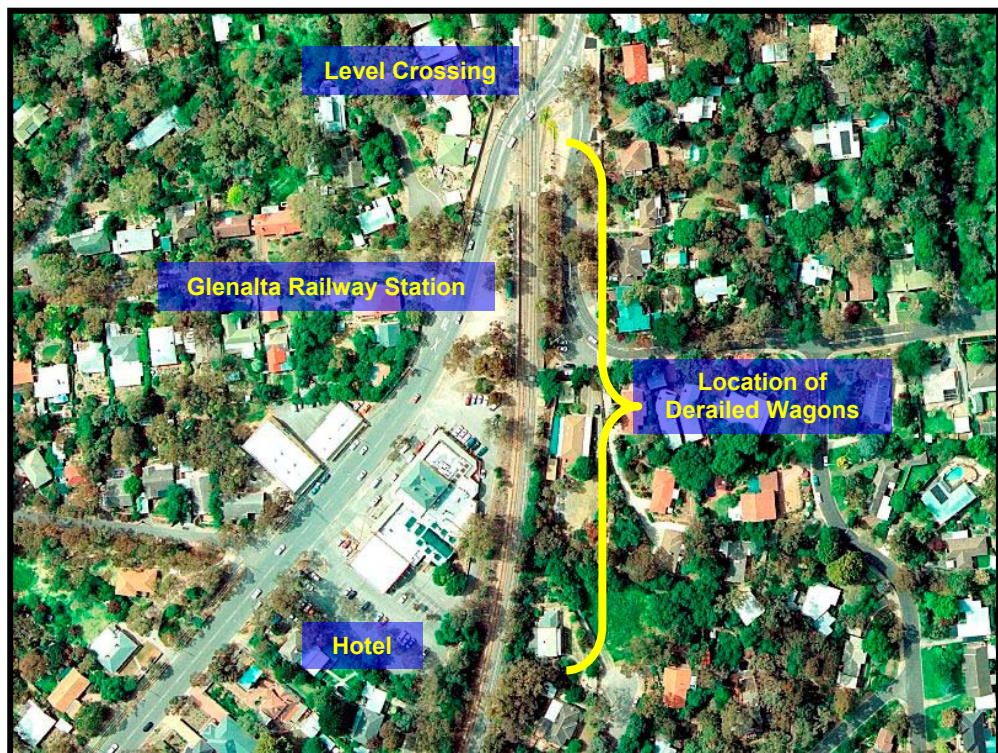
Figure 3: Aerial photograph of Glenalta, South Australia

The majority of infrastructure damage occurred in the vicinity of the Glenalta railway station where derailed wagons came to rest in private residential properties and obstructed the TransAdelaide track. Figure 3 provides an aerial view of the derailment site and illustrates the proximity of residential properties and public areas such as the road level crossing, railway station and an adjacent hotel.

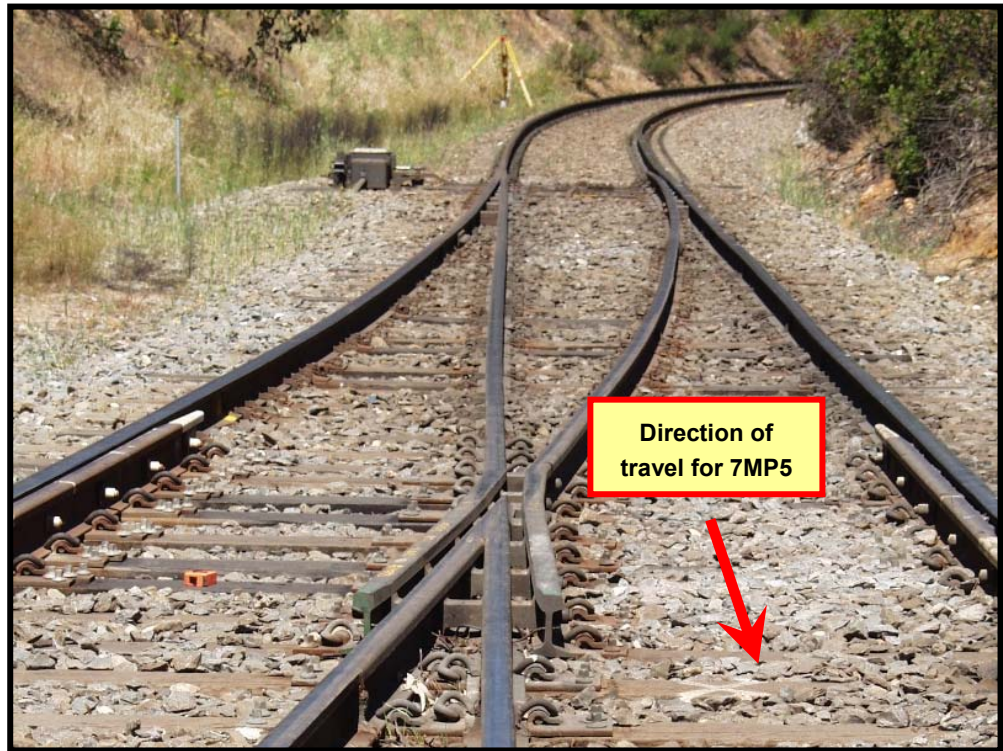
Figure 5: The turn-out at the entry to the Belair crossing loop

Wheel flange markings at point of derailment, damage to civil infrastructure and the post derailment location of wagon components suggest that initially only the lead bogie of the fourth platform (Platform #2 of 5-unit well wagon RQZY7066, coupled immediately behind the locomotives) derailed. The wheels from both axles continuing to strike the concrete sleepers on the right-hand side of each rail as the train progressed towards Glenalta. At the exit of the Belair crossing loop (1.7km) the leading derailed wheels struck the check-rail and Vee of the turn-out, resulting in the bogie lifting over to the left-hand side of the track and subsequently striking the point machine (number 7 points).

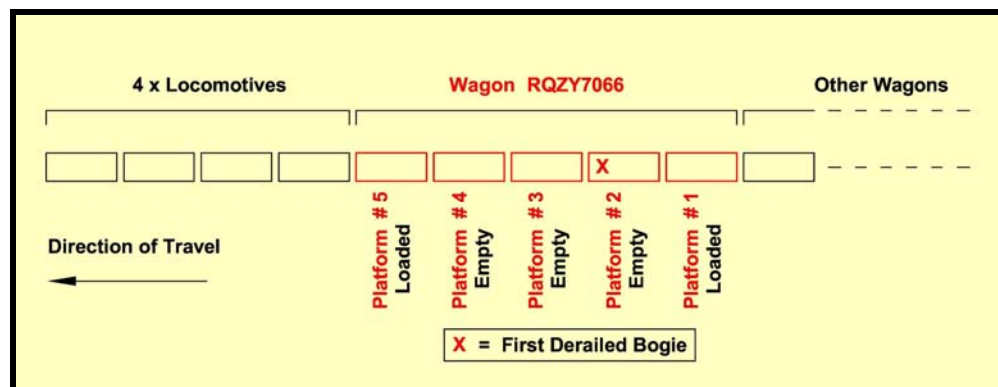
Figure 14: Train 7MP5, showing RQZY7066 and the first bogie to derail

Wagon number RQZY7066, a 5-unit well wagon, was coupled immediately behind the locomotives with Platform #5 leading. Platform #5 was loaded with a 26.5 tonne container giving a gross platform weight of 46.1 tonnes. Platform #1 was loaded with an 8.85 tonne container giving a gross platform weight of 28.45 tonnes. The remaining three platforms were unladen, giving a gross platform weight of 19.6 tonnes each.

Wheel flange markings at point of derailment, damage to civil infrastructure and the post derailment location of wagon components suggests that the leading bogie (number RQFE-11003) of the fourth platform in the train consist (Platform #2 of RQZY7066, as per Figure 14 above) was the first bogie to derail. As the investigation progressed, analysis determined that the mechanism of derailment related primarily to the platform initially derailed (Platform #2) and the adjoining two platforms (Platform # 3, leading and Platform # 1 trailing).

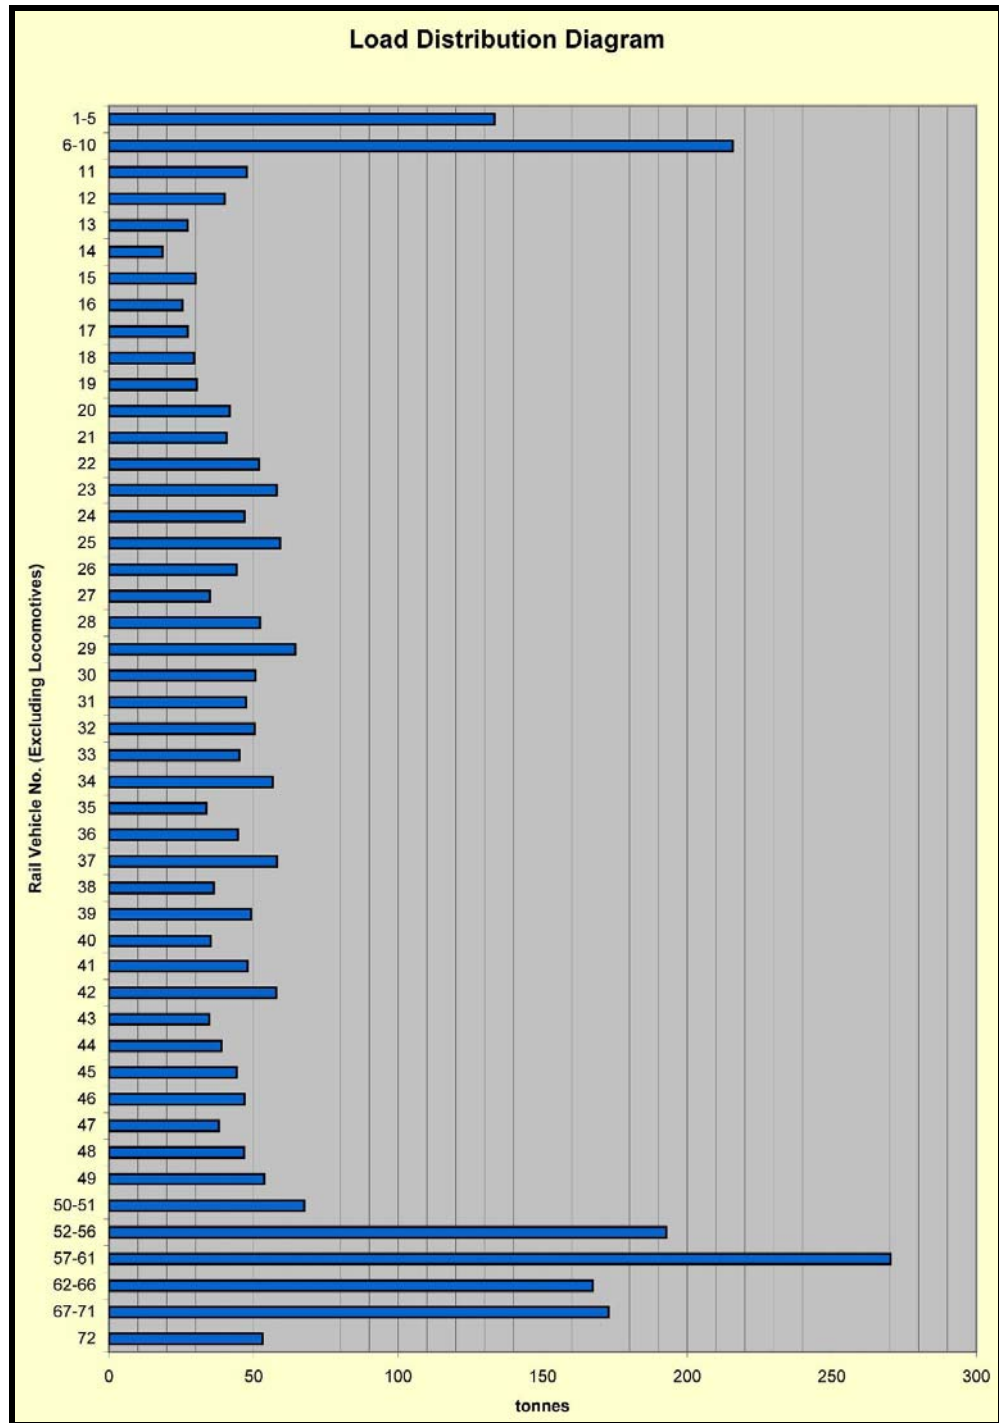
Figure 16: Load distribution diagram similar to that displayed in 7MP5 Train Consist Report

Similarly, the Load Distribution Diagram within the Train Consist Report also indicates the gross mass of an entire multiple platform wagon and not individual platforms. Figure 16 illustrates the load distribution of 7MP5 in a similar format as that displayed in the Train Consist Report. Note that the upper two load bars (labelled 1-5 and 6-10) correspond to the first two multi-platform wagons coupled immediately following the locomotives. From the diagram, the load of the first two wagons would seem to be greater than 130 tonnes and 210 tonnes respectively. However, each of these loads represents the total gross weight of five individual platforms.

It is also impossible to use the Load Distribution Diagram as a tool for identifying all empty or lightly loaded rail vehicles within the train consist. In most cases a wagon weighing less than 20 tonnes would usually be empty. When referring to the Load Distribution Diagram in Figure 16, only wagon (Number 14) is less than 20 tonnes. However, the diagram does not illustrate the three empty platforms that existed in the multi-platform wagon labelled 1-5.

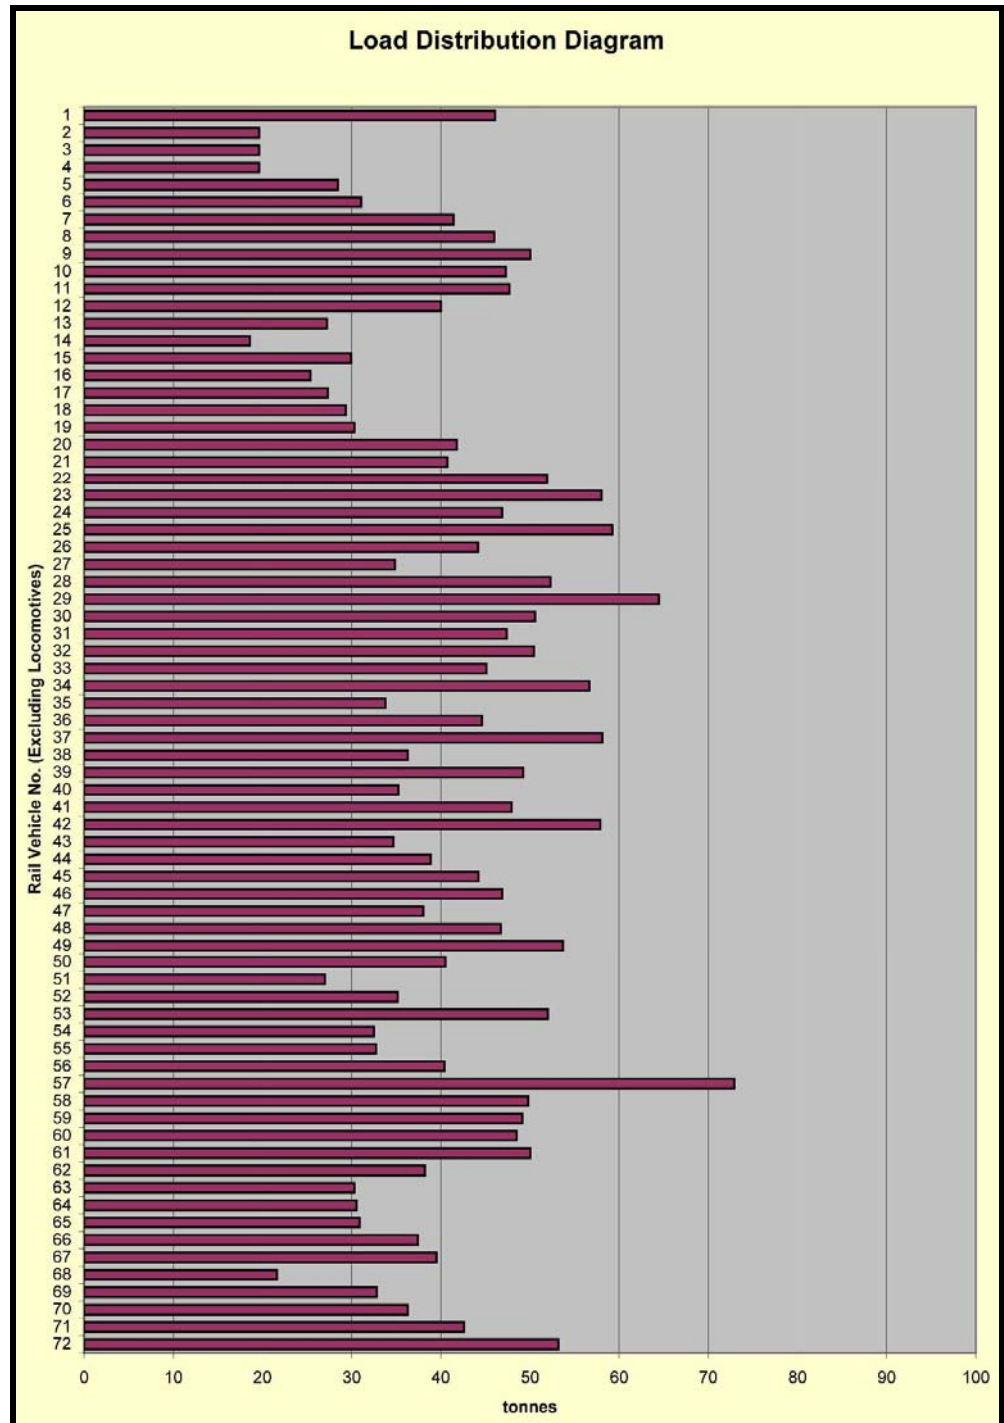
Figure 17: Load distribution diagram of 7MP5, if each platform within a multiple platform wagon were displayed

Figure 17 illustrates the load distribution of 7MP5 in a format where each platform within a multi platform wagon is displayed. In this diagram rail vehicle numbers 2, 3 and 4 are clearly displayed as weighing less than 20 tonnes and correspond to the empty platforms within the first multi-platform wagon coupled immediately following the locomotives. (Note the different load scale to that displayed in Figure 16)

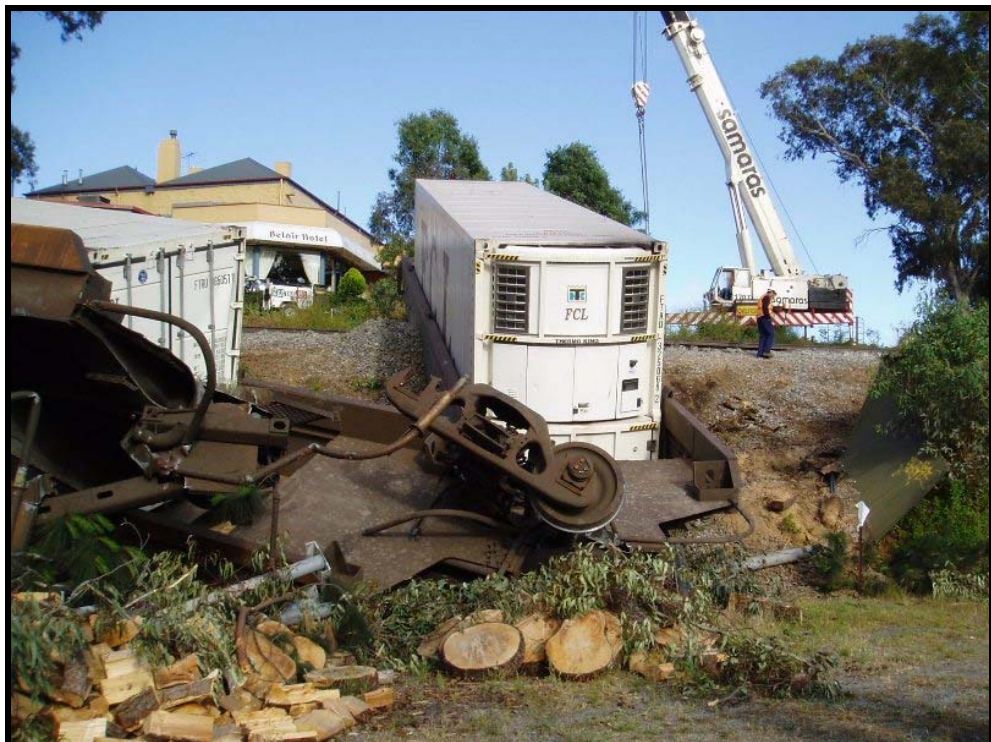
Figure 20: View of rollingstock in private property and recovery process

In relation to the derailment of 7MP5, the site recovery phase was conducted in an efficient, coordinated and professional manner. All parties cooperated in a manner that allowed items of interest to be identified and recovered in a manner appropriate to allow future examination and analysis. Normal ARTC operations resumed at approximately 1930 on 23 November 2004, while TransAdelaide’s metropolitan passenger services resumed on 25 November 2004.
