ATSB TRANSPORT SAFETY INVESTIGATION REPORT
Rail Occurrence Investigation Report - 2005/004
Final

Level Crossing Collision

Edith Street, Horsham, Victoria
11 August 2005

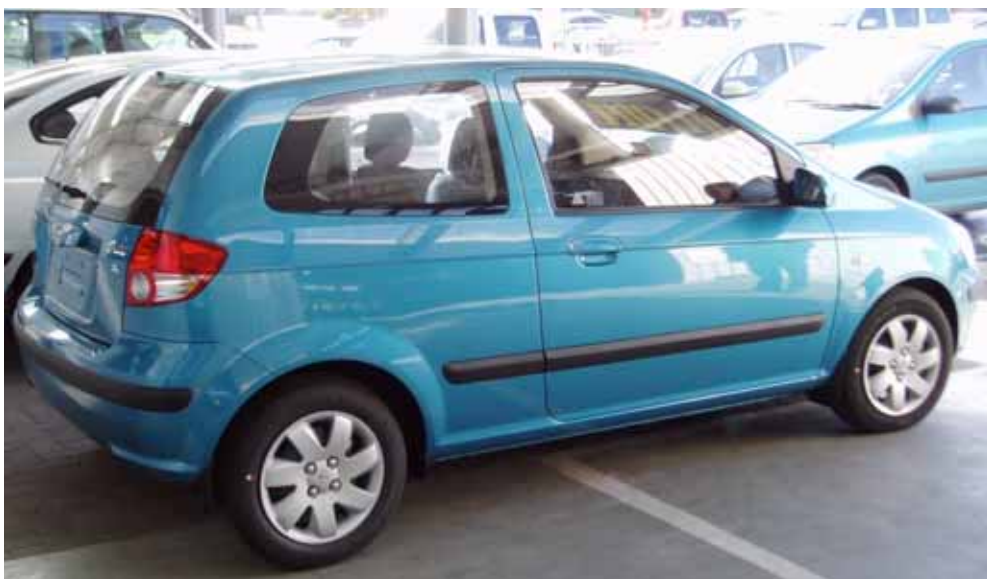
Figure 10: Hyundai Getz (2 door)

An examination of the motor vehicle by the Victoria Police concluded that it was in a roadworthy condition prior to the accident. An inspection of the vehicle did not reveal any mechanical fault that would have contributed to the collision.

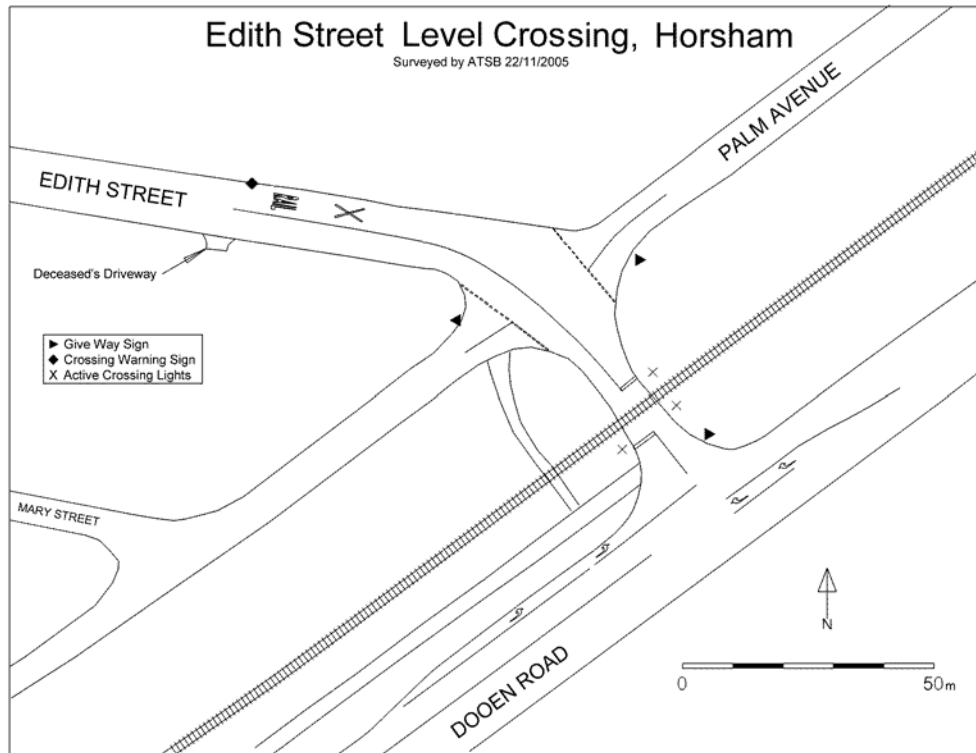
Figure 11: Site Survey Edith Street level Crossing

The Edith Street level crossing (Fig. 11) consists of one standard gauge track crossed at right angles by the roadway.

Edith Street intersects Palm Avenue on the north western side of the level crossing before terminating on the south east side of the crossing at Dooen Road.

Flashing lights, a bell, approach warning signs and road markings protect the Edith Street level crossing. In addition to the main flashing lights, the crossing is equipped with supplementary flashing lights and associated signs to warn road traffic approaching the crossing from Palm Avenue and Dooen Road. The Australian Standard AS 1742.7-1993 'Manual of uniform traffic control devices Part 7: Railway crossings' (Fig 12) prescribes the standard for road markings and signage to be used in conjunction with active warning protection used throughout Australia.

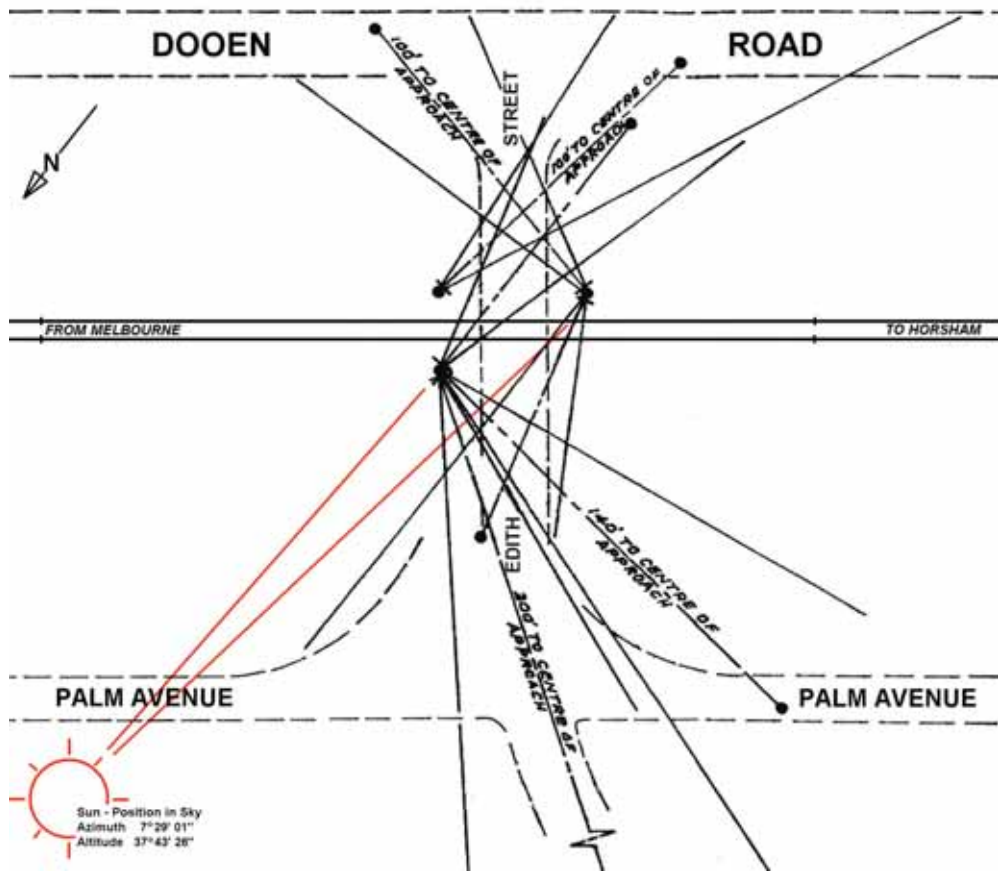
Figure 13: Focusing Diagram

Flashing lights were installed at the Edith Street level crossing on 26 February 1975. They consist of a combination of main-lights, backlights and supplementary lights that have been set-up/aligned to provide coverage in accordance with the 'Horsham Edith Street – Focusing and Apparatus Diagram' (Fig. 13).
