ATSB TRANSPORT SAFETY INVESTIGATION REPORT
Rail Occurrence Investigation 2006/015
Final

Level crossing collision between
The Ghan Passenger Train (1AD8)
and a
Road-Train Truck
Ban Ban Springs, NT

12 December 2006

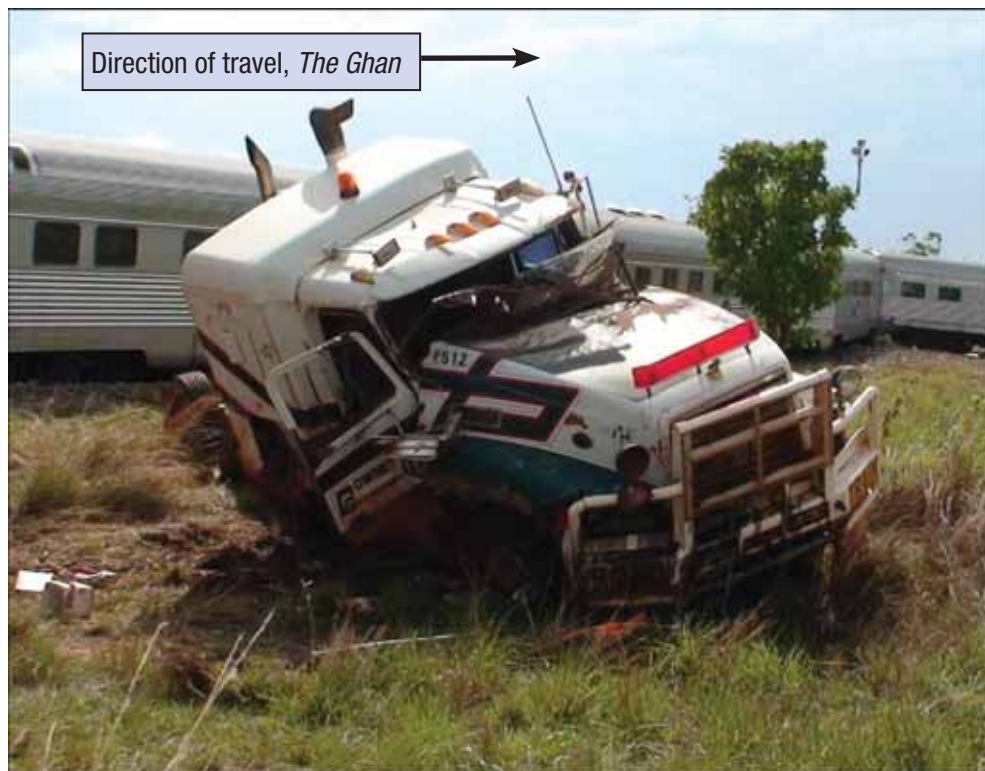
Figure 6: Prime-mover of road-train

The next thing he remembered was that the prime-mover was being thrown about and, shortly after, came to a rest on a lean not far from the road. He immediately got out and waved to a helicopter that was in the vicinity. The helicopter came straight down and landed on the road a short distance away from the prime-mover. An occupant alighted, walked to where he was standing and asked how he was.

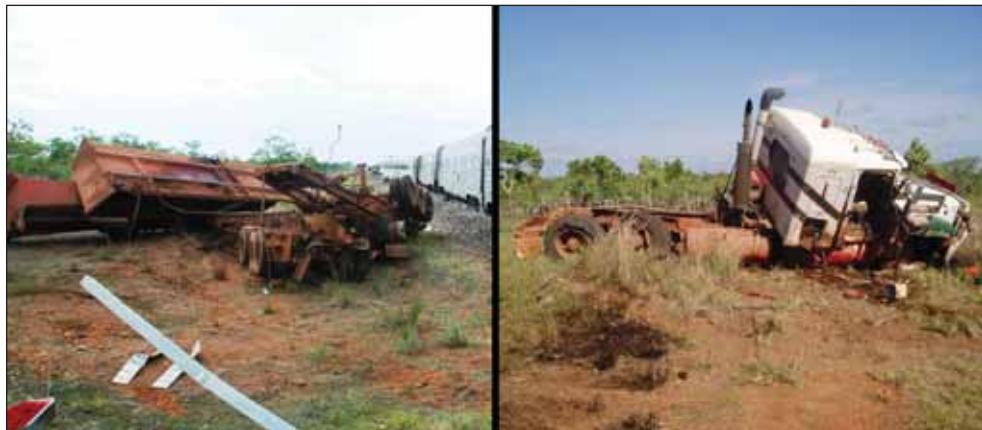
Figure 13: Damaged prime-mover (right) and trailers (left)

The prime-mover, converter dolly and two trailers suffered substantial structural damage, including significant distortion of the truck and trailer chassis. The prime-mover and the body of the second trailer had become detached from their respective chassis. The road-train combination was damaged beyond repair.

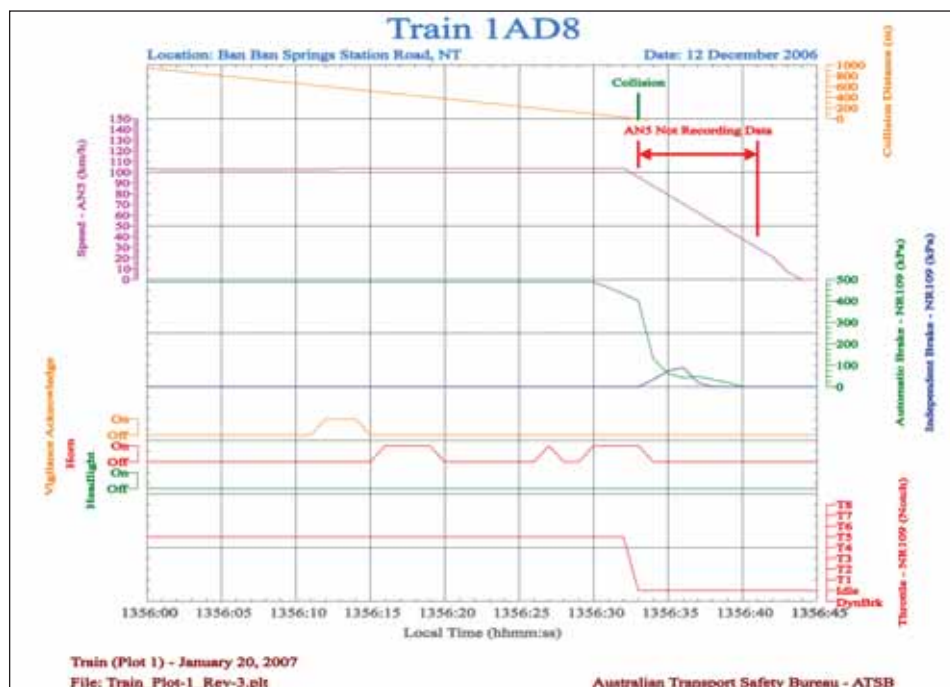
Figure 15: Data download AN 5 and NR 109

- At 1356:30 the leading end of AN 5 was 85 m from the collision point, the speed was 104 km/h, the throttle was in notch five, the brakes were released and the horn was sounded³¹.
- At 1356:32 the leading end of AN 5 was 28 m from the collision point, the speed was 104 km/h, the throttle was in notch five, the brake-pipe pressure was 434 kPa and decreasing, and the horn was still sounding.
- At 1356:33 the collision occurred. The speed was 101 km/h (recorded from NR 109), the throttle was in idle, the brake pressure was 399 kPa and decreasing and the horn was off.
- At 1356:38 AN5 separated from NR 109.
- At 1356:44 AN5 was recorded as being stationary³².

It appears from the data log that the train driver's first reaction to sighting the truck was to sound the horn at 1356:30 when the front of the train was 85 m from the collision point. Allowing for a nominal reaction time of 2.5 seconds, the truck was probably seen when the lead locomotive was about 158 m (or 5.5 seconds) from the collision point. Between 1356:30 and 1356:33, the brake-pipe pressure had fallen by 90 kPa, a rate consistent with an emergency application of the train brake. With the exception of the headlight (recorded as being off), this closely corroborates the accounts given by the train drivers.

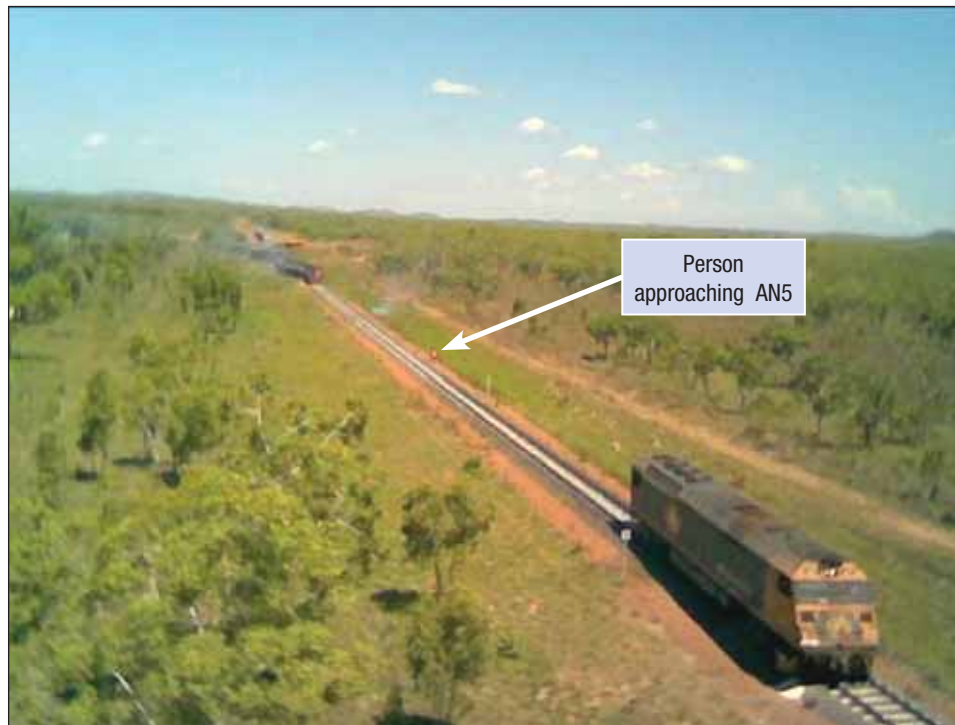
Figure 16: Locomotive AN 5 shortly after the accident, headlight appears to be illuminated

the Brocks Creek GBS Gold mine site (Figure 16). The leading locomotive (AN 5) headlight appears to be illuminated. The helicopter can be heard overhead (in the background) of the recordings of the conversations between the train drivers and the train control and coordination centres (see section 2.1.2). These conversations occurred before the drivers were told to shut down the locomotives and isolate the electrical power which would have extinguished the headlight. It is thought that the person seen approaching AN 5 in figure 16 is the off-duty driver from the crew van who told the drivers in the cab of the locomotive to shut it down.

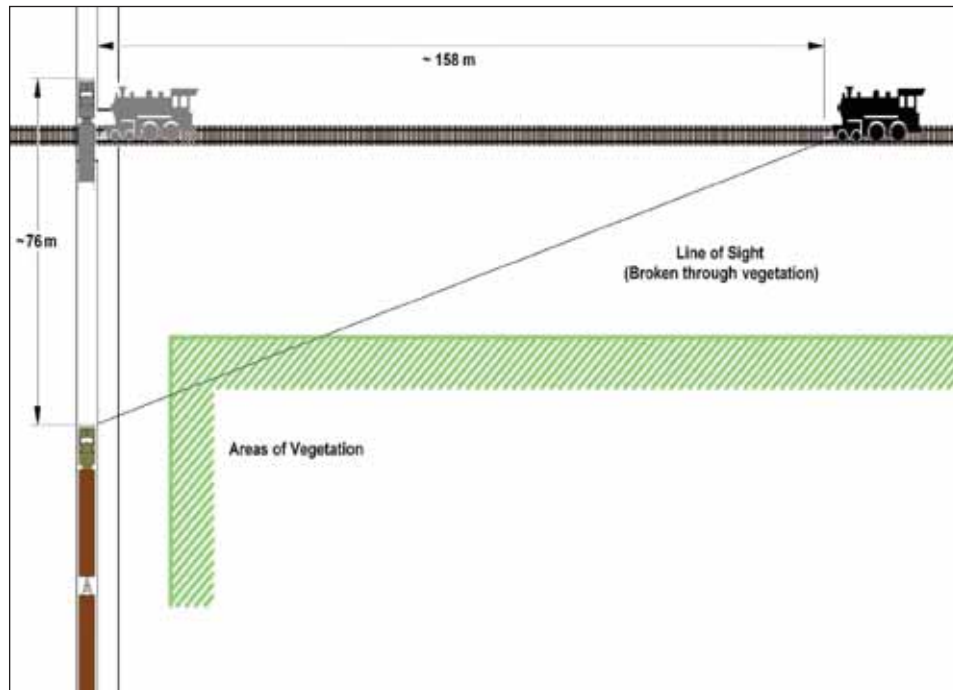
Figure 18: Distances travelled, for both train and truck, between train driver sighting the truck and the collision

If the truck was travelling at an average speed of 50 km/h on the approach to the level crossing then, 5.5 seconds before the collision, it would have been about 76 m from the level crossing when the train driver first sighted it. This scenario seems to be the most likely.

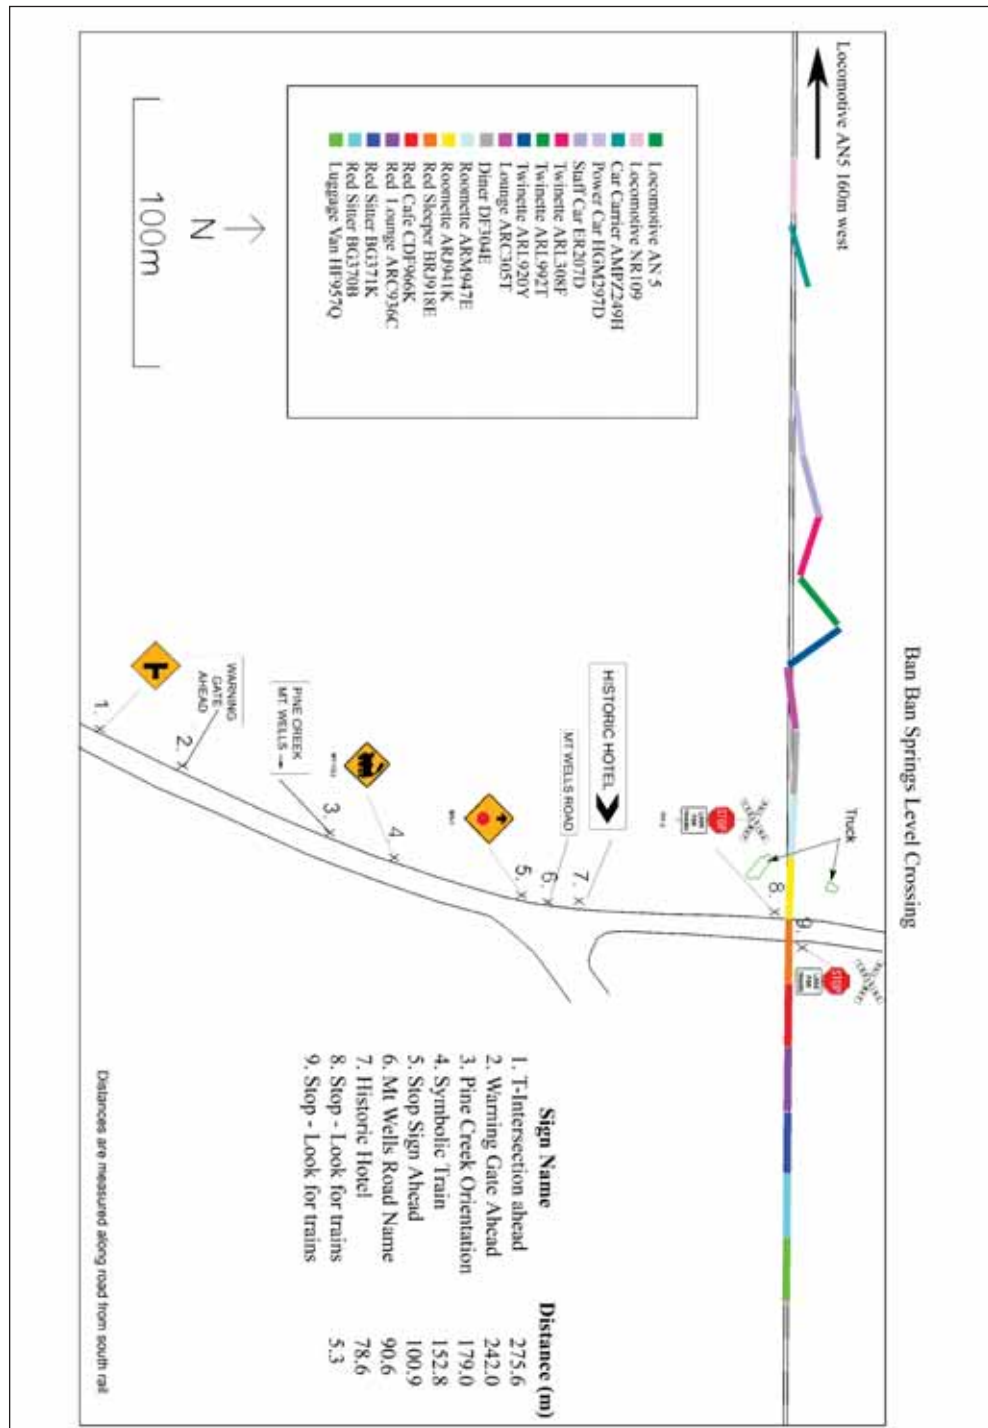
Figure 23: Site plan

By the time the train had stopped, the two locomotives, the motorail wagon and nine passenger carriages had derailed, the fuel tanks on both locomotives had been ruptured and a minor grass fire had ignited adjacent to the track. The lead locomotive was 160 m from the second locomotive and 440 m from the level crossing.

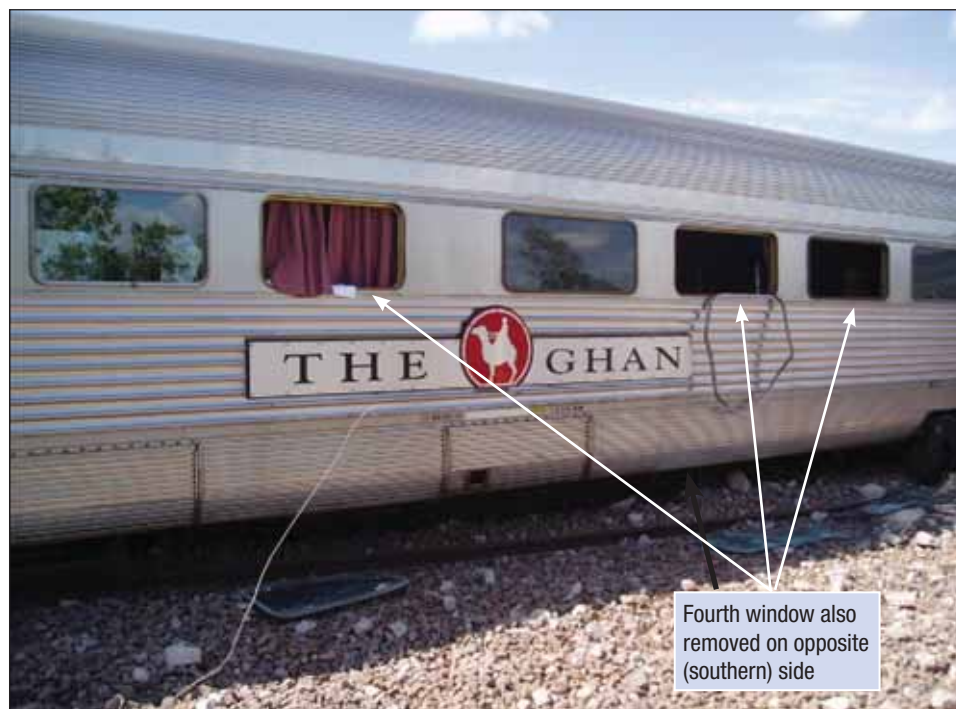
Figure 24: Gold Kangaroo Lounge Car (AFC 305T)

Because the air conditioning was not functioning, passengers were monitored for signs of heat stress, given fluids and, where necessary, wet towels. In order to improve ventilation in the Gold Kangaroo lounge car four windows were removed with a sledgehammer a short time after the transfer of the unconscious female passenger to this carriage. GSR staff had limited involvement in caring for the unconscious passenger because of the availability of medically qualified persons from GBS Gold and the two doctors travelling as passengers who had made themselves known to the GSR staff.

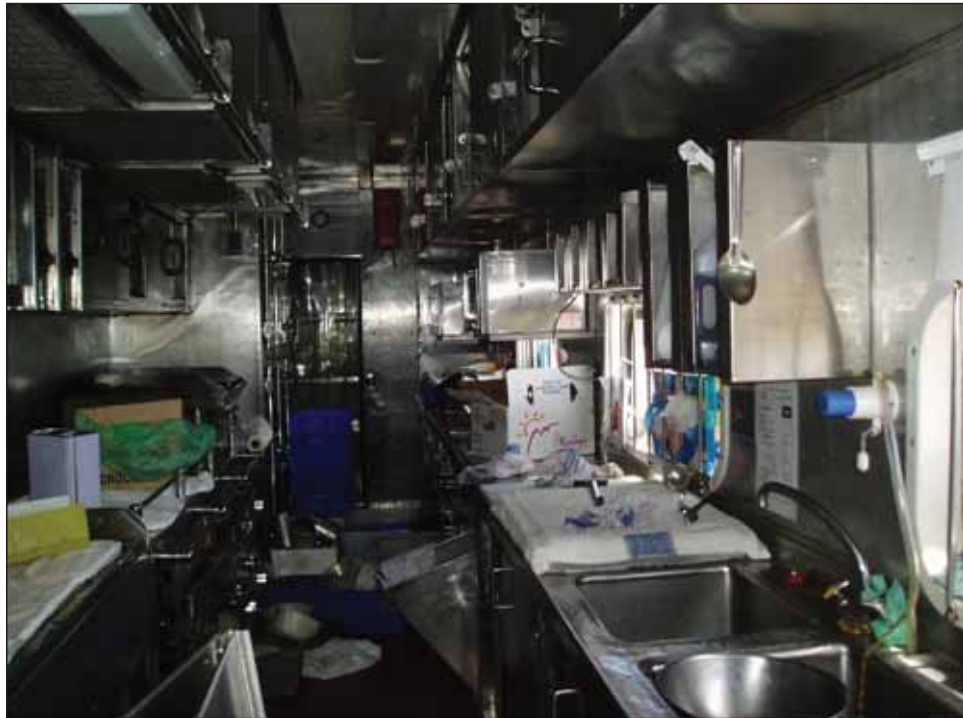
Figure 27: Kitchen, Gold Kangaroo carriage

about. This was most evident in the kitchen/pantry and bar areas where some cupboard doors opened, thereby allowing contents to spill out.

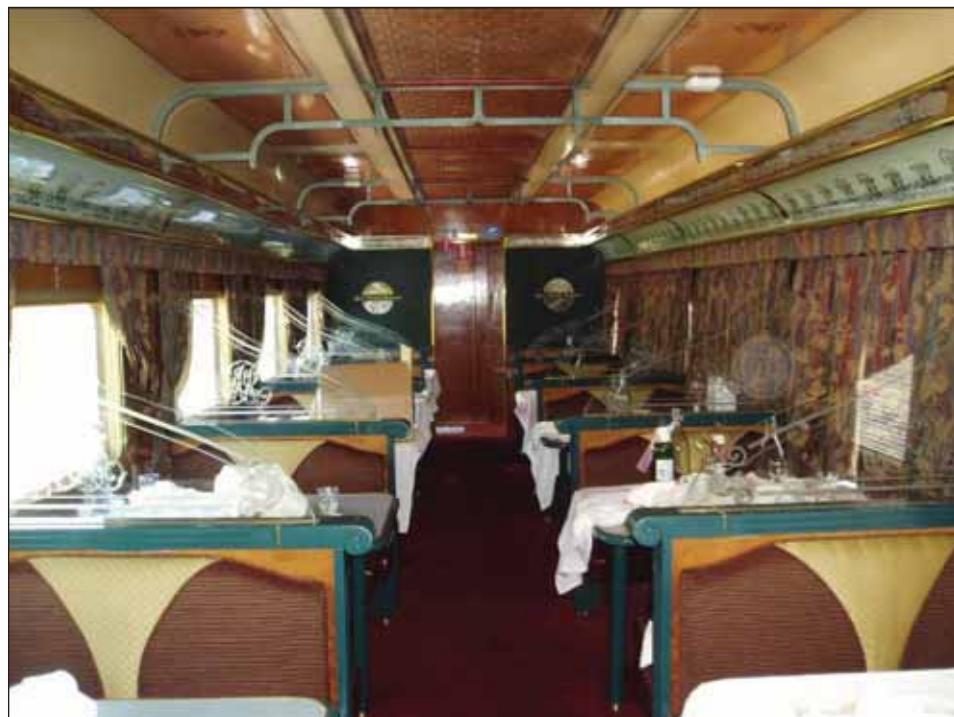
Apart from the walkway/vestibule areas as mentioned, occupant safety was not compromised by failed carriage structural components. Any danger to passengers or staff within the carriage saloons resulted from the unrestrained movement of persons and/or unsecured items.

Figure 29: Gold Kangaroo dining car. All fixtures in place

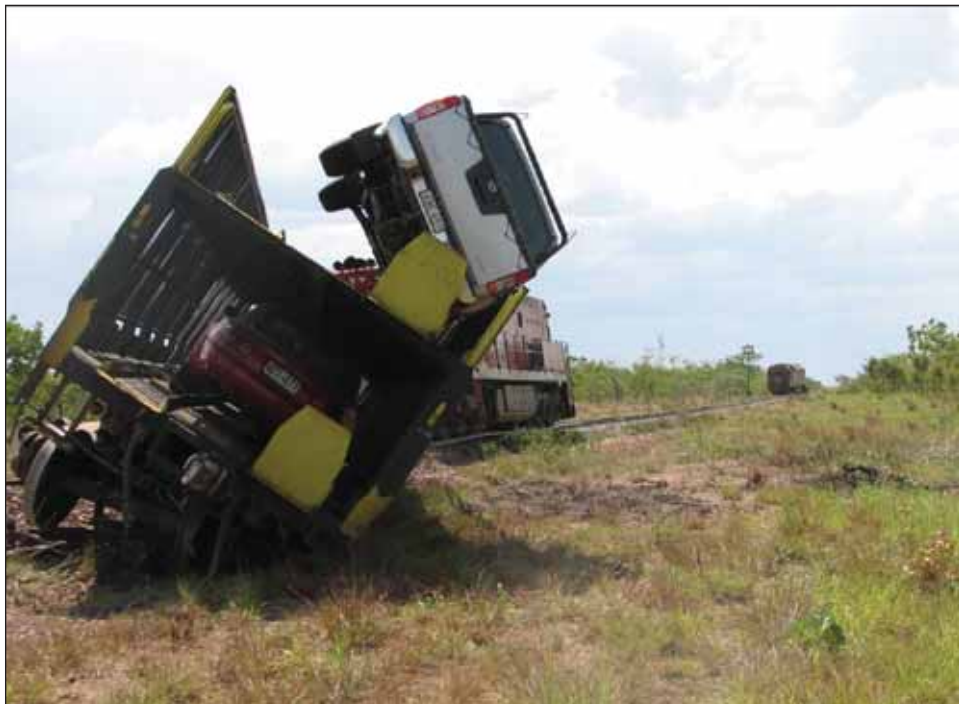
Figure 30: Motorail wagon

This wagon incurred significant structural damage. At the time of the accident four motor vehicles were being carried on the motorail wagon, three in the lower deck and one in the upper deck. These vehicles were secured by adjustable wheel 'clamps'. The vehicle on the top deck partially dislodged; the three on the lower deck remained substantially secured.

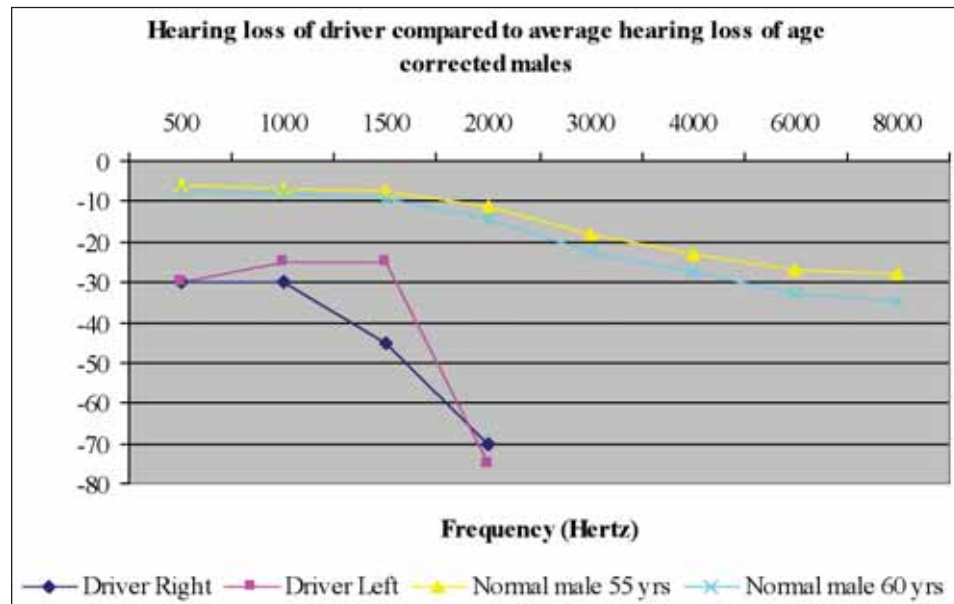
Figure 35: Comparison graph

75db at 2000Hz, and no hearing threshold level registered at 3000Hz or above. To provide a relative comparison of the truck drivers hearing capability, age corrected curves developed by Spoor (1967) were used to compare with male individuals of a similar age (cited in Ward, Royster and Royster, 2000). Figure 35 provides a graphical representation of the road-train driver's hearing profile in both ears with these curves. Hearing threshold levels did not register at 4000Hz, 6000Hz, or 8000Hz.

This comparison indicates that he had severe bilateral hearing loss, with the greater loss being in his right ear.

The road-train driver's severe hearing loss is a potentially significant factor in the collision. Had he either heard the train approaching at the time he said he was stopped and closing the gate on the trailer (which is unlikely given the train's distance from the crossing at that time), or either of the first two blasts of the train horn when he was approaching the crossing (a four second blast at 488 m and a one second blast at 172 m from the crossing), it is possible that he could have avoided the collision, or at worst, its consequences may have been less severe. While the helicopter mustering cattle may have made it more difficult to hear the train and/or its horn, it is probable that that road-train driver's hearing loss, particularly in his right ear (the direction from which the train approached), also affected his ability to hear *The Ghan* approaching the crossing compared with a male with 'normal' hearing of the same age.

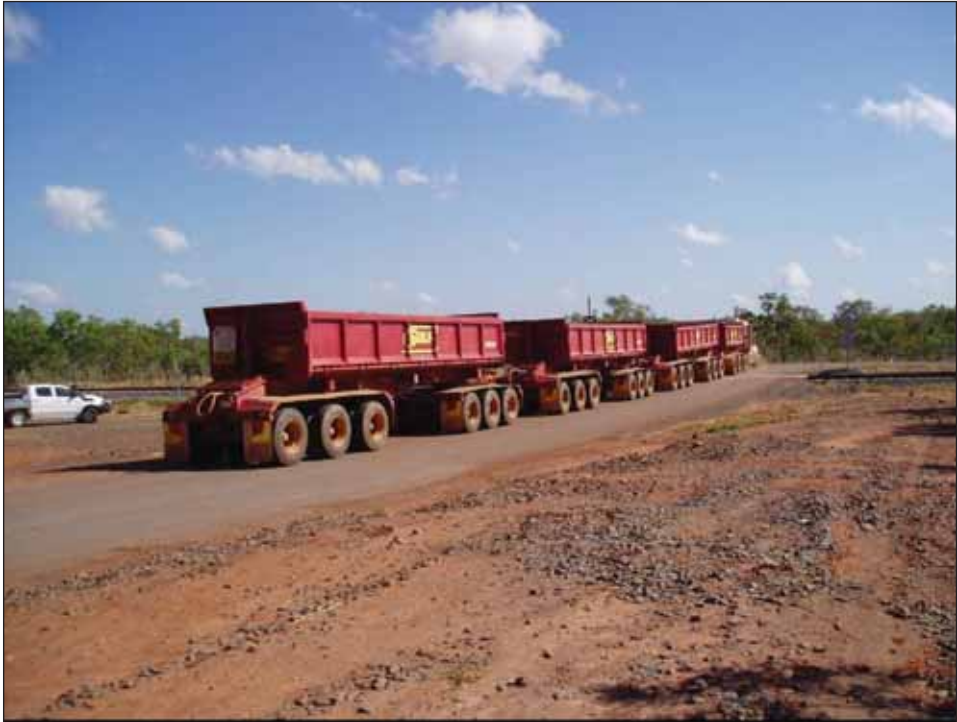
Figure 37: Northbound B+2A road-train during test

During the investigation of *The Ghan* collision and derailment, ATSB investigators noted that road-train B+2A side tipper combination vehicles of up to 53.5 m regularly used the Fountain Head Road level crossing and other roads and level crossings in the vicinity. These road-train combinations are over 17 m longer than the road-train involved in the accident at the Fountain Head Road level crossing and are the largest in terms of weight and length allowed on public roads in the world. It was also noted that some privately conducted clearance time trials had been recently undertaken, the results of which led to a potential concern regarding the adequacy of sighting distances as calculated by AS 1742.7 2007.

Tests conducted on 53.5 m long B+2A road-trains at the Fountain Head Road level crossing, Ban Ban Springs, found that the procedure/standard used to calculate and/or assess the level crossing sighting distance was probably inadequate for the truck configuration tested. It is likely that sighting distances at other level crossings controlled by 'Stop' signs, used by high combination gross mass road vehicles, may be similarly deficient and more research is needed to accurately assess this risk.
