ATSB TRANSPORT SAFETY INVESTIGATION REPORT  
Rail Occurrence Investigation No. 2006/004  
Final

Collision between  
**Rigid Tipper Truck/Quad Axle Trailer  
and Freight Train 4AM3**

Lismore, Victoria

25 May 2006

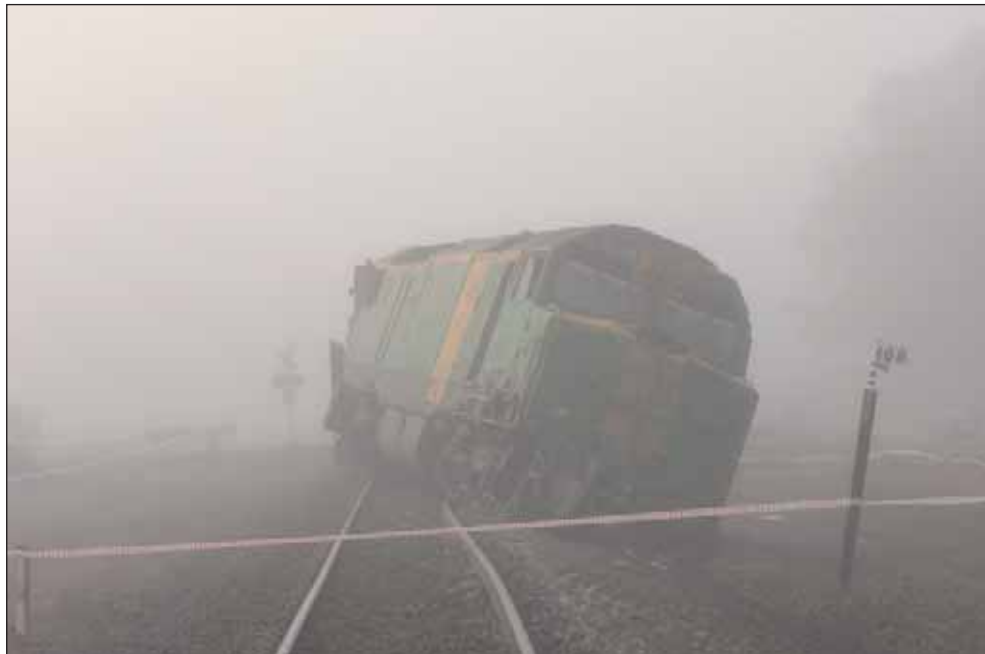
**Figure 5: Photo taken of DL 40, just after 0900**

Bureau of Meteorology (BoM) records indicates that sunrise was at 0728, about 14 minutes after the accident. However, after sunrise the visibility did not significantly improve for several hours due to the fog. BoM records also indicate that the minimum and maximum temperatures for the day at Lismore were about 3°C and 12°C respectively.

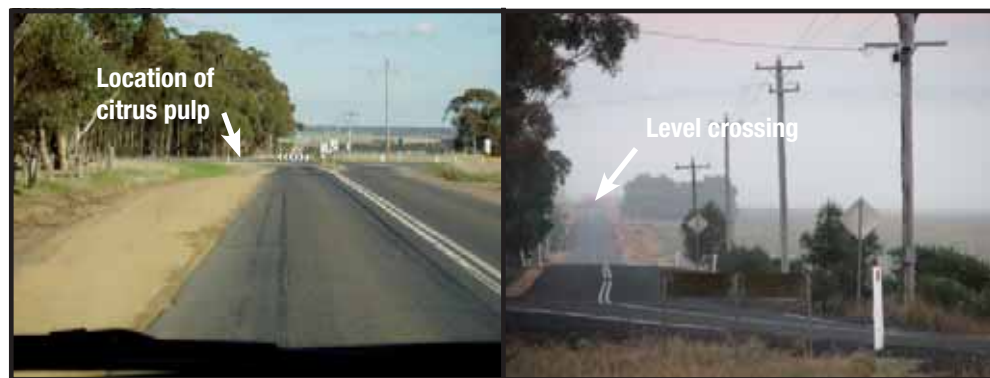
Figure 14: Lismore Skipton road before off-set intersection with the Hamilton Highway and beyond to level crossing

At the Lismore Skipton Road / Hamilton Highway intersection it is necessary to slow, give way to traffic on the Hamilton Highway and then proceed through the off-set intersection towards the Lismore Skipton road level crossing. Following the accident fresh deposits of citrus pulp were found on the eastern side of the Lismore Skipton Road immediately before this intersection. Multiple dual tyre skid marks of unknown origin were also found.

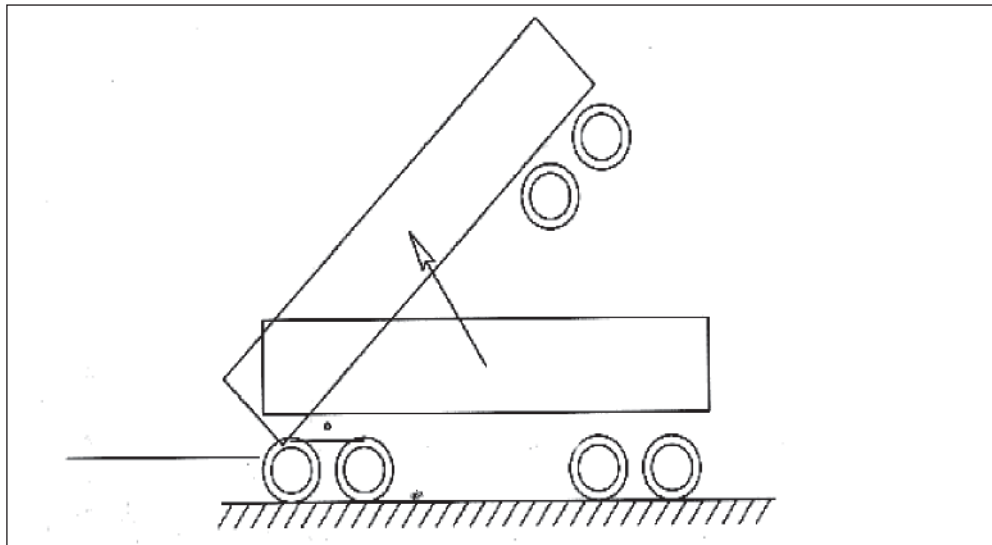
**Figure 16: Representation of the trailer pivoting at the connection between the trailer body and turntable**

The trailer body pivots on a turntable located between the axles on the front bogie and it would be about this point that the body of the trailer would pivot as it lifted from the ground.

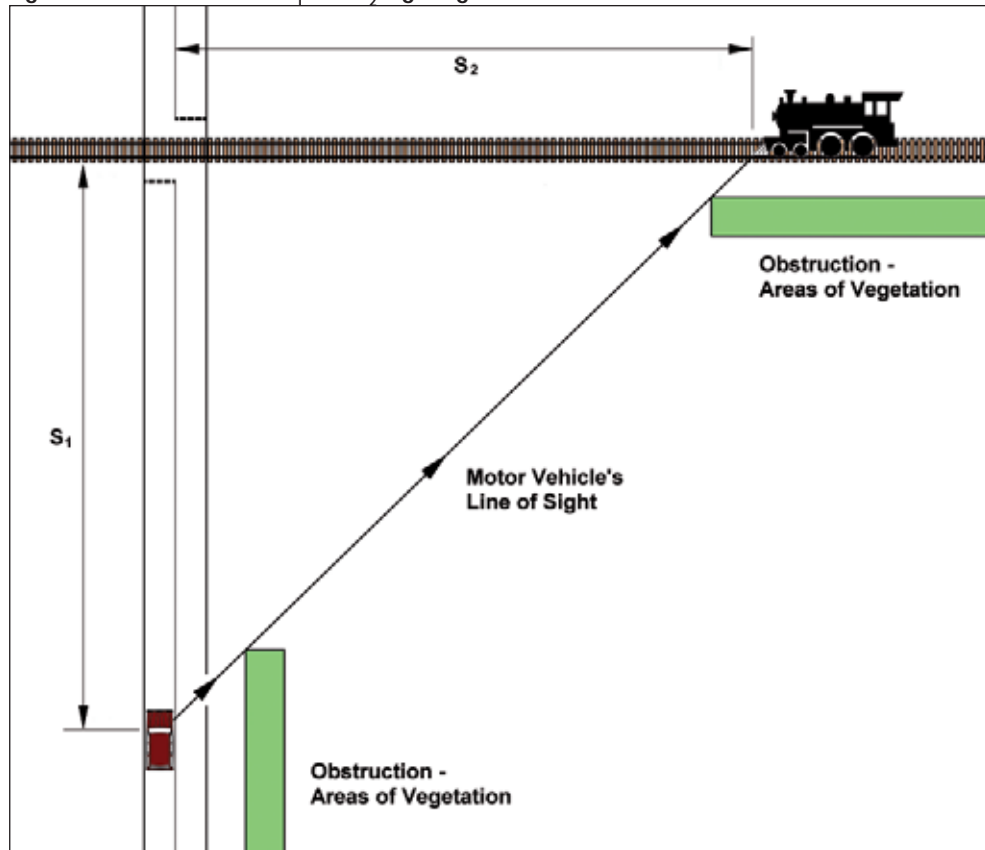
Figure 20: Illustration of  $S_1$  and  $S_2$  sighting distances

The driver of an approaching vehicle, travelling at the 85<sup>th</sup> percentile speed can see a train travelling at maximum operating speed when the vehicle and the train are at distances  $S_1$  and  $S_2$  respectively from the crossing, such that the vehicle can either safely stop short of the crossing, or clear the crossing before the train reaches it.

In accordance with these guidelines, calculations using a road speed of 100km/h (85th percentile speed unknown), a coefficient of friction between the tyres and road of 0.26 and a train speed of 115 km/h are used. The  $S_1$  sighting distance is 230 m and the  $S_2$  sighting distance is 462 m. See Appendix C.

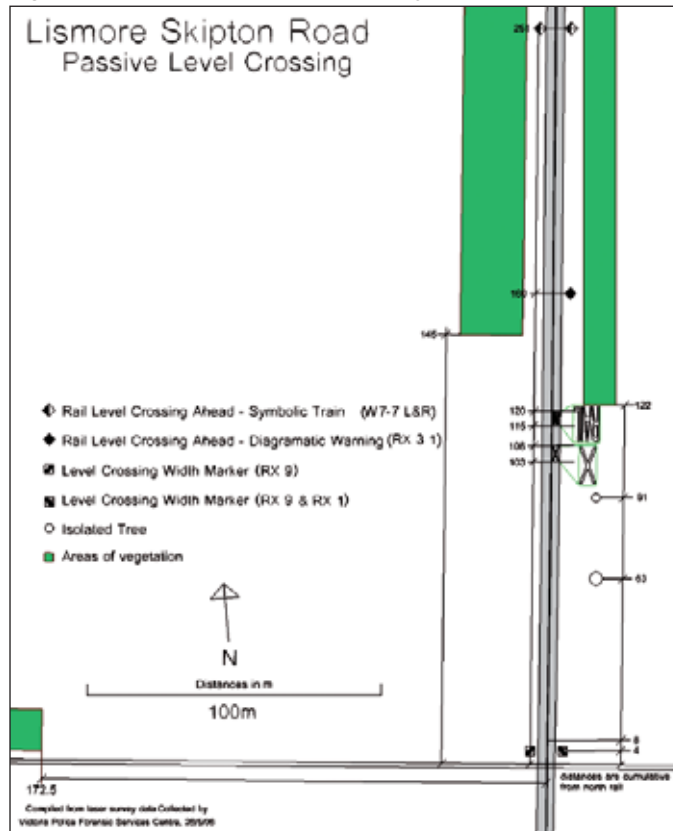
Figure 22: Reproduction of site survey

A train travelling at 115 km/h will take 5.40 seconds to reach the level crossing after passing the point where the stand of trees beside the rail line ends. A road vehicle travelling at 100 km/h will take 5.23 seconds to reach the closest rail line after passing the point where the stand of trees beside the road ends. A truck of the type involved in the collision on 25 May 2006 travelling at 100 km/h has a calculated stopping distance (including reaction time of 2.5 seconds)<sup>17</sup> of 168.7 m and a corresponding time frame of 9.67 seconds. See Appendix 5.2.

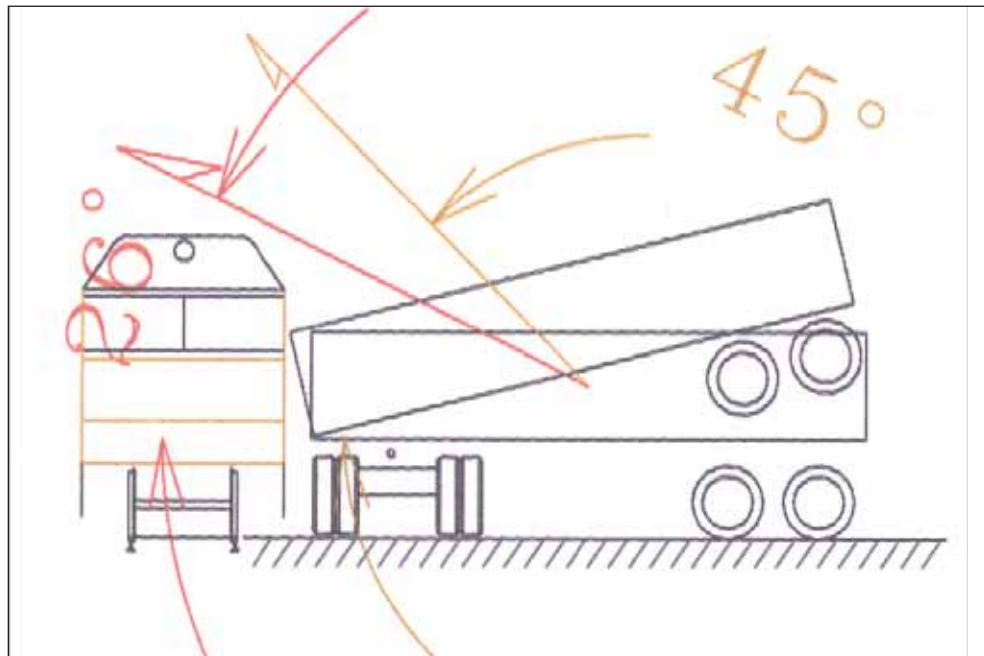
**Figure 1:** Scaled representation showing the trailer against the side of NR 33 with the possible angle of projection from the centre of mass of the load to clear the locomotive.

The third calculation is with the trailer hard against the side of the train to the midpoint and extremity of the citrus pulp on the opposite side of the road. In this instance though, the minimum angle of launch necessary to clear the top of the locomotive is taken into account. This angle is 26 degrees. The distances from the centre of mass of the trailer to the midpoint and extremity of the citrus pulp remain the same as the first calculation (23.93 m and 42.28 m respectively). However, an angle of projection at 26 degrees requires a faster launch speed to reach these distances. These speeds calculate to 57 km/h to 78 km/h.
