ATSB TRANSPORT SAFETY INVESTIGATION REPORT
Rail Occurrence Investigation No. 2006/009
Final

Collision between
**Prime-mover/low loader combination and
Ballast train 4MR1**

Tailem Bend, SA

4 October 2006

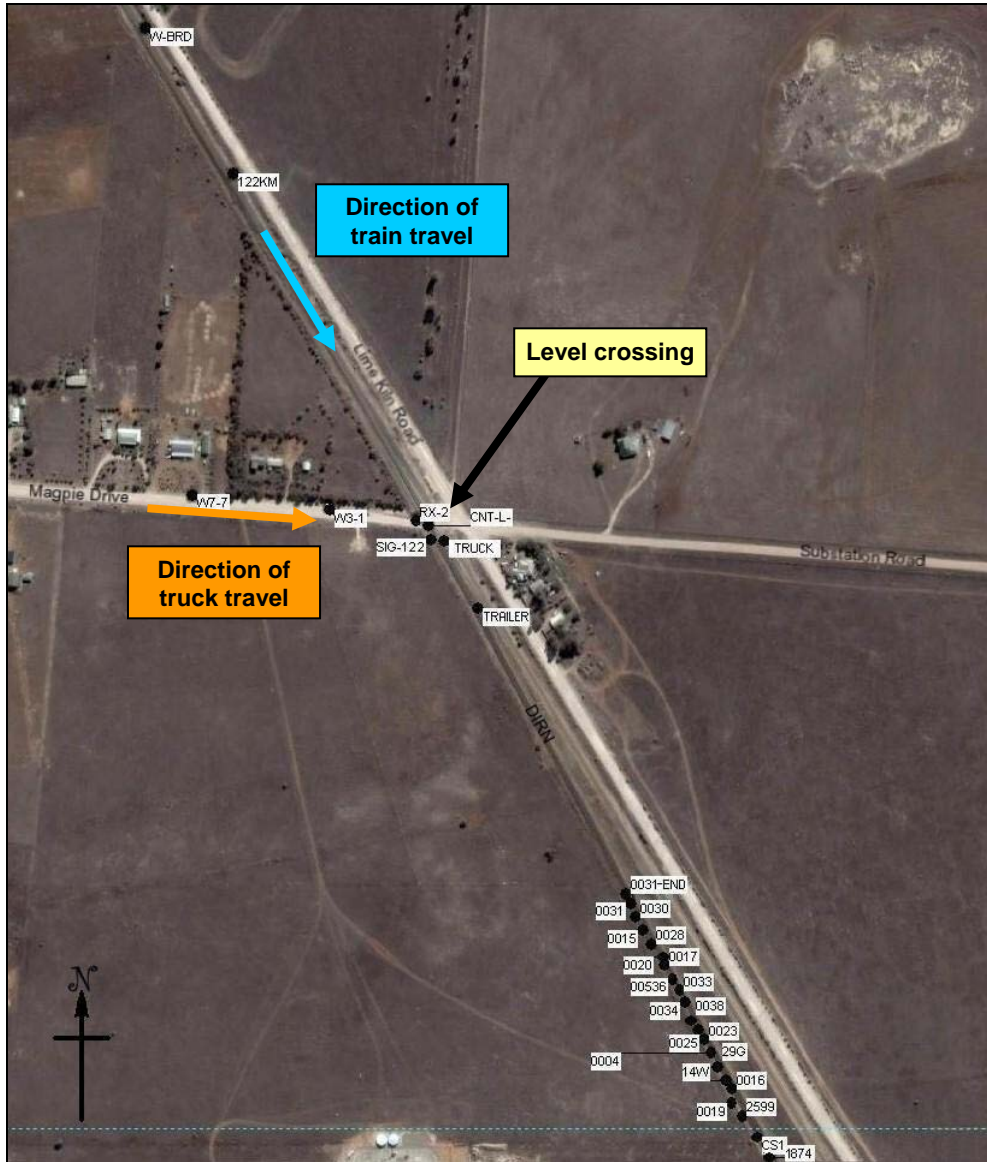
Figure 2: Aerial view Magpie Drive level crossing showing accident site.

Travelling along Magpie Drive, in an easterly direction, the visibility of the rail line and rail traffic is obstructed by vegetation bordering the northern side of Magpie Drive and the north-western side of the rail corridor. Magpie Drive (Fig. 2) intersects with the Adelaide to Melbourne rail line and the Pinnaroo line at an angle of close to 60 degrees. After passing over the level crossing, Magpie Drive intersects with Lime Kiln Road and is re-named as Substation Road.

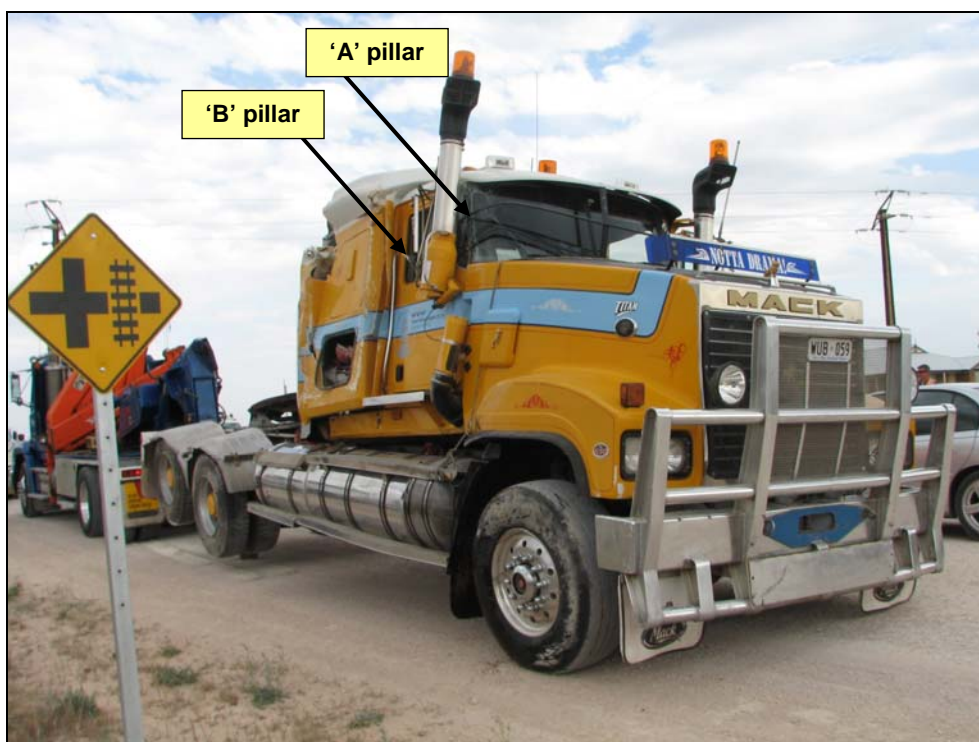
Figure 4: Mack Titan prime mover involved in collision.

The emergency response was both timely and adequate. There was minor damage to the locomotive, the truck prime mover was heavily damaged and the truck's trailer was destroyed as a result of the collision. Damage to fixed infrastructure included the destruction of a signal and a cable pit on the south-west side of the level crossing. There was minor damage to the track.

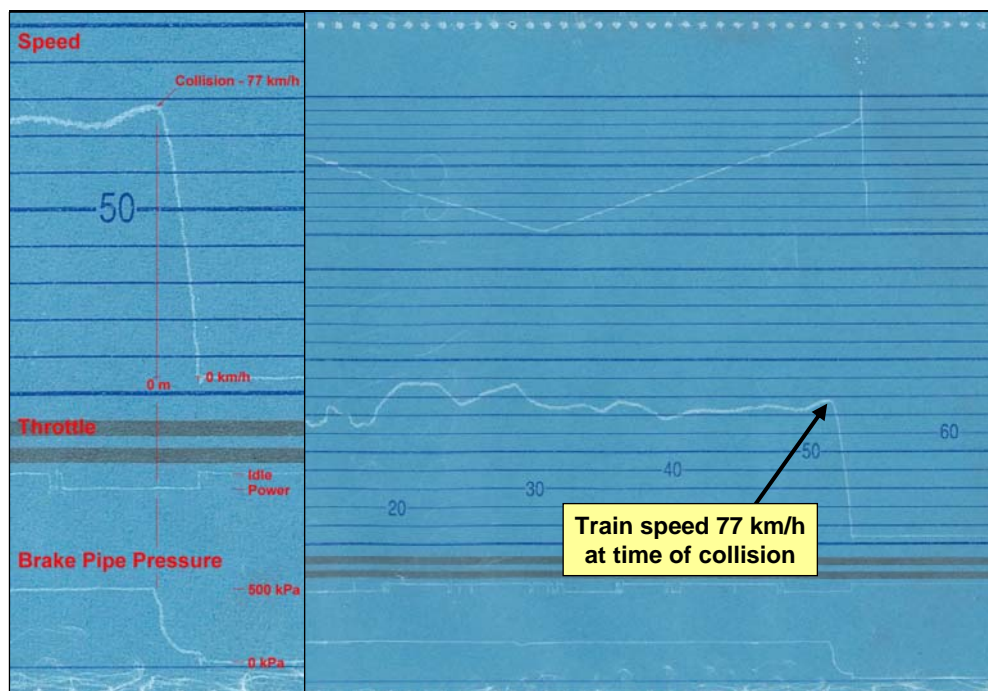
Figure 9: Extract of data download 'Hasler' event data logger from CS1

The event loggers on locomotives NA1874 and CS1 (extract at Fig. 9) capture time, speed, distance, brake and vigilance activation. The speed recorded by the event data loggers was corrected for wheel diameter and synchronised with the CTC clock/time. The CTC and locomotive data was used to reconstruct the timing of the collision. The examination of this data has established that:

- The collision occurred at 1101:43.
- The speed of the train at the time of collision was 77 km/h; this was 3 km/h below the maximum permitted speed for the train.
- The train brakes were applied as a direct consequence of the collision when air was lost from the train braking system. This was corroborated by the train crew who also stated that they were unaware of the truck until after the collision.

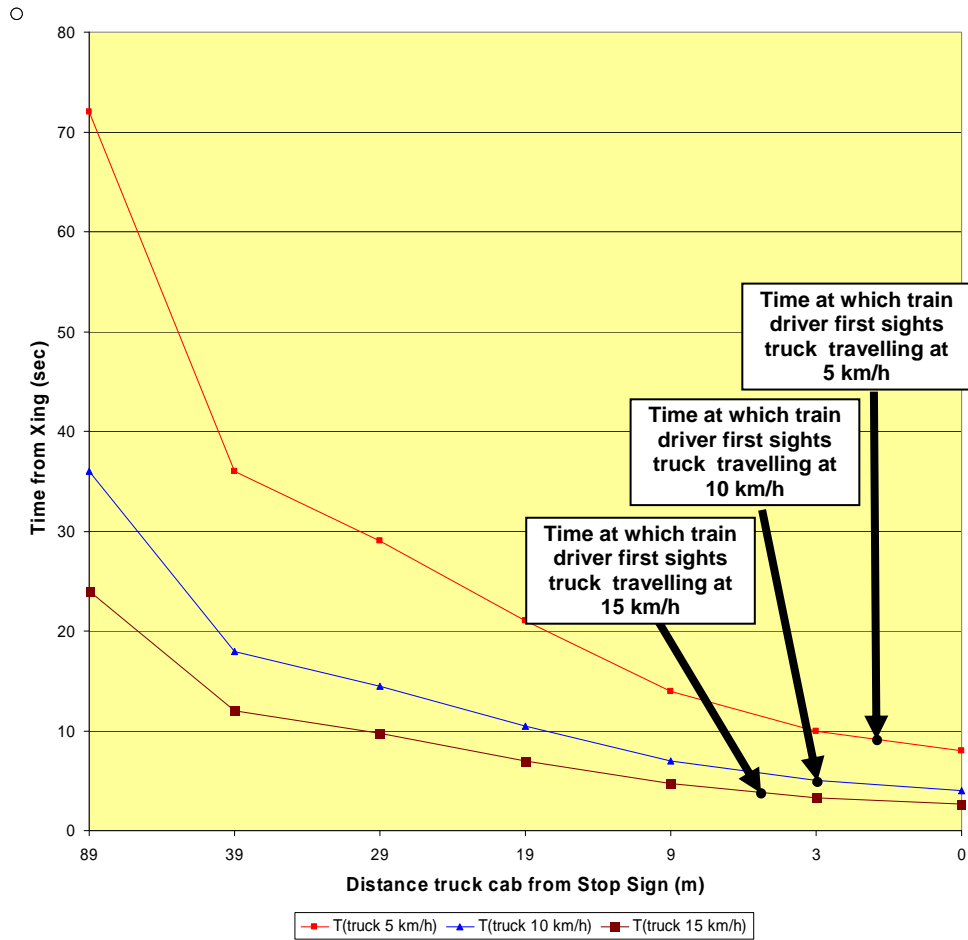
Figure 10: Taillem Bend – Sighting Times Calculation

The attached graph at Fig. 10 is a time versus distance plot for the truck (speed 20 km/h, 10 km/h and 5 km/h) approaching the 'Stop' sign and train 4MR1 approaching the level crossing at 77 km/h.

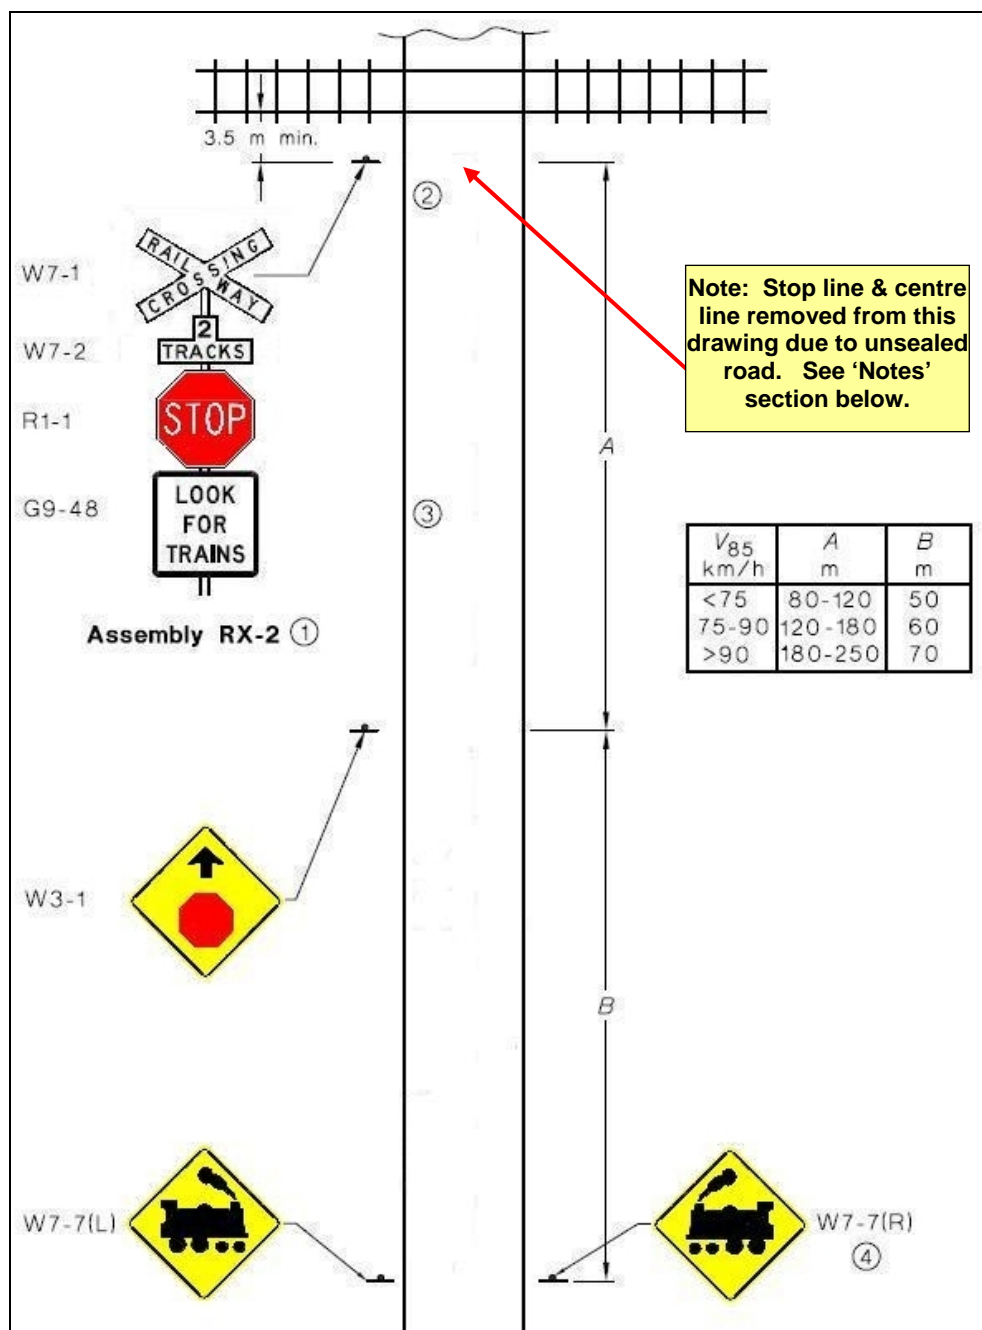
Figure 11: AS1742.7-1993, Standard signage and road marking layout for 'level crossing with straight approach controlled by stop signs (Passive Control)'.

All of the required signage (Fig. 11, Fig. 12 & Fig. 13) was found to be present on the western approach to the Magpie Drive level crossing. The signs were in a very good condition and clearly visible to approaching road traffic. Road pavement markings were not provided and are not required at this location as the road is unsealed. During discussions with the Coorong District Council it was noted that they did not have a scheduled maintenance program covering the inspection of level

crossings and approach warning signage. These programs should desirably be in place to ensure quality of infrastructure and currency of standards are maintained.

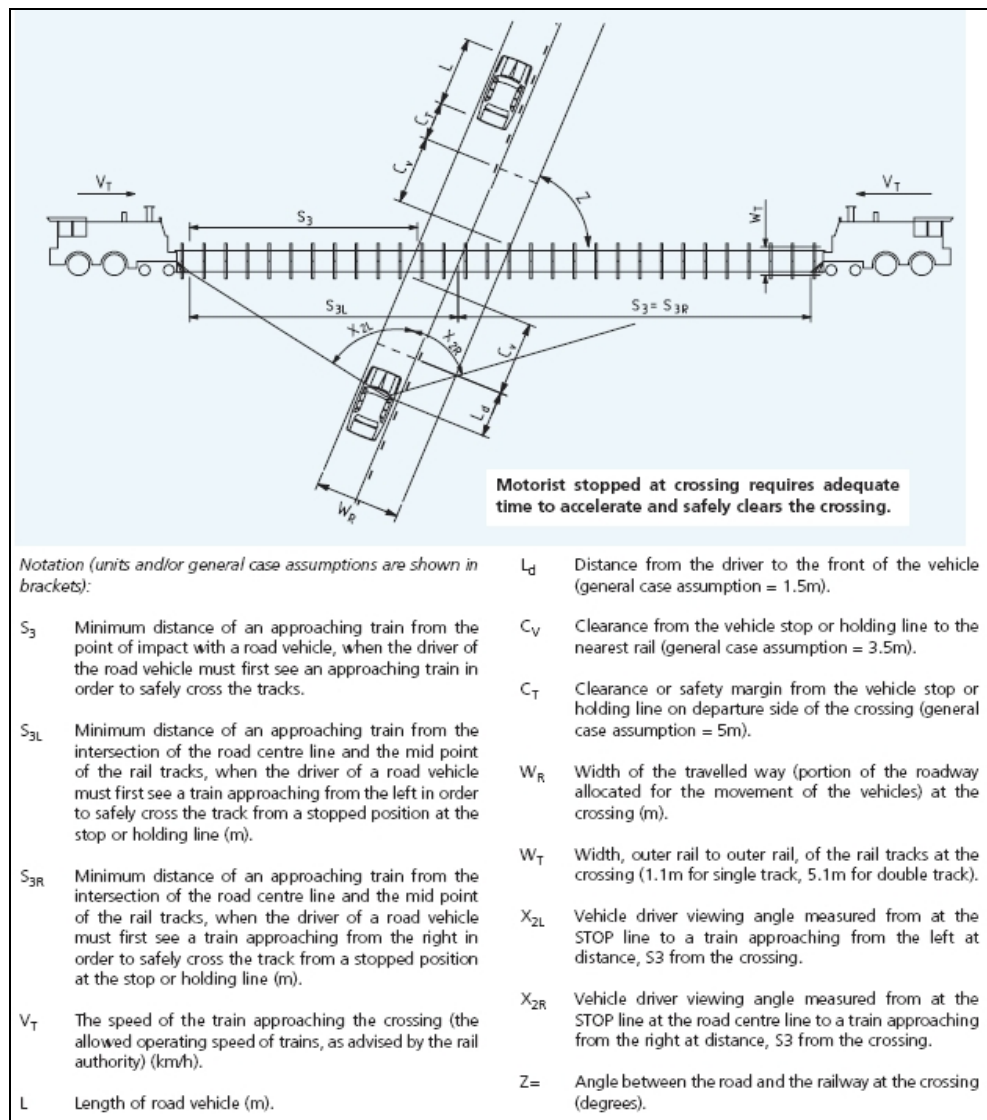
Figure 14: Approach distances and viewing angles

‘Stop’ sign control at a level crossing requires that the driver of a motor vehicle has sufficient sighting distance (including viewing angles) along the track when stopped to clearly see any approaching train, and then be able to accelerate safely clear of the crossing before the train arrives.
