Australian Government
Australian Transport Safety Bureau

Safety of rail operations on the interstate rail line between Melbourne and Sydney

ATSB Transport Safety Report
Rail Safety Issue Investigation
RI-2011-015
Final – 22 August 2013

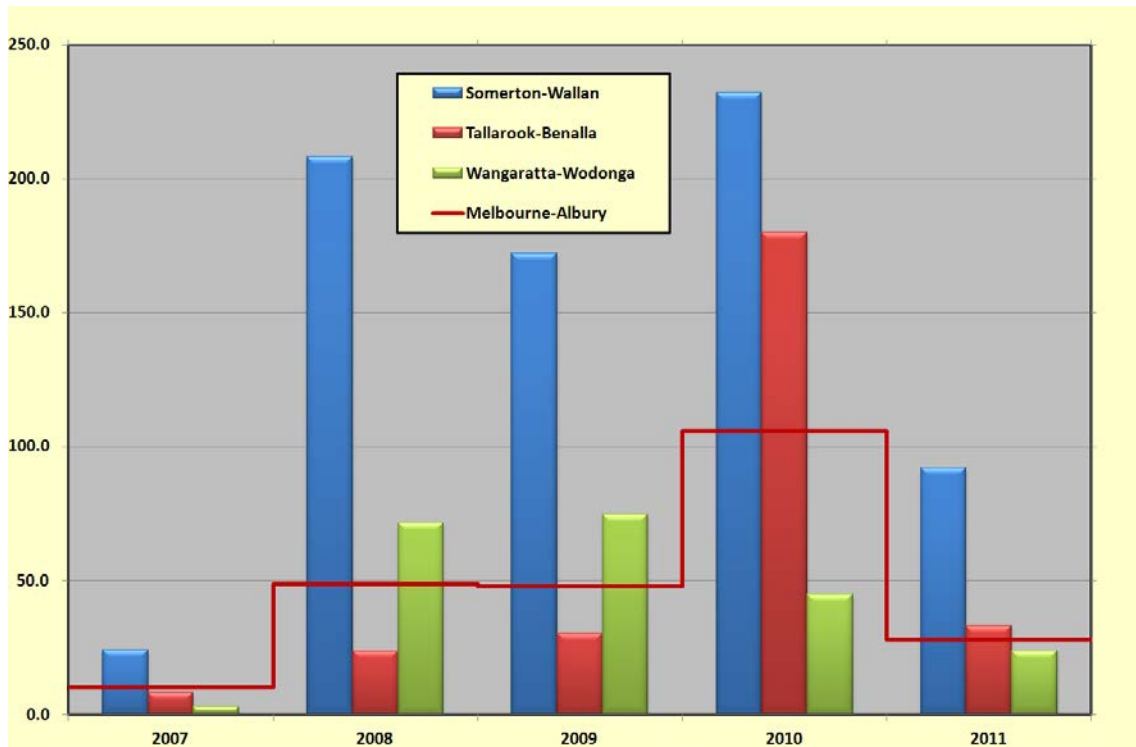
Figure 7: Reported track condition incidents per 100km (Victoria)

Examination of the incident data from Victoria indicated that the majority of track condition type incidents (train partings, rough riding and mud-holes) were focussed around three sections of track; Somerton to Wallan (about 25 km), Tallarook to Benalla (about 110 km) and Wangaratta to Wodonga (about 65 km). These sections combined, represent about 66% of the track length between Melbourne and Wodonga. Figure 7 illustrates the density of track condition type incidents reported in Victoria (each year) between 2007 and October 2011 for each of the identified track sections. For comparison, Figure 7 also illustrates the density of track condition type incidents (for each year) over the entire track between Melbourne and Albury.

When considering the track condition type incidents between Melbourne and Albury, it was evident that the overall incident density increased about five-fold in 2008, stayed constant through 2009 before doubling again in 2010. In 2011, the overall incident density decreased to about three times the 2007 level.

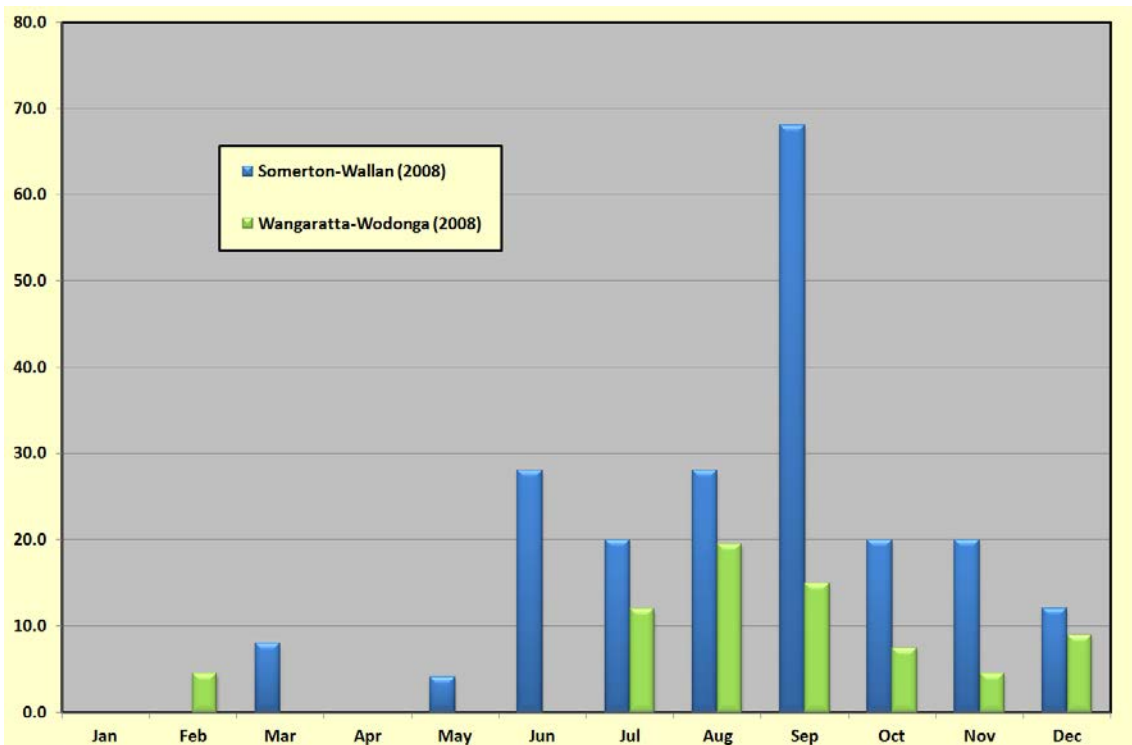
Figure 8: Incident data (per 100 km) for 2008 (Victoria)

The number of incidents between Somerton and Wallan showed a significant increase in density during 2008. Similarly, the section between Wangaratta and Wodonga also increased in 2008, though not to the same extent. Incidents occurring in both sections remained high during 2009. Examination of the data showed that the majority of incidents were recorded later in each year with a higher concentration occurring in July, August and September. Figure 8 illustrates the spread of data during 2008; a similar distribution was evident for 2009.

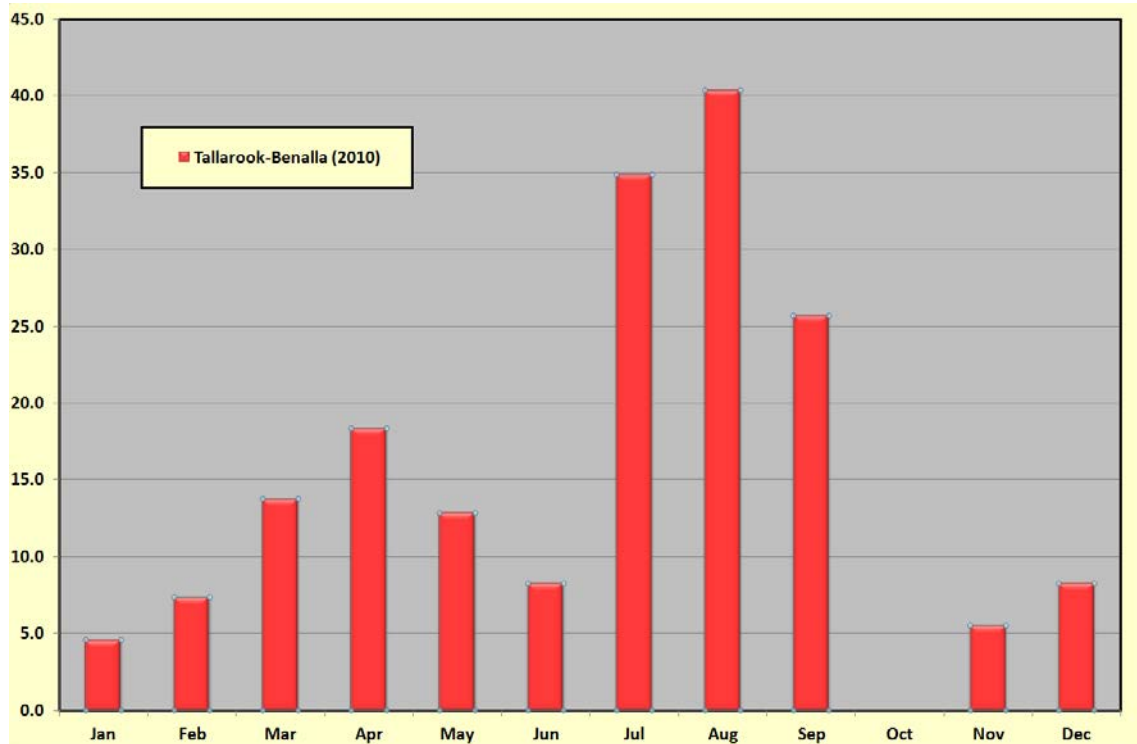
Figure 9: Incident data (per 100 km) for 2010 (Victoria)

The number of incidents between Tallarook and Benalla showed a slight increase in density during 2008 (remaining constant during 2009), but was relatively low when compared to the increases over the other sections and when compared to the incident density over the entire track. Figure 7 also shows that in 2010, the density of incidents between Tallarook and Benalla increased significantly.

Similar to the other sections of track during previous years, examination of the data showed a high concentration of incidents during July, August and September. In 2010, a large proportion of incidents also occurred during the first half of the year. Figure 9 illustrates the spread of data during 2010 for the section of track between Tallarook and Benalla²³.

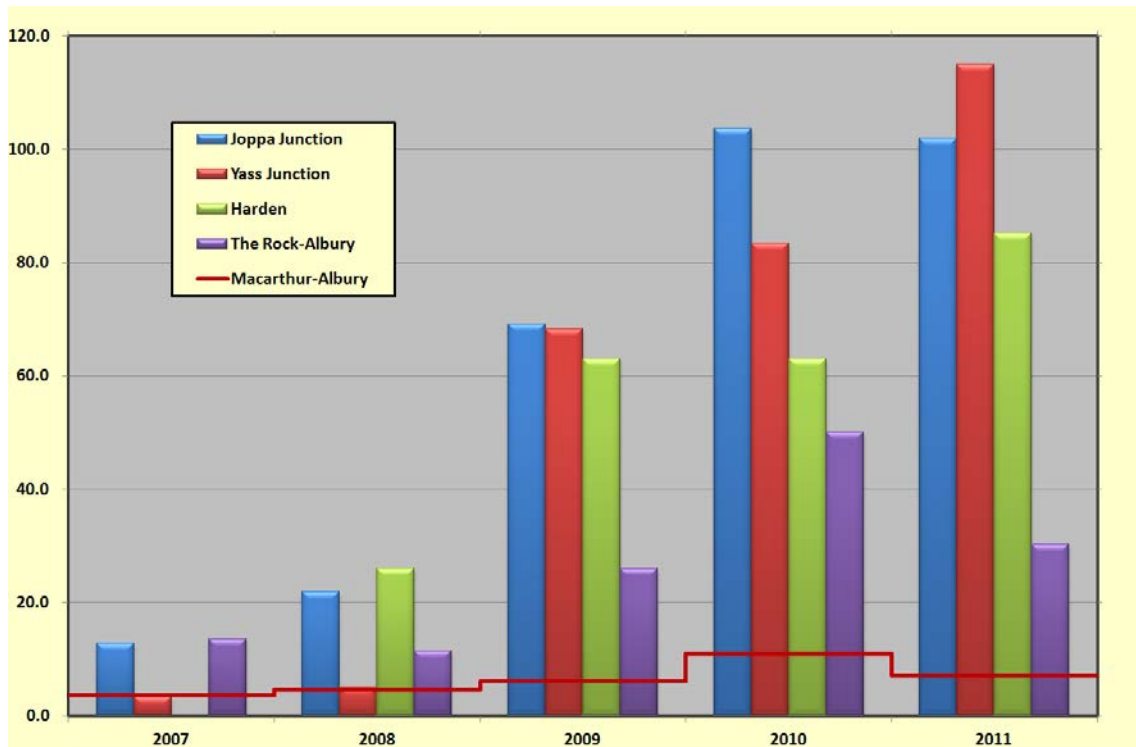
Figure 10: Reported track condition incidents per 100 km (New South Wales)

Examination of the incident data from New South Wales indicated a focus of track condition type incidents (train partings, rough riding and mud-holes) around Joppa Junction, Yass Junction, Harden and a 100 km section of track between The Rock and Albury. These sections combined, represent about 40% of the track length between Albury and Macarthur. Figure 10 illustrates the density of track condition type incidents reported in New South Wales (each year) between 2007 and October 2011 for each of the identified track sections. For comparison, Figure 10 also illustrates the density of track condition type incidents (for each year) over the entire track between Albury and Macarthur.

When considering the track condition type incidents between Macarthur and Albury, the increase in overall incident density was less than Victoria. The overall incident density between Macarthur and Albury increased slightly in 2008 and again in 2009 before almost doubling in 2010 and dropping in 2011. The overall incident density in 2010 was only about three times that of 2007, whereas in Victoria the 2010 figure was about 10 times that of 2007.

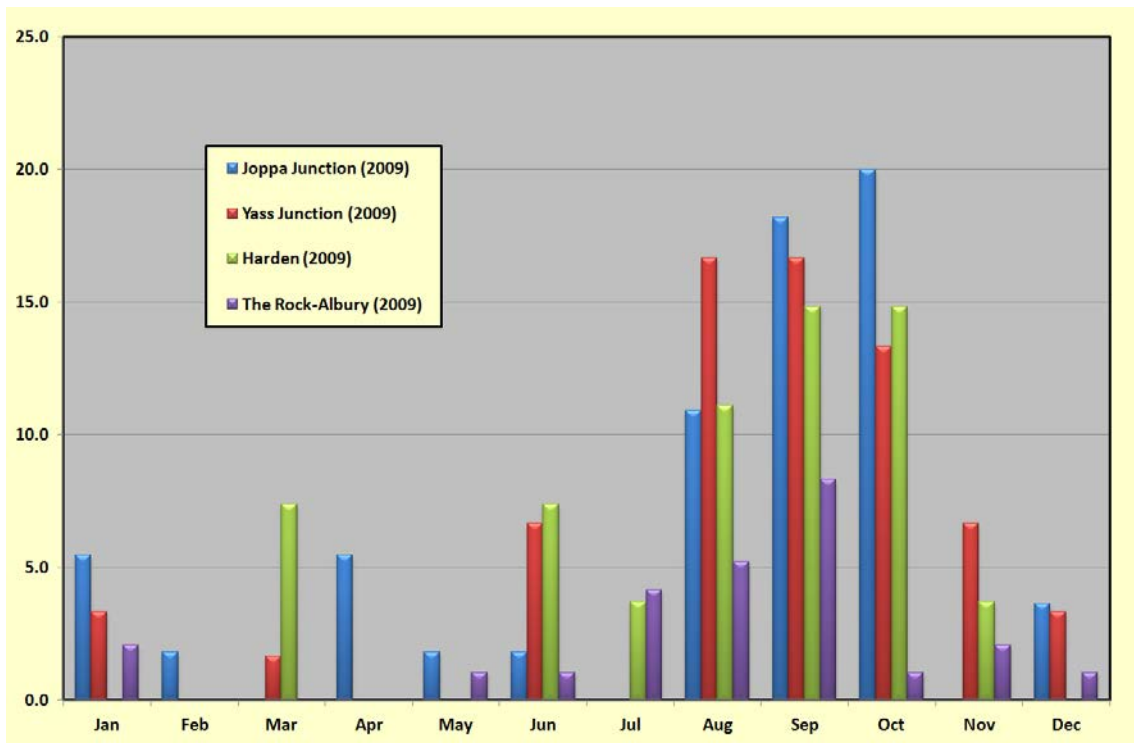
Figure 11: Incident data (per 100 km) for 2009 (New South Wales)

The number of incidents that occurred in the track sections identified above increased slightly in 2008 and then significantly increased in 2009. Examination of the data showed that the majority of incidents were recorded later in each year with a higher concentration occurring in August, September and October. Figure 11 illustrates the spread of data during 2009.

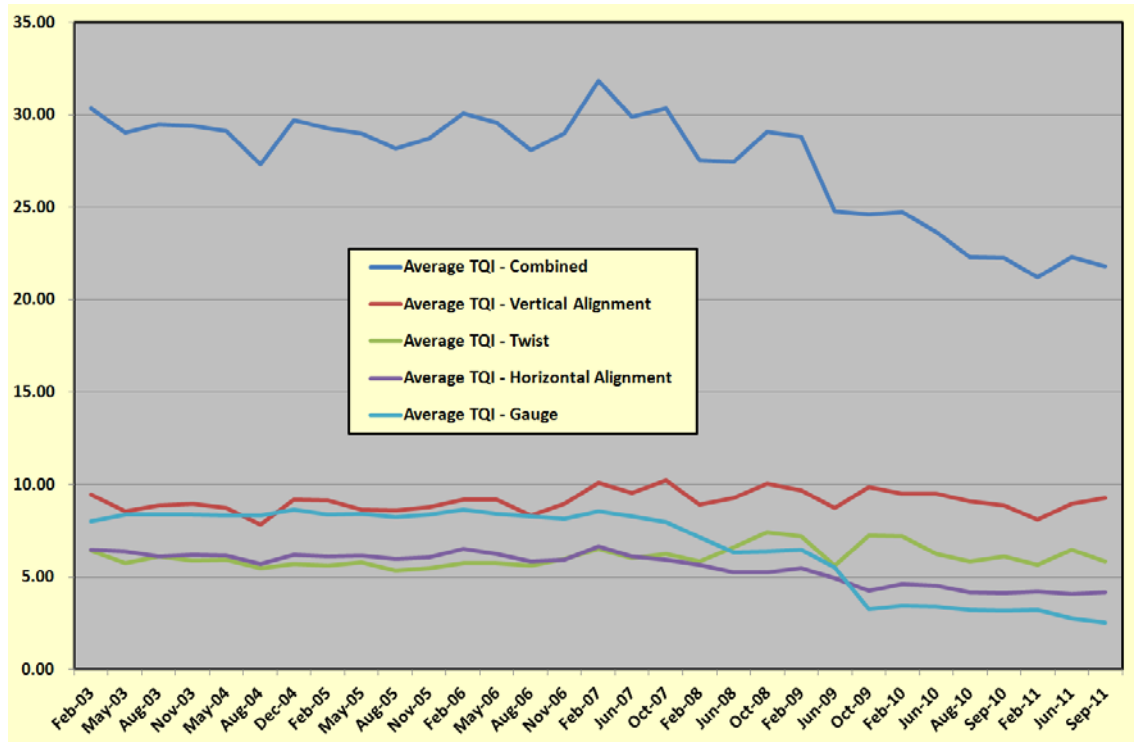
Figure 12: Average TQI – Melbourne to Wodonga (Victoria)

Figure 12 illustrates the average TQI figures for the standard gauge track²⁶ between Melbourne and Wodonga. Examination of the data indicated that before 2007, the combined average TQI was generally just below 30. In 2007, the combined average TQI increased to 31.8 before decreasing to 21.8 in September 2011. This would suggest an overall improvement in track quality since 2008, but this is inconsistent with the track condition incident data which increased between 2008 and 2010 (see section titled Incident data).

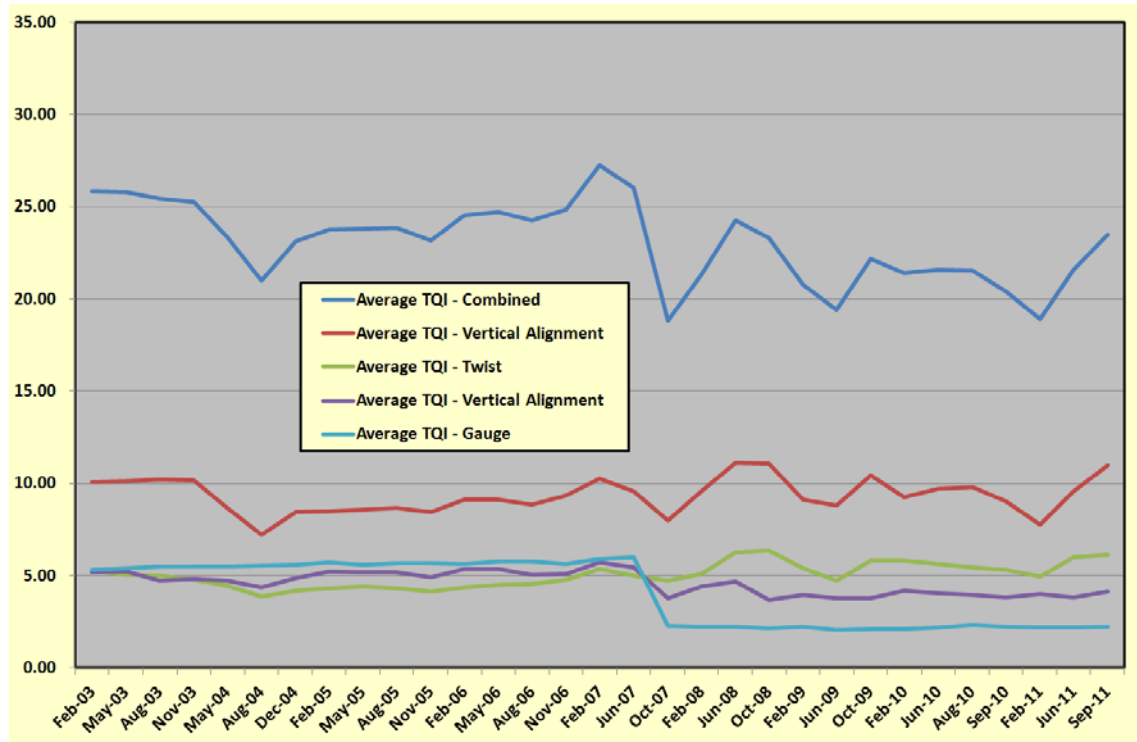
Figure 13: Average TQI – Somerton to Wallan (Victoria)

Figure 13 illustrates the average TQI figures for the standard gauge track between Somerton and Wallan. Examination of the individual indices showed a significant improvement for track gauge between June 2007 and October 2007, which coincides with the installation of concrete sleepers. There was also a corresponding (though not so significant) improvement to horizontal alignment, vertical alignment and twist during the same period. However, by June 2008, the figures for vertical alignment and twist had increased again and were at their highest levels since 2003. While the overall average TQI may have improved between Somerton and Wallan since June 2007 (consistently below the ARTC's target of 25), the track condition elements of vertical alignment and twist deteriorated.

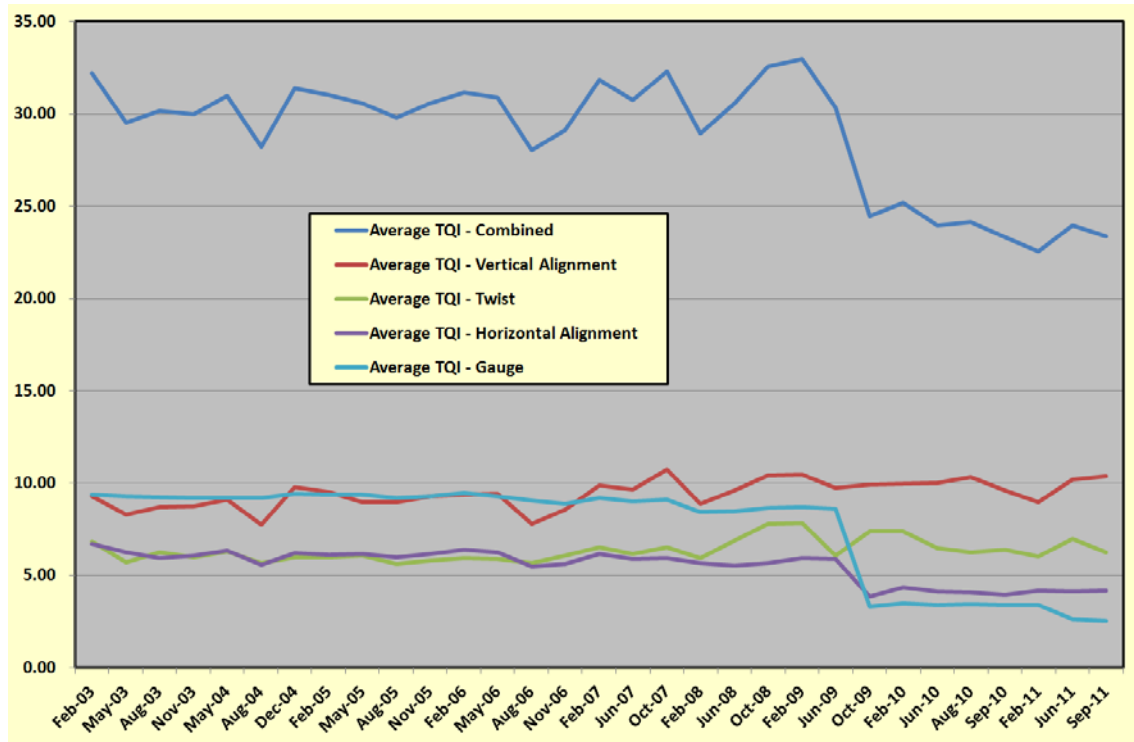
Figure 14: Average TQI – Tallarook to Benalla (Victoria)

Figure 14 illustrates the average TQI figures for the track between Tallarook and Benalla. Examination of the individual indices showed a significant improvement for track gauge and horizontal alignment between June 2009 and October 2009, which coincides with the installation of concrete sleepers. However, the figures for vertical alignment and twist had appeared to have gradually increased since 2003 and showed no obvious improvements due to the installation of concrete sleepers. While the overall average TQI may have improved between Tallarook and Benalla since June 2009 (consistently below the ARTC’s target of 25), the track condition elements of vertical alignment and twist deteriorated.

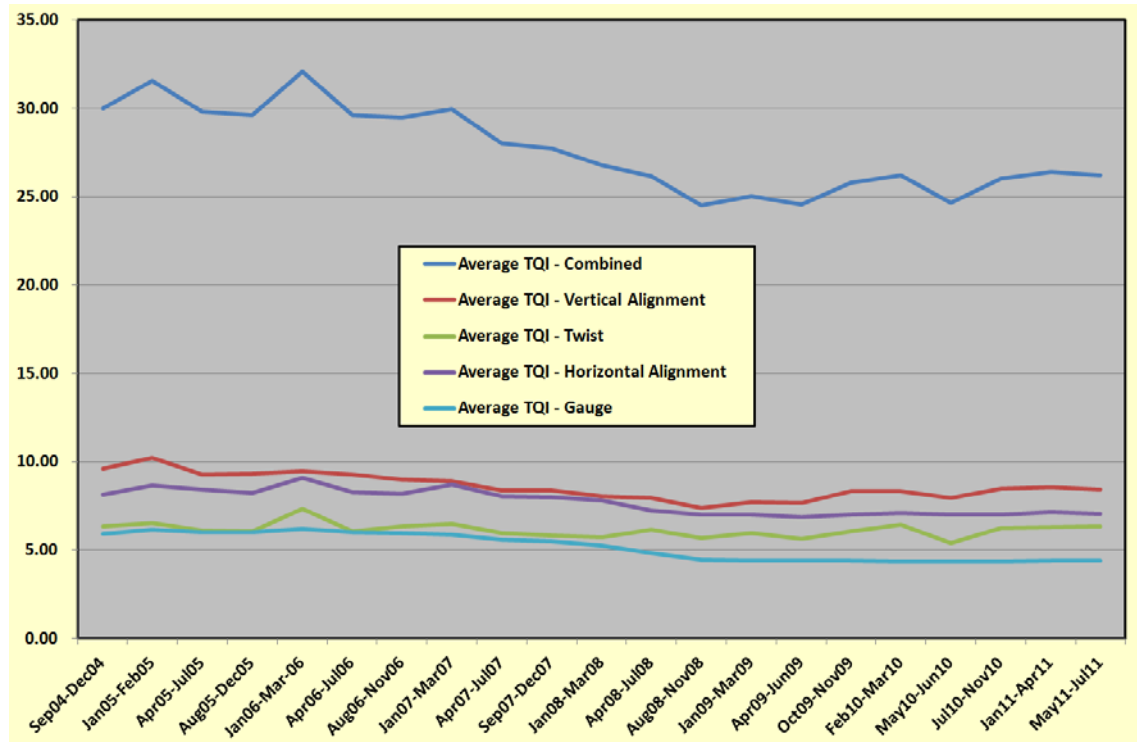
Figure 15: Average TQI – Albury to Macarthur (New South Wales)

Figure 15 illustrates the average TQI figures (combined up and down) tracks between Albury and Macarthur (New South Wales). Examination of the data indicated that before 2007, the combined average TQI was generally about 30. After 2007, the combined average TQI gradually decreased to about 25 by January 2009 increasing slightly to 26.2 in July 2011. While the decrease in TQI was not as significant as that in Victoria, the reduction still implied an overall improvement in track quality since 2008. However, similar to Victoria, this conclusion does not appear consistent with the track condition incident data (see section titled Incident data) as the density of track condition type incidents increased between 2008 and 2010.

When examining the individual indices, it is evident that the average TQI for track gauge decreased from about 6.0 (before 2007) to about 4.4 (by July 2011). The average TQI for horizontal alignment also showed slight improvement over the same period. Unlike Victoria, the average TQI for vertical alignment showed gradual improvement from 2004 until late 2008 before increasing slightly by July 2011. The average TQI for twist remained relatively constant.

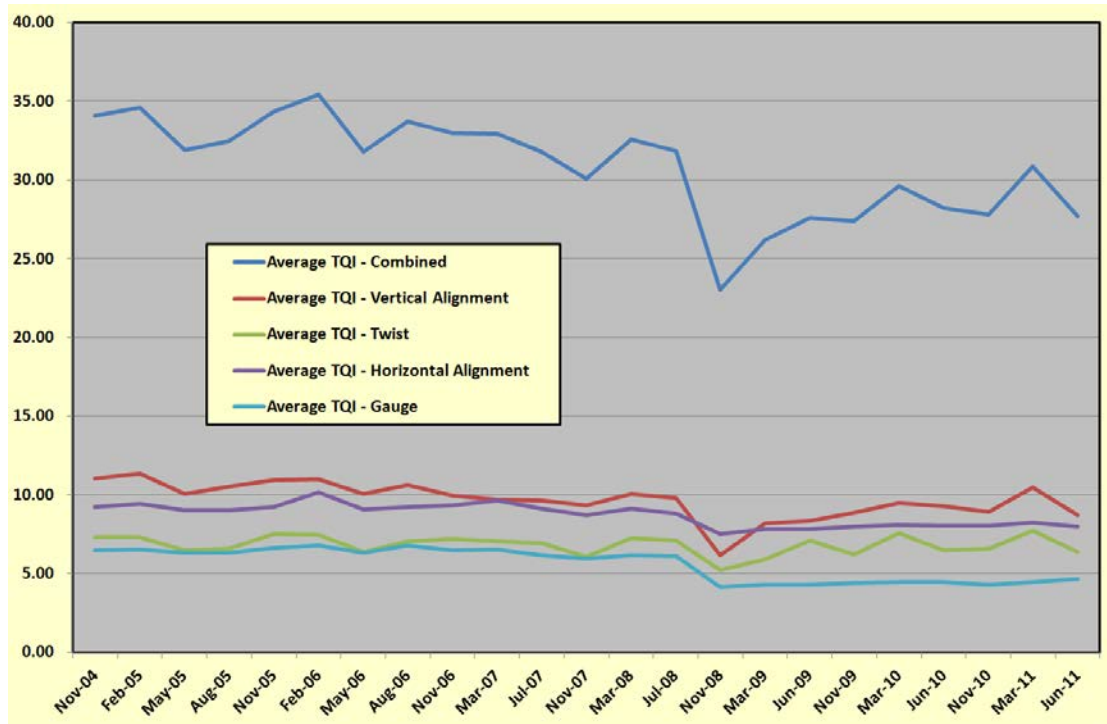
Figure 16: Average TQI – Up track near Joppa Junction (New South Wales)

An example from the track condition incident data (see section titled Incident data) showed significant increases in incident density near Joppa Junction and Yass Junction. Figure 16 illustrates the average TQI figures for the up track near Joppa Junction. Examination of the data showed an improvement against all indices between July 2008 and November 2008, which coincides with the installation of concrete sleepers. The average TQI figures for track gauge and horizontal alignment then remained relatively constant until June 2011. However, the figures for vertical alignment and twist gradually increased to pre-2008 levels over the same period. While an initial improvement to overall average TQI may have occurred near Joppa Junction after concrete sleepers were installed, vertical alignment and twist deteriorated.

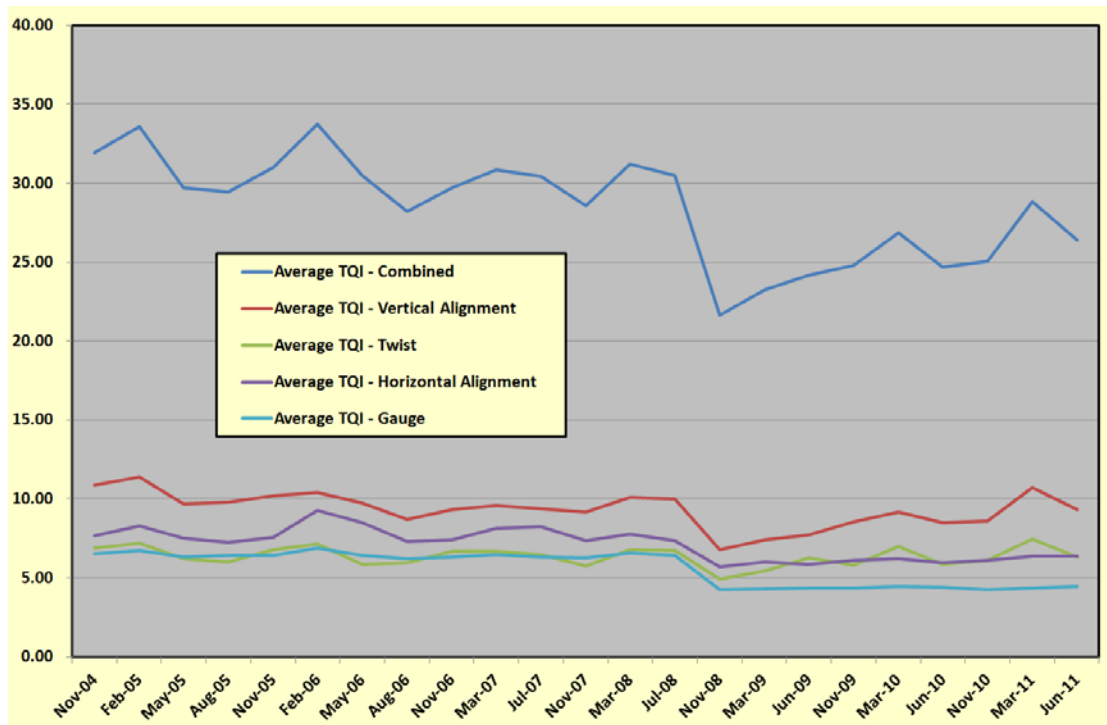
Figure 17: Average TQI – Up track near Yass Junction (New South Wales)

Figure 17 illustrates the average TQI figures for the up track near Yass Junction. Examination of the data showed similar results to that of the track near Joppa Junction. Again, an initial improvement to overall average TQI occurred between July 2008 and November 2008 (coinciding with the installation of concrete sleepers), but the track condition elements of vertical alignment and twist indicate deterioration after that date. Examination of the data for the down track showed similar results which again coincide with the installation of concrete sleepers.

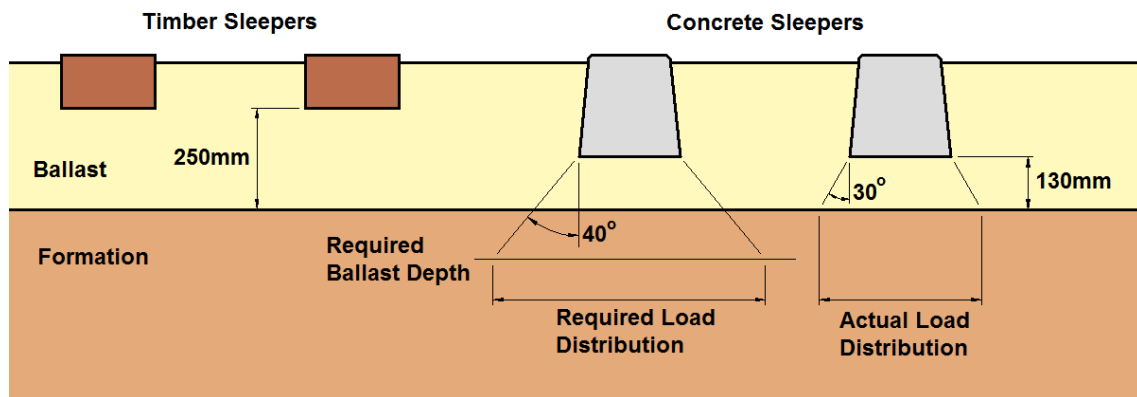
Figure 20: Load distribution with reduced ballast depth

height³⁵. Since the concrete sleepers (about 250 mm deep) are almost twice the depth of timber sleepers (about 130 mm deep), the ballast depth under the sleepers was considerably less than the required 250 mm. The consequence of these decisions was a considerable decrease in the area over which the load would be distributed (Figure 20), with a corresponding increase in pressure on the formation. A rough calculation indicates that pressure on the formation would be about twice the pressure than if the required ballast depth was maintained.

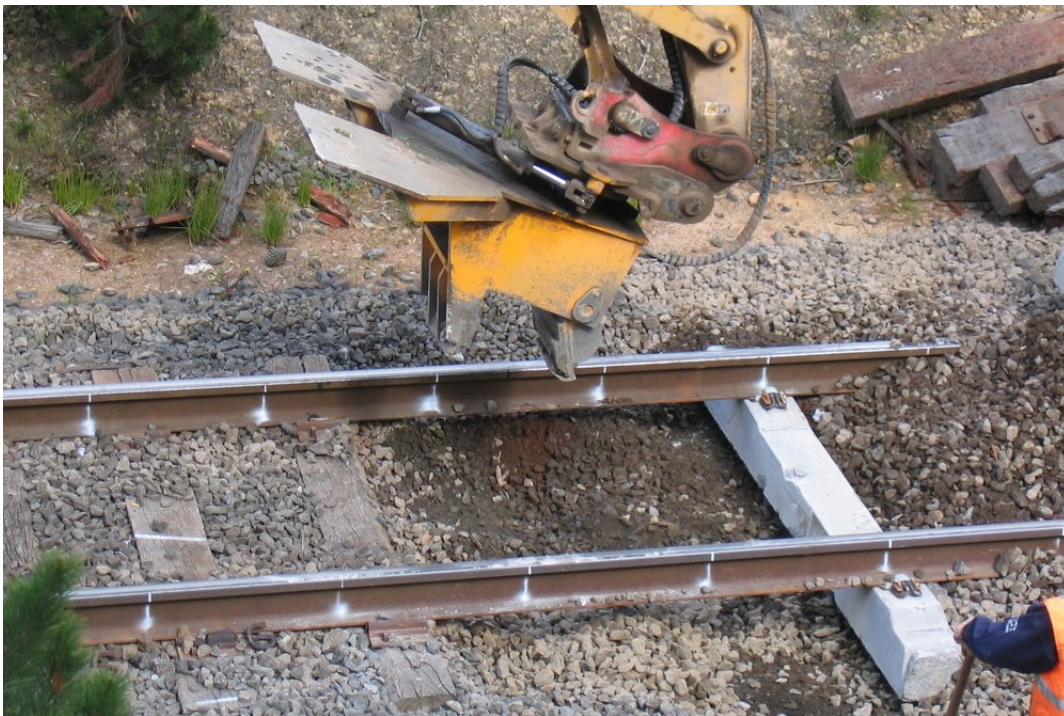
Figure 26: Concrete sleeper clipped in position

Figure 26 illustrates a location where the ballast appears to have been completely removed from the top surface of the formation. It also shows that there is a gap of only about 50 mm to 100 mm between the bottom face of the concrete sleeper and the scarified ballast. It is evident that at this location, the depth of ballast under the new concrete sleepers is inadequate and that exposure of the formation is likely to have increased the risk of subgrade damage. Information provided to the ATSB during various interviews suggested that these conditions may have been relatively common, though verifiable evidence of the issue was limited.

The ARTC advised that in the early stages of the project, the pre-lift process was not done which resulted in penetration into the formation layer⁴⁴. Also, in some cases, the pre-lift process was not done because of infrastructure limitations (for example, road and pedestrian crossings, station platforms and bridge structures). The photos (above) were taken relatively early in the project (October 2007), so it is possible that they were taken before the ARTC recognised the potential problems associated with formation damage and subsequently took action to address the issue.

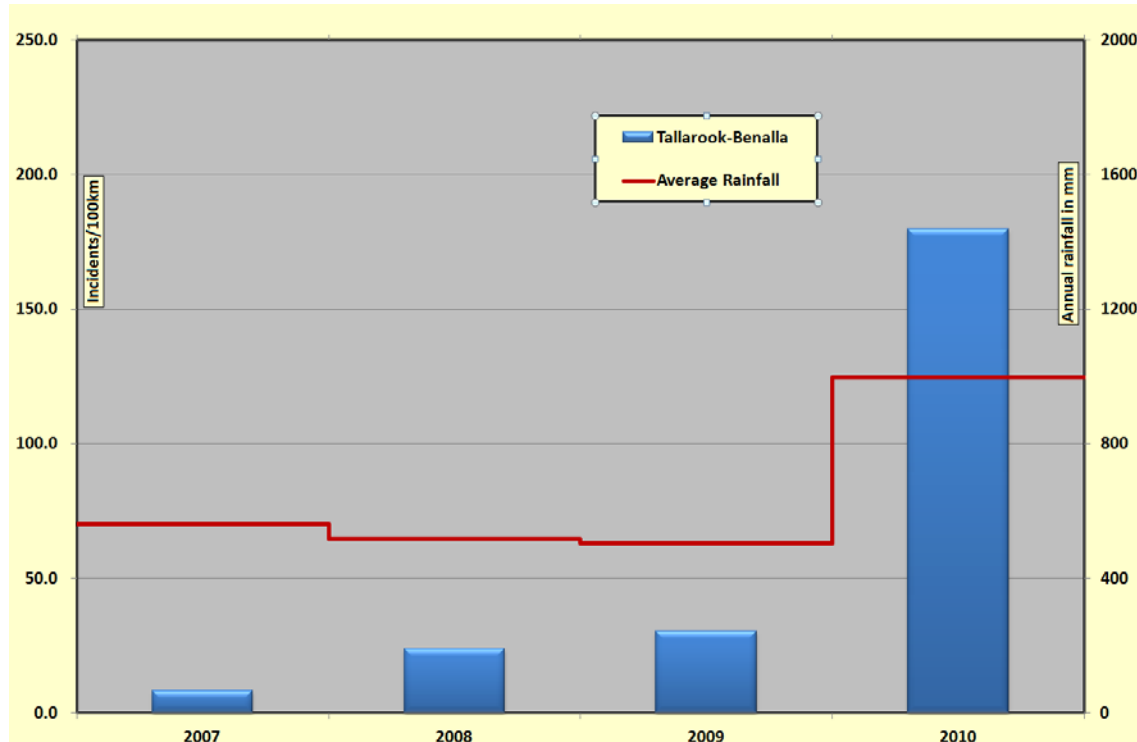
Figure 34: Incident data (Tallarook - Benalla) and Rainfall (Euroa)

For example, between Tallarook and Benalla, the number of track condition type incidents remained relatively low during 2007, slightly increased in 2008 and 2009, but significantly increased in 2010. The concrete sleepers were installed in this area between mid-2008 and mid-2009, but the number of incidents did not increase significantly until 2010 when record rainfalls were experienced (Figure 34).

On the balance of evidence this would suggest the primary factor influencing the increase in incident rates between Tallarook and Benalla was related to the heavy rains in 2010.

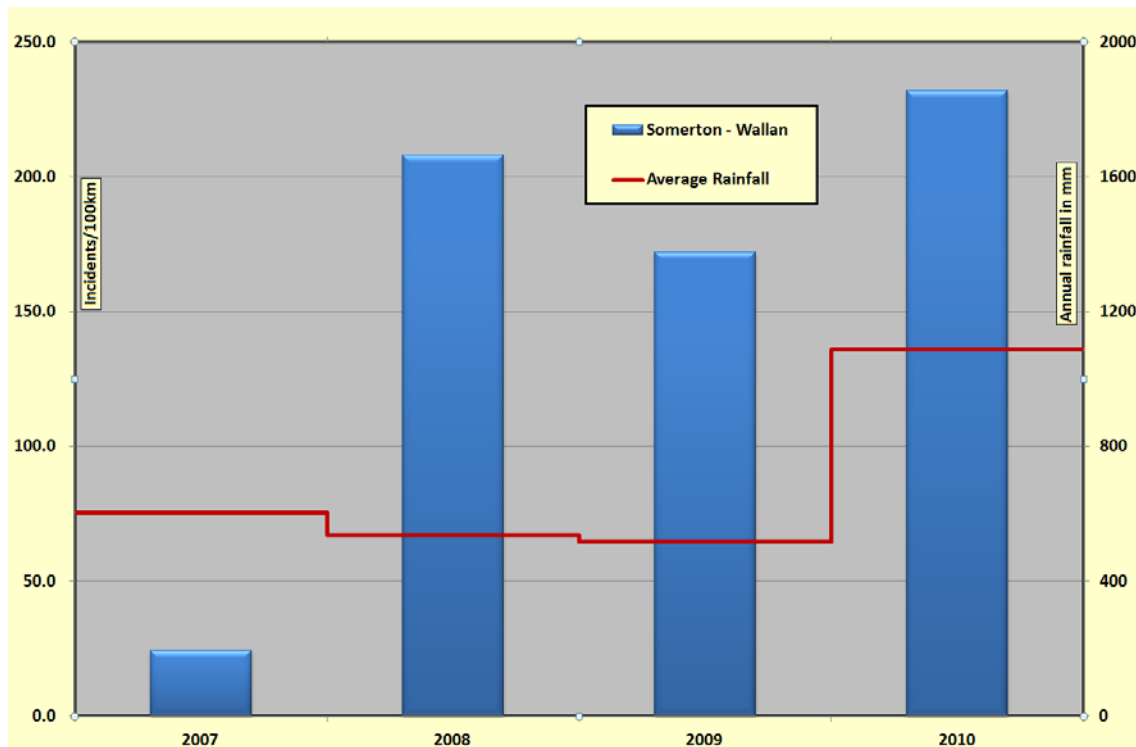
Figure 35: Incident data (Somerton - Wallan) and Rainfall (Wallan)

By comparison the area between Somerton and Wallan shows that track condition type incidents remained relatively low during 2007, but increased significantly in 2008 and remained high during 2009 and 2010. Concrete sleepers were installed in this area between mid-2007 and early 2008, followed almost immediately by an increase of track condition type incidents. High rainfall was not experienced until 2010 (Figure 35).

As mentioned in the section titled 'Drainage', well-constructed and maintained track should direct water away from the track structure, including water resulting from higher than average rainfalls. Critical to this process is good ballast condition (no fouling) and good formation condition (good shape and cap layer). In the areas examined, track condition type incidents were relatively high following the high rainfall experienced during 2010 and 2011, suggesting that water retention due to fouled ballast was probably a significant contributor to the track geometry issues, rough riding and the development of mud-holes.

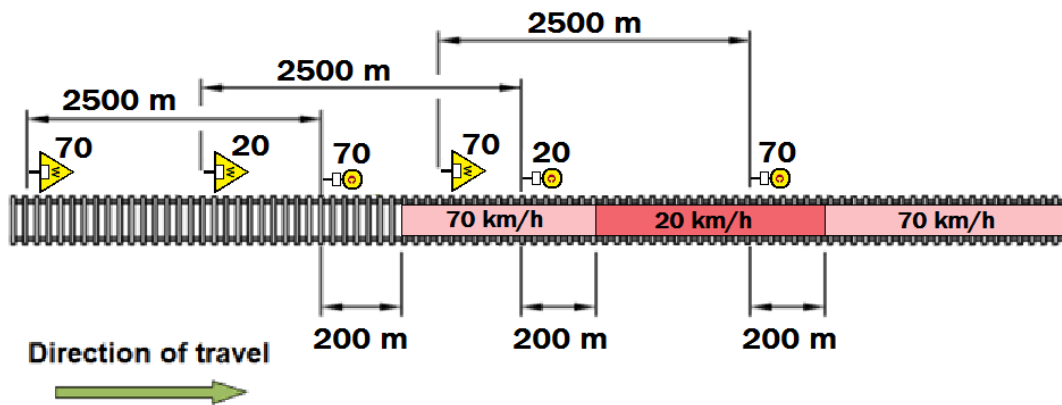
Figure 44: Multiple speed restrictions (Victoria)

Figure 44 illustrates an example (only the warning and caution signs are illustrated) where a driver would see a 20 km/h 'Warning' sign immediately before the first 70 km/h 'Caution' sign. Similarly, a 70 km/h 'Warning' sign precedes the 20 km/h 'Caution' sign. In both cases, the warning sign preceding the caution sign is not intended for the next speed restriction immediately ahead. This configuration may present a confusing, if not misleading, indication of the impending speed

The configuration in Figure 44 does not illustrate the ‘Normal Speed’ sign (200 m after each TSR location) and the ‘Normal’ sign (1200 m after each TSR location). Without any guidance to the contrary, it is possible that signage may be applied to affected areas without consideration of adjacent or nearby TSRs. Consequently, a ‘Normal Speed’ and/or a ‘Normal’ sign may be installed at a location whereby a restriction could be unintentionally released when a TSR was intended to remain (similar to the scenario described above in New South Wales).
