Failure of wheel on locomotive SCT 008

near Fisher, South Australia | 28 May 2011

Rail Occurrence Investigation

RO-2011-009

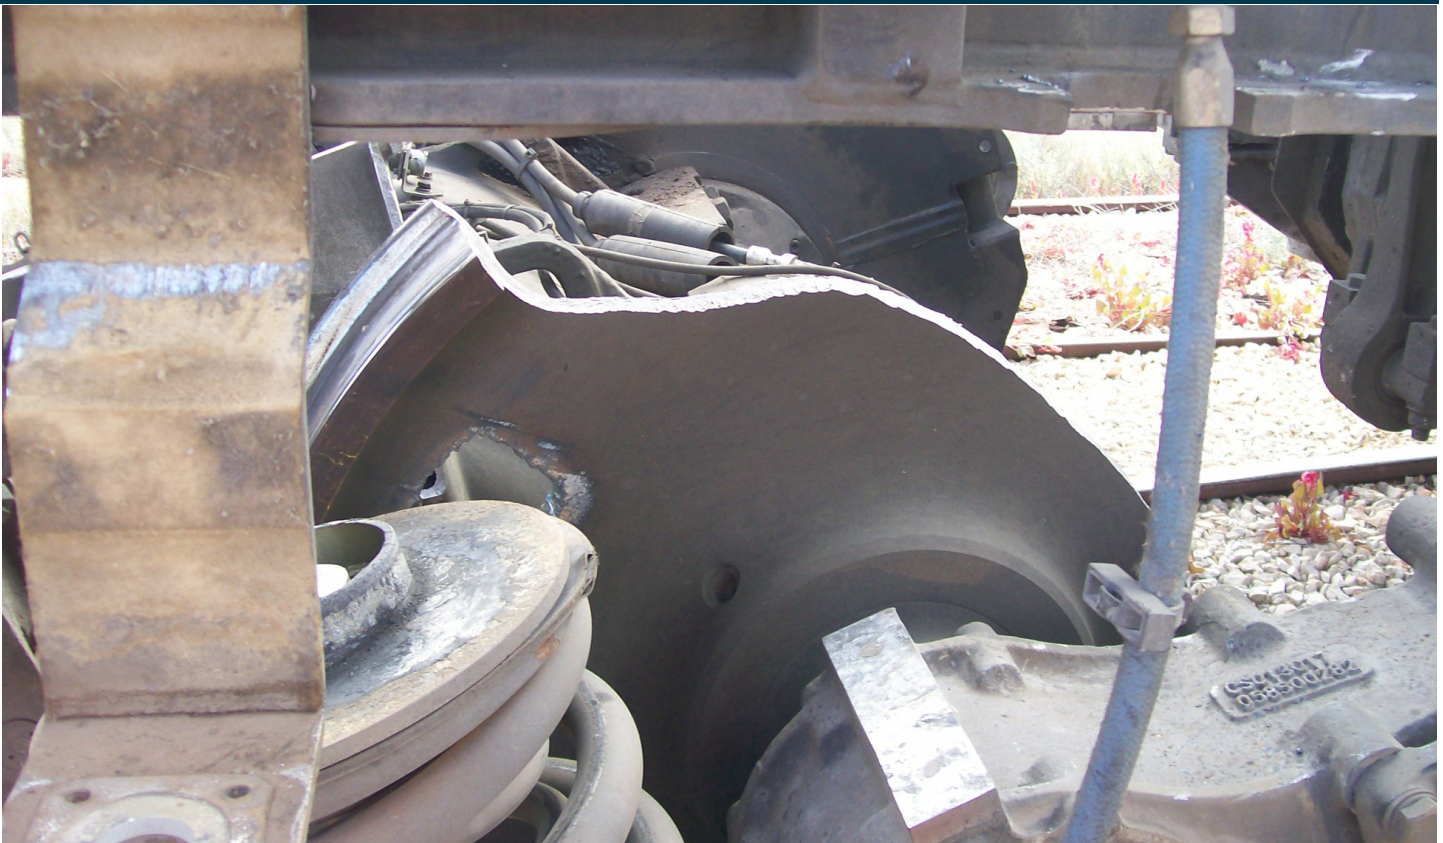
View of fractured wheel on locomotive SCT 008

The investigation found that a fatigue crack had initiated at a small indentation on the inside of the wheel rim and then radiated towards the flange and tread regions before the wheel completely failed.
