# Derailment of train 7SP5

between Caragabal and Wirrinya NSW | 23 October 2011

**ATSB Transport Safety Report**  
Rail Occurrence Investigation  
RO-2011-017  
Final – 14 March 2014

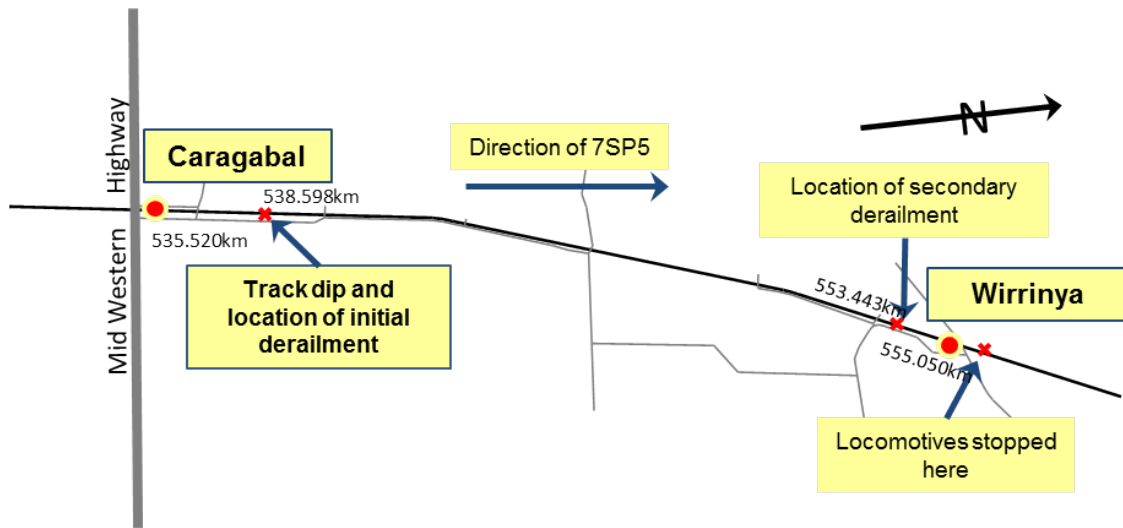
Figure 7: Map of track where train 7SP5 derailed and came to a stand

Evidence of derailed wheels travelling on the sleepers extended back for approximately 15 km, over six level crossings, to the 538.598 km mark where a dip<sup>4</sup> in the track was evident and fresh flange marks were found over the rail head (Figure 7). No evidence of the derailment was found on the track behind this location (that is, prior to the 538.598 km mark), which established this location as the initial point of derailment.

The first derailment witness mark (caused by a wheel flange) was found on the head of the right hand rail approximately 4 m past the track dip. The witness mark started about 12 mm in from the gauge face and extended for about 6.5 m along the rail before ending on the field side<sup>5</sup> of the rail (Figure 8), followed by rail wheel witness marks on the sleepers and in the ballast. The marking indicated that a wheel had unloaded, lifted off the rail, and landed with its flange on the head of the right-hand rail. This wheel then ran along the head the rail, dropping off on the field side of the rail and onto the right-hand sleeper ends, causing the left hand wheel to drop into the four-foot.<sup>6</sup>
