Collision between two road rail vehicles

Rinadeena, Tasmania | 4 June 2013

ATSB Transport Safety Report
Rail Occurrence Investigation
RO-2013-014
Final – 11 June 2014

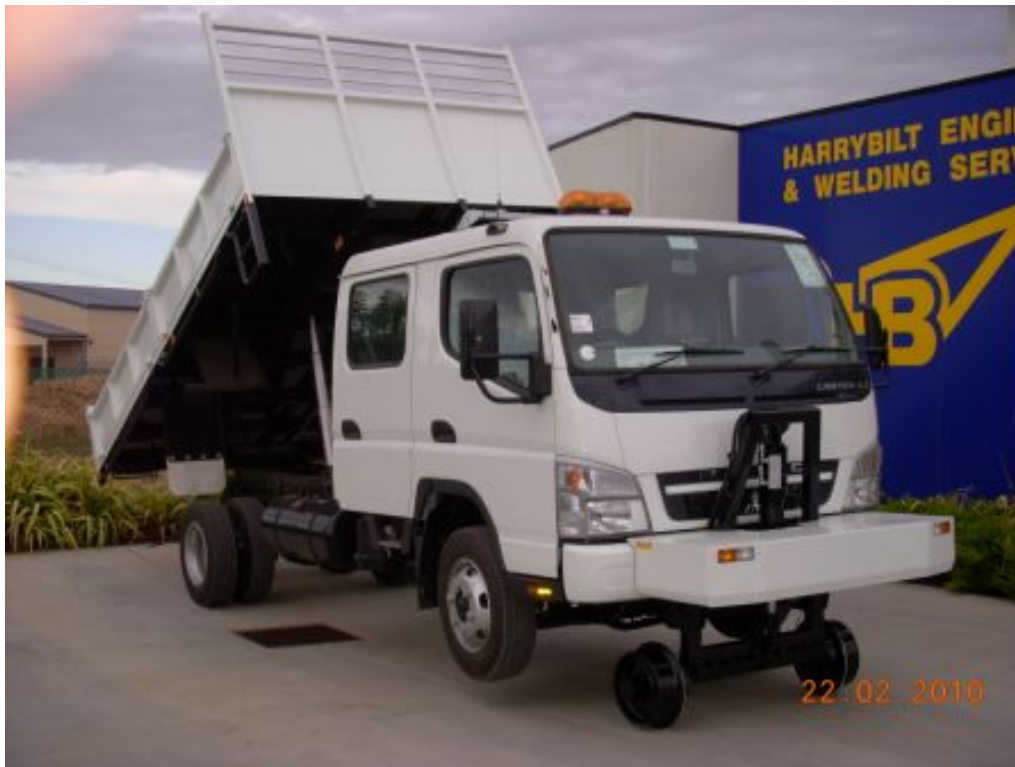
Figure 7: Hirail 3 with rail guidance wheels lowered

Hirail 3 was a 2009 Mitsubishi Fuso Canter dual-cab tip truck (Figure 7) which was modified for rail operations by Harrybilt Engineering and Welding Services (Harrybilt) in Ballarat, Victoria. When the vehicle was ordered, WCWR did not have their own documented design standard for road-rail vehicles, but they specified that all four of the vehicle's rail guidance wheels should be braked.

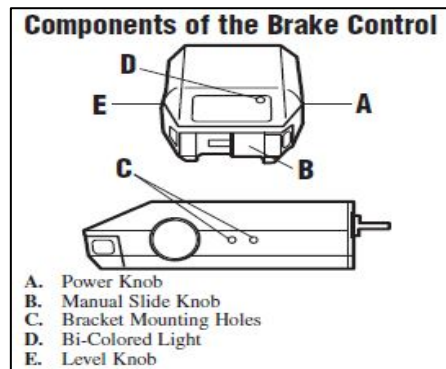
Figure 9: Tekonsha brake controller

The Tekonsha Voyager Electric Brake Controller was not designed specifically for road-rail vehicle application and was typically used in an automotive application to control trailer/caravan electric brake systems.

The controller had three control knobs for brake performance adjustment and a single bi-coloured light emitting diode (LED) for indication (Figure 9 item D).

The power knob (Figure 9 item A) set the maximum braking effort that would be applied to the rail wheels by varying the amount of voltage applied to the electromagnet mounted within the brake housing. An increase or decrease in voltage adjusted the attraction force applied to the rotating brake drum armature and the consequential mechanical effort that was applied between the brake shoes and the circumferential brake drum friction surfaces (Figure 8).

The level knob (Figure 9 item E) controlled the progressive application of braking effort when the brake pedal was depressed, from zero up to the maximum effort set by the power knob. The effect of the level knob adjustment was described as ranging from least aggressive to most aggressive brake application.

The manual slide knob (Figure 9 item B) enabled the operator to manually activate the brakes independently of the vehicle’s brake pedal.

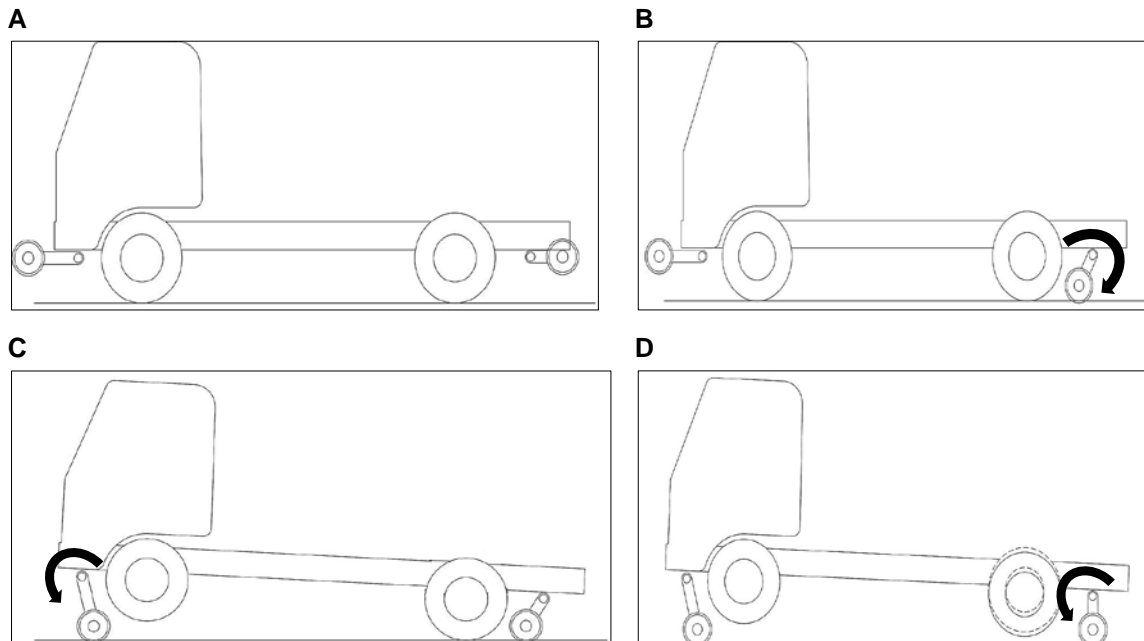
Figure 12: A) Hirail in road position. B) Hirail rear wheels lowered. C) Hirail front wheels lowered. D) Hirail rear wheels lifted raising the road wheels.

The usual method of placing the road-rail vehicles on and off track at Rinadeena was to position the vehicle on the track and lower the rear guidance wheels onto the head of the rails (Figure 12:B). As the rear radius arm swung the rail wheels through the vertical/centre position where maximum chassis lift was achieved, braking effort existed predominantly through the front road wheels. The vehicle would then be moved forward or backwards to line up the front rail guidance wheels. When the front rail guidance wheels were lowered into position, the front radius arm lifted the front truck wheels off the ground (Figure 12:C). During this process, braking effort was applied through the rear rail guidance and road wheels.

The operator would then drive towards the worksite while adjusting the brake controller and, as a result, varying the applied braking effort to the rail guidance wheels.
