# Derailment of freight train 7AD1

Edith River near Katherine, Northern Territory | 27 December 2011

**ATSB Transport Safety Report**  
Rail Occurrence Investigation  
RO-2011-019  
Final

**27 December 2011**

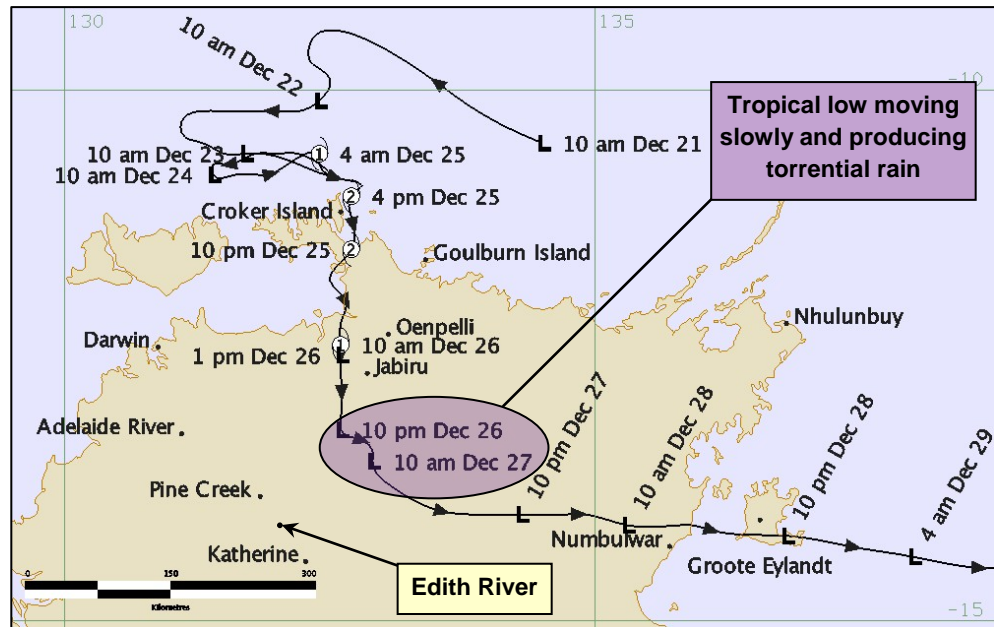
**Figure 4: Track of Tropical Cyclone Grant**

Examination of evidence established that at the time BJB was undertaking the track inspection the centre of the tropical low was north (Figure 4) of the Edith River catchment area.

The weather system continued to move further south, slowing in the vicinity of the Edith River catchment area (Figure 4 - mauve highlighted area). Heavy rain commenced falling at about 1700 on 26 December 2011. At this time the Darwin based relief drivers, for train 6AD1, were travelling by road along the Stuart Highway and nearing Katherine. They noted heavy rain falling and water lying over sections of the Stuart Highway; however, they considered that this was not unusual for the time of year.

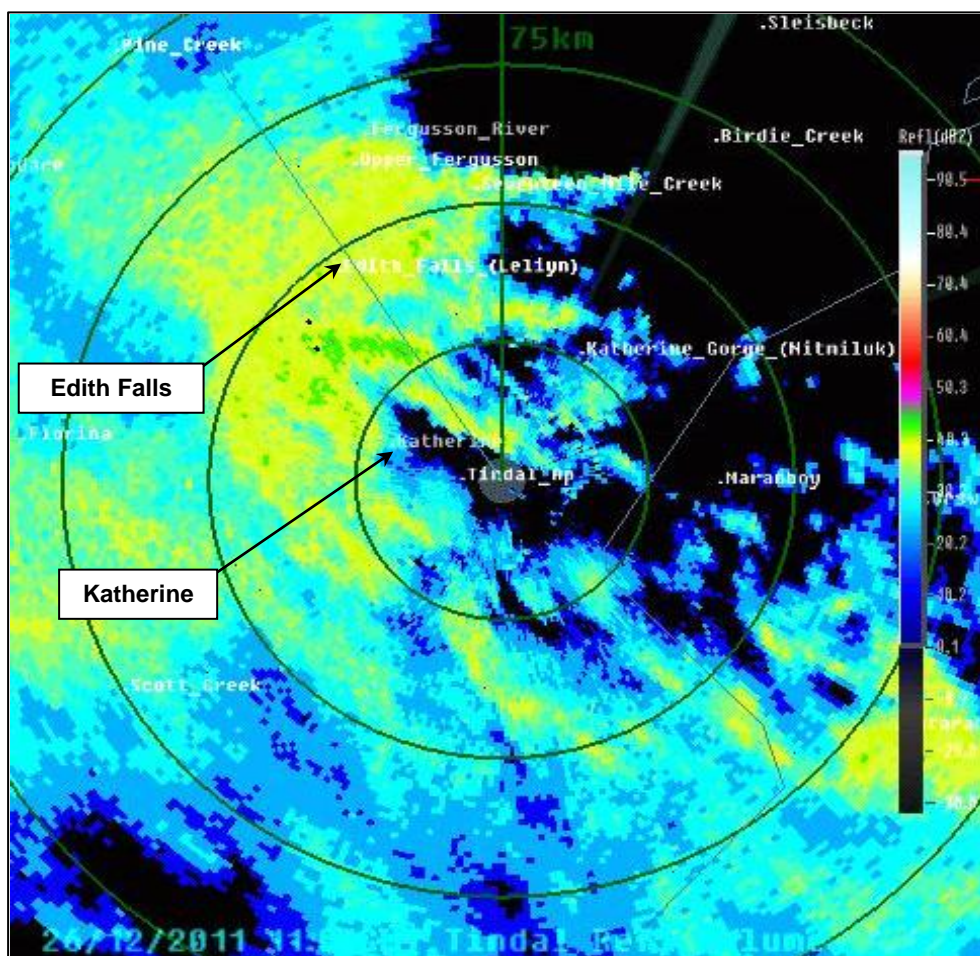
**Figure 6: Tindal Radar image taken at 2030 (1100 UTC) on 26 December 2011**

Following arrival at Katherine the drivers joined train 6AD1. They received authority to depart at 2020. At this time the co-driver said he checked the BoM website radar image, (Figure 6) it was raining heavily. He also stated that he checked the web site for river levels and noted that the heights for the Edith, Fergusson and Cullen rivers ranged up to a maximum of about 2.5 m and therefore in his opinion did not pose a flood risk for their train movement.

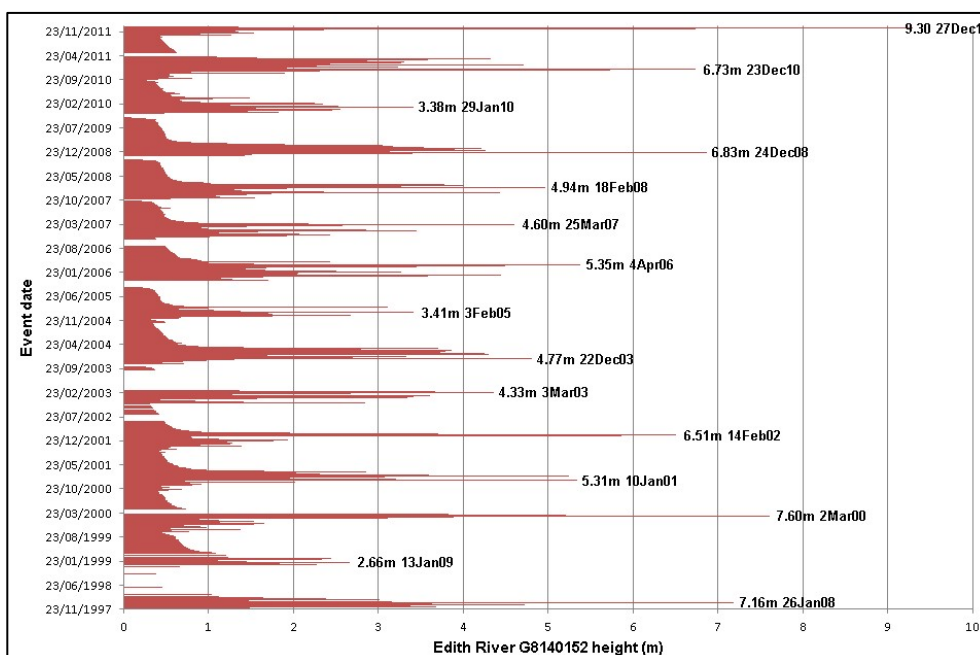
**Figure 7: Edith River recorded river height from 1996 to 2011**

After 2220 the rain began to ease, but runoff was still being channelled into the Edith River catchment. The Edith River began to swell with a previous record height of 7.6 m (Figure 7 - 2 March 2000) being reached just after midnight, about 2.5 hours after train 6AD1 had passed over the bridge. The river level continued to rise, reaching a height of 9.305 m by 0230; this level was now well in excess of any previously recorded maximum.

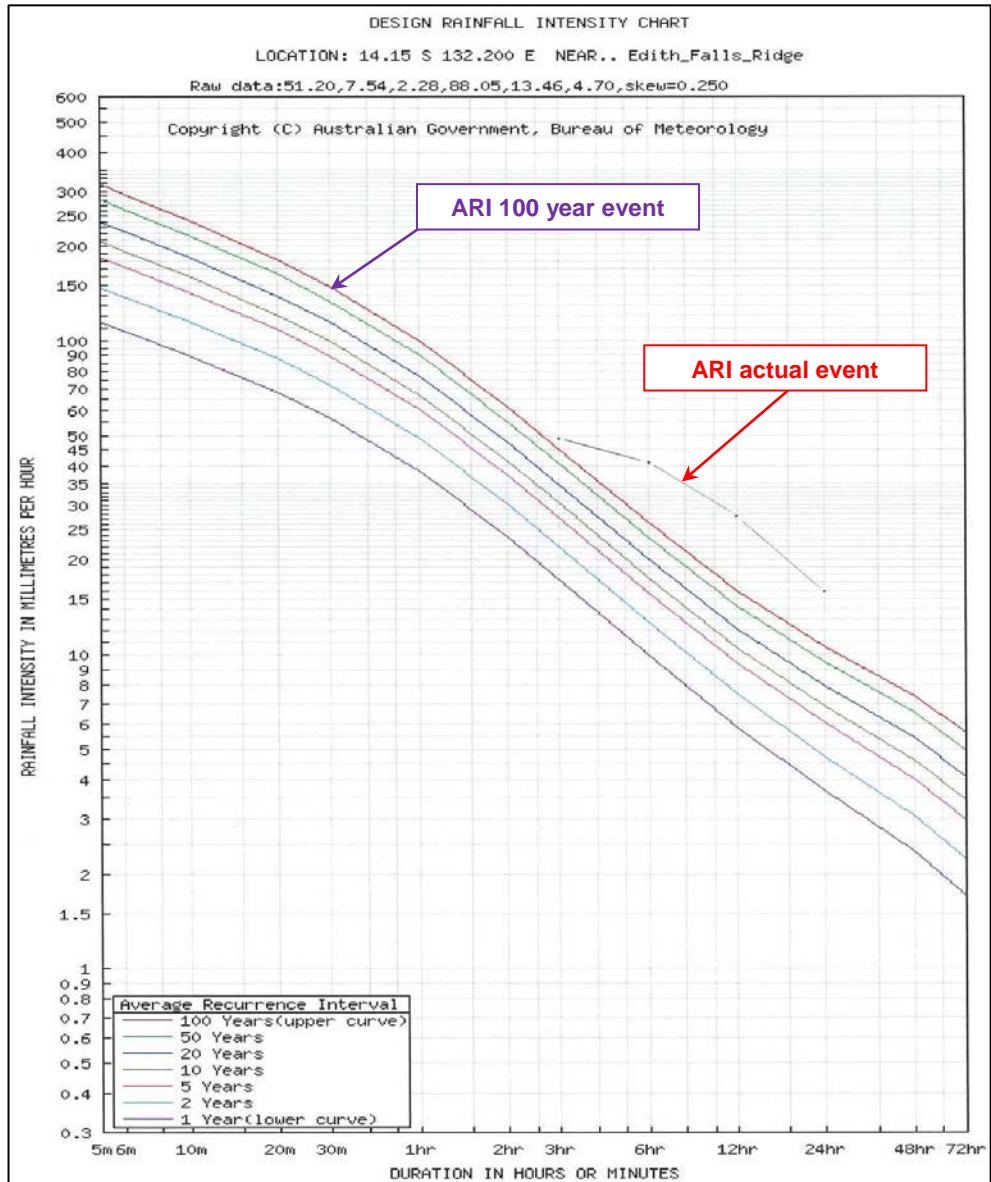
Figure 8: Rainfall Intensity Frequency Duration - Edith Falls Ridge

During the 12 hour period preceding the derailment, that is, from 1700 on 26 December 2011 to 0500 on 27 December 2011, in excess of 330 mm of rain had fallen near Edith Falls Ridge. This is well in excess of the rainfall assumed for a 100 year Average Recurrence Interval<sup>15</sup> (ARI) event (Figure 8) for this region.

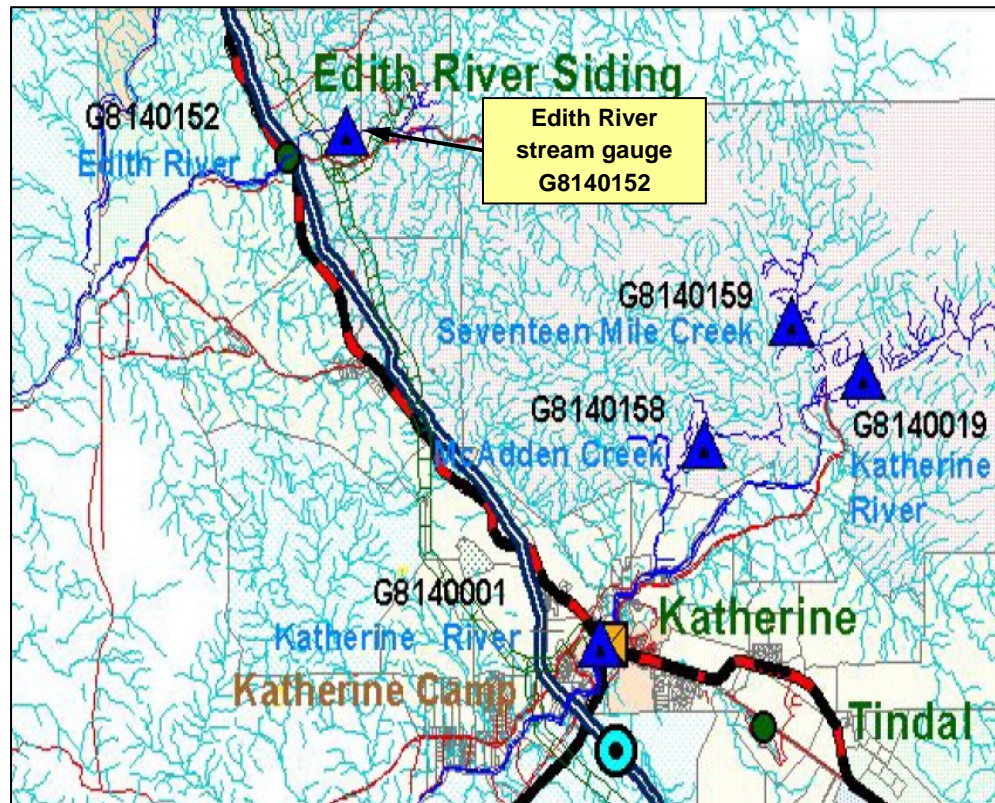
**Figure 14: Location of the Edith River stream gauge G8140152**

Hydrological estimations were based on a combination of the Rational Method<sup>18</sup>, Regional Method<sup>19</sup> and RORB Model<sup>20</sup> to determine theoretical flood flows throughout the area. This was supplemented by data sourced from NRETAS stream gauge locations, such as G8140152 (Figure 14) located 4.75 km up stream of the Edith River rail bridge. At the time of bridge design, ADrail had about 35 years of

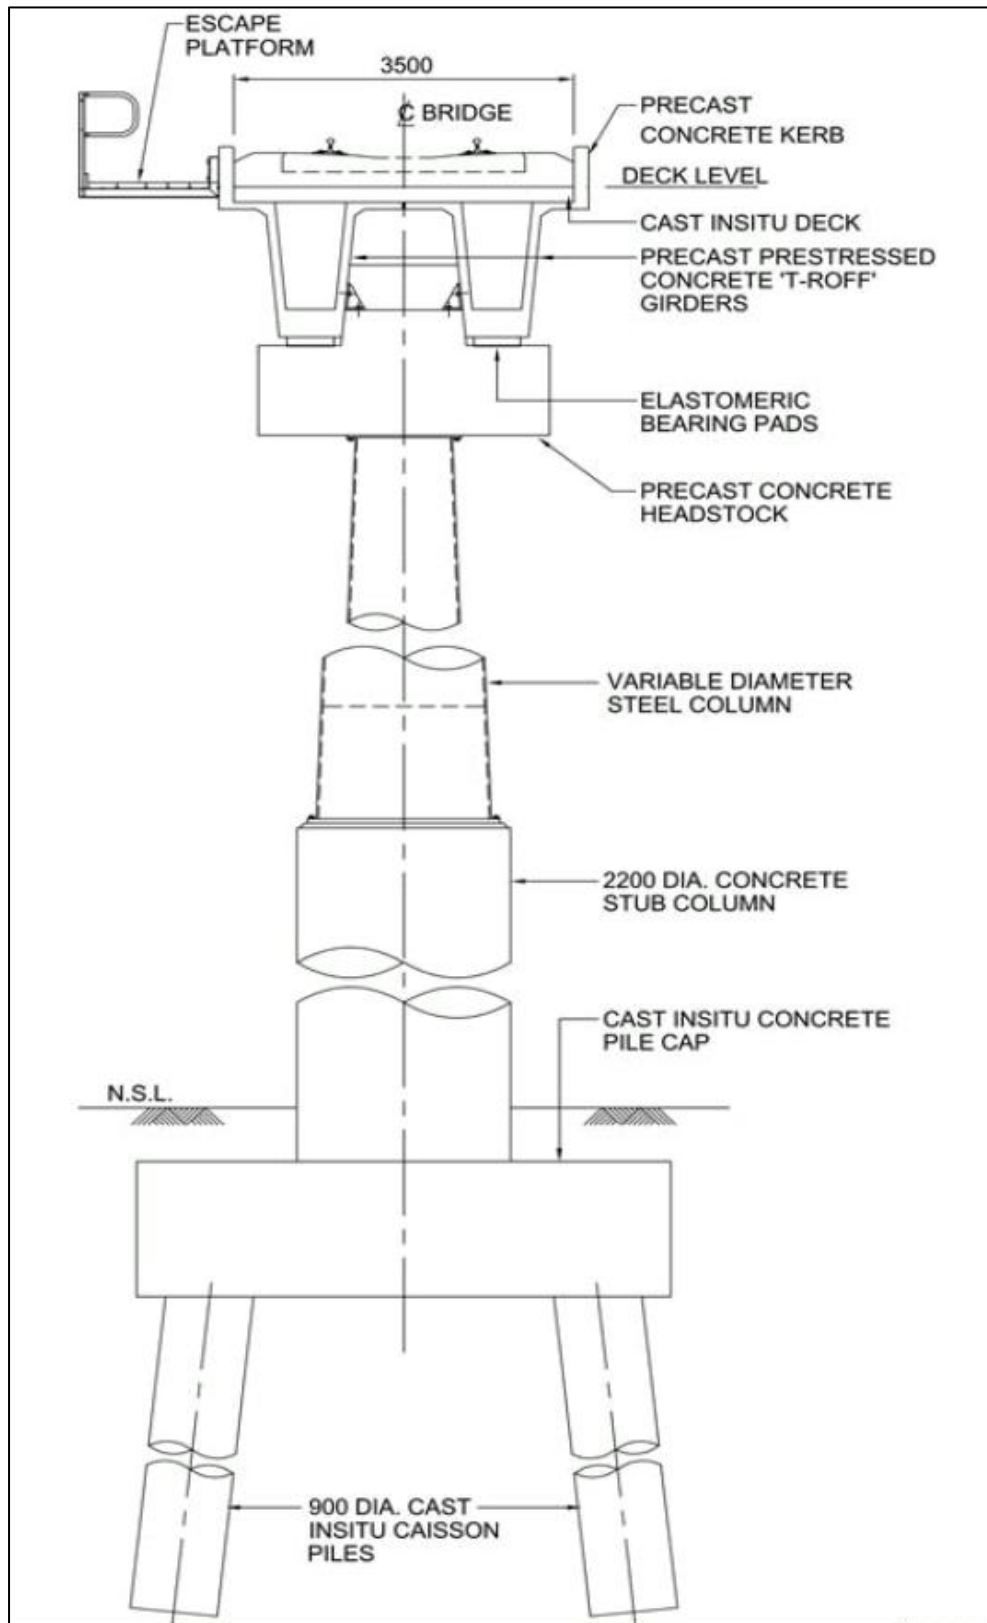
Figure 15: Typical bridge cross section

The supporting structures comprised three intermediate tapered steel columns carrying precast concrete headstocks (Figure 15). The steel columns were in turn supported on a concrete column/footing anchored into the river bedrock. These columns had a nominal height of 8 m, including the headstock, above the river bed. At each end of the bridge, the T-Roff beams were supported by abutments comprising a concrete headstock/column (pier) mounted on a concrete footing with integrated wing-wall.

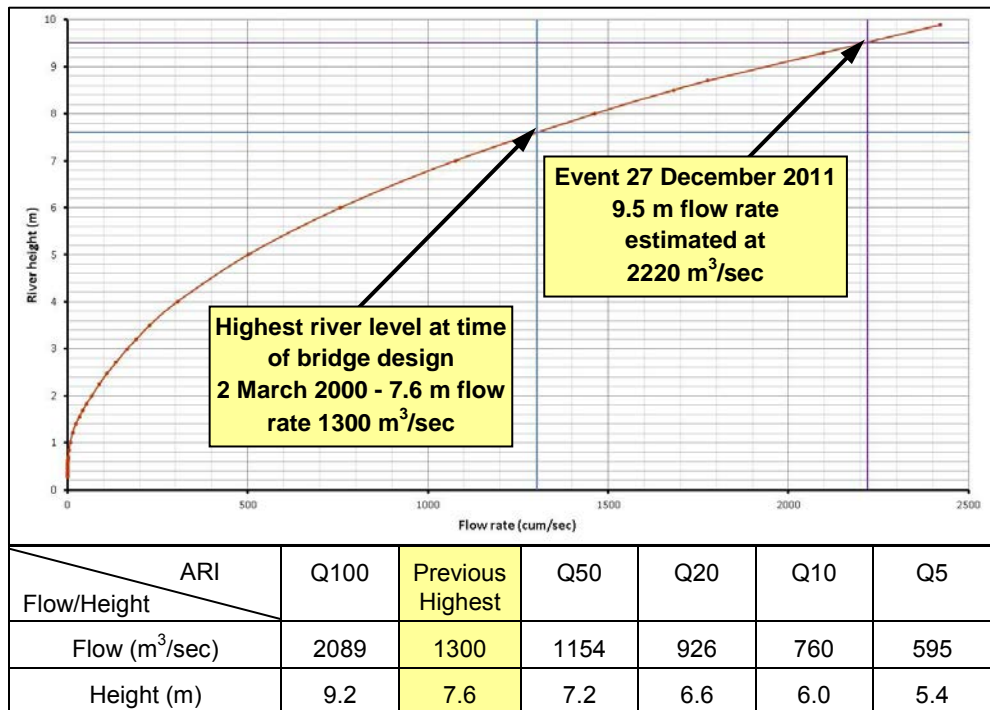
**Figure 17: Theoretical flow data for Edith River at gauge G8140152**

Figure 17 ‘Theoretical flow data for Edith River at gauge G8140152’, sourced from NRETAS, indicates the assumed height of a 100 year ARI event as 9.2 m, which was calculated to result in a flow rate of 2089 m<sup>3</sup>/sec.
