**ATSB TRANSPORT SAFETY REPORT**  
Occurrence Investigation Report AO-2007-046  
Final

**Collision with terrain**  
**Doongan Station, WA**  
**25 September 2007**  
**VH-HCN**  
**Robinson Helicopter Company R22**  
**Beta II**

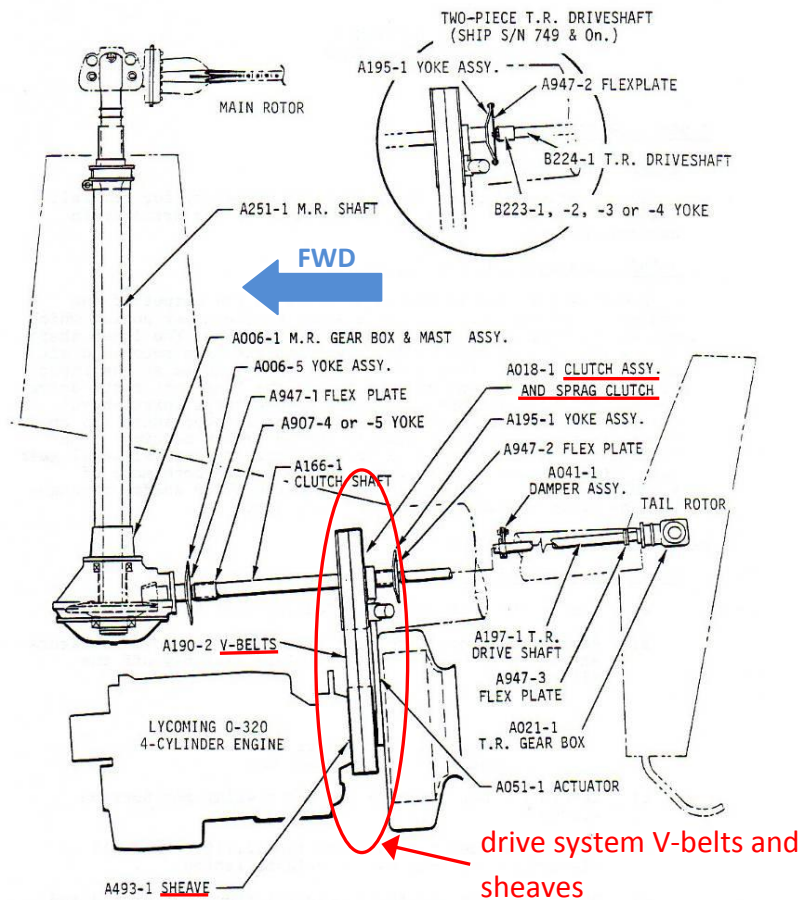
**Figure 3: R22 drive belt system**

On the R22 helicopter, engine power was transmitted to the rotor system through a drive-belt system that consisted of two rubber double V-belts, running on matching multi-grooved sheaves (Figure 3). Both the upper and lower sheaves were constructed of aluminium alloy; with a thermally-sprayed, metallised coating applied to improve wear resistance.

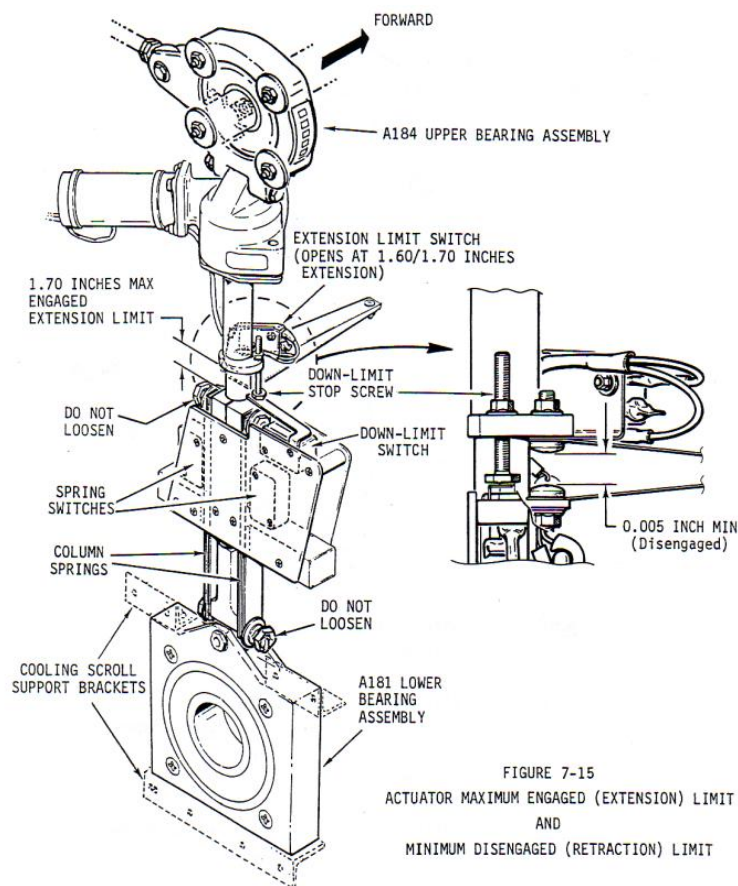
**Figure 4: Electric clutch actuator**

The upper drive sheave was mounted on the clutch shaft adjacent to a flexible coupling and could be moved relative to the engine-mounted drive sheave by means of an electric clutch actuator (Figure 4). That movement had the effect of varying the tension being applied to the belts.

During shutdown, the actuator was used to lower the top sheave to loosen the drive belts. During engine start, the belts were loose, allowing the engine to run without driving the rotor system. After engine start, the clutch switch located on the instrument console was selected by the pilot, powering the actuator to slowly move the top sheave up to the flight position and tighten the belts. The actuator was thereafter controlled by a load-sensing switch, which automatically maintained the correct belt tension during flight. Any movement of the electric actuator was indicated to the pilot by the illumination of a 'clutch light' that was positioned on the upper right side of the instrument panel.
