**ATSB TRANSPORT SAFETY REPORT**  
Occurrence Investigation Report AO-2007-070  
Final

**Leading edge device failure**  
**Norfolk Island**  
**29 December 2007**  
**VH-OBN, Boeing 737-229**

**Leading edge device failure  
Norfolk Island**

**VH-OBN, Boeing Company 737-229**

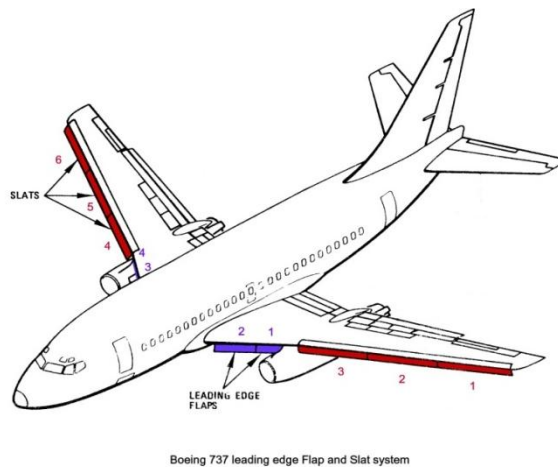
**Figure 1: Leading edge flap/slat system**

The leading edge flap/slat system formed part of the aircraft's high-lift devices, which changed the camber of the wing to increase lift during low-speed flight. Three leading-edge slats were installed on each wing outboard of the respective engine, with two leading edge flaps installed inboard of the engine on each wing. The slats were numbered 1 through 6 from left to right. The number-4 slat was directly outboard of the right engine (Figure 1). Each slat was attached to the wing by two main tracks and two auxiliary tracks (Figure 2).

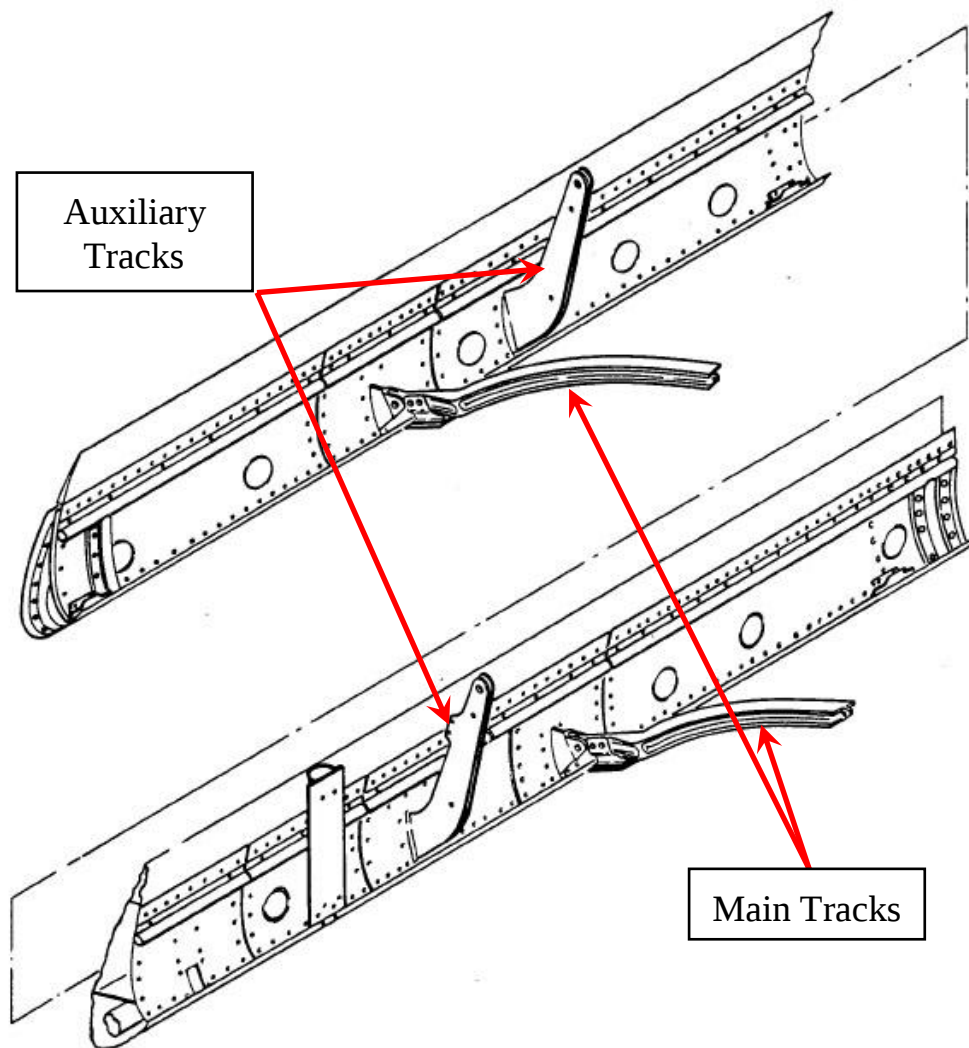
**Figure 1. Leading edge slat\***

The slats consist of ribs attached to a beam, inner and outer clad aluminium skins and a honeycomb trailing edge. A void between the inner and outer skins provides a path for thermal anti-icing. Anti-icing ducts installed in the slat leading edge connects with hot air supply lines through a telescoping tube. A three position hydraulic actuator is attached to the centre of all leading edge slats (1 thru 6). Each slat has two main tracks and two auxiliary tracks which ride on rollers in the wing leading edge. A third auxiliary track is installed at the outboard end of slats No. 1 and 6. Structural stops are provided in both the extended and retracted slat positions. The downstops are attached to the slat tracks and contact with track guides in the extended position. The upstops consist of three adjustable plates which contact with the slat beam when the slats are retracted. All slats (1 thru 6) are stabilised at the intermediate position by a torsion rod and support arm assembly attached to the front spar between the auxiliary slat tracks.

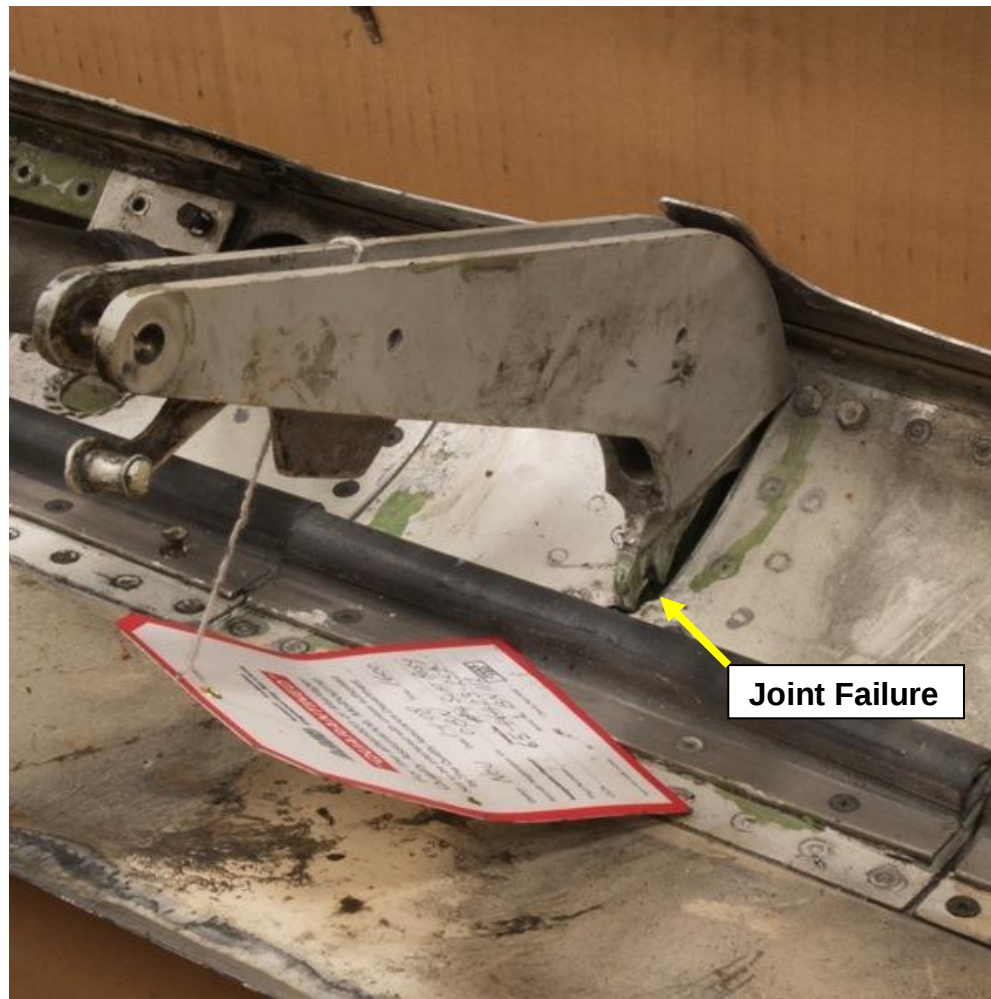
Figure 11. Inboard auxiliary track in situ

The auxiliary tracks should have been fixed at two joints in the slat but were found to have considerable vertical movement, indicative of failure of the joint closest to the upper surface of the slat (Figure 11).

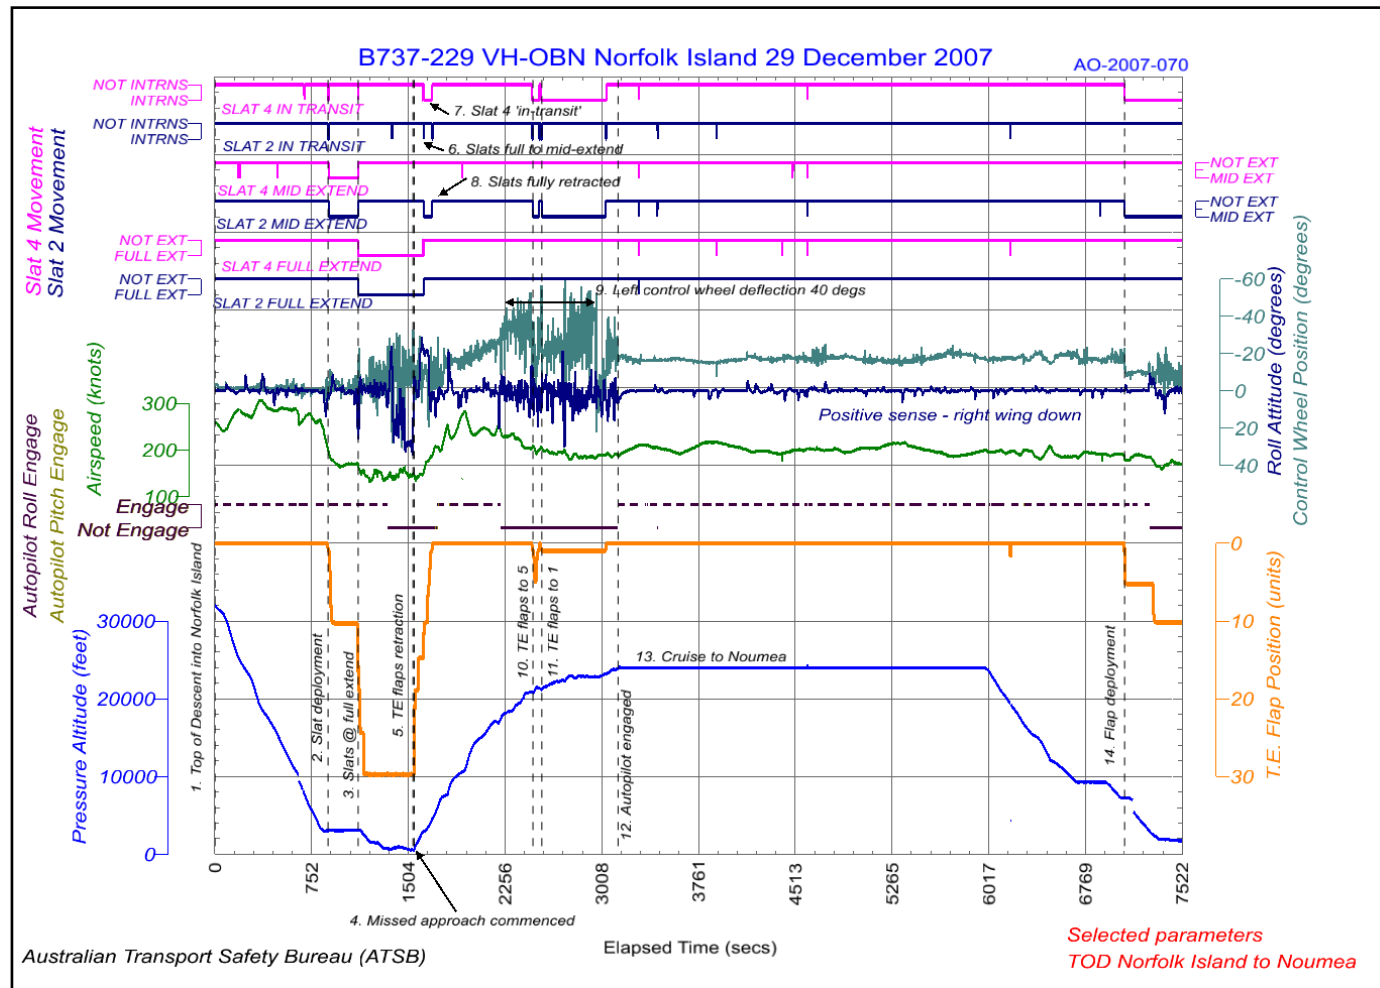
## APPENDIX D: GRAPHICAL REPRESENTATION OF DFDR DATA

| <b>Approx Elapsed Time (secs)<sup>28</sup></b> | <b>Event number<sup>29</sup></b> | <b>Event</b> | <b>Pressure Altitude (ft)</b> | <b>Airspeed (kts)</b> | <b>Trailing edge flap position (Units)</b> | <b>Slats position</b> |
|---|---|---|---|---|---|---|
| 7,073 – 7,076 | 14 | Flap deployment on descent | 7,237 - 7,292 | 178 – 187 | 0 - 5 | Number-4 slat remains 'in transit' while the other slats move to the mid-extend position |
