**ATSB TRANSPORT SAFETY REPORT**

Aviation Occurrence Investigation – AO-2008-010

**Mid-air collision**

Mid-air collision - 53 km NNW of Gascoyne Junction, WA - 13 February 2008 - VH-OUS, Piper Aircraft Corporation PA-18 Super Cub, VH-ZDP, Robinson Helicopter Company R44 Raven

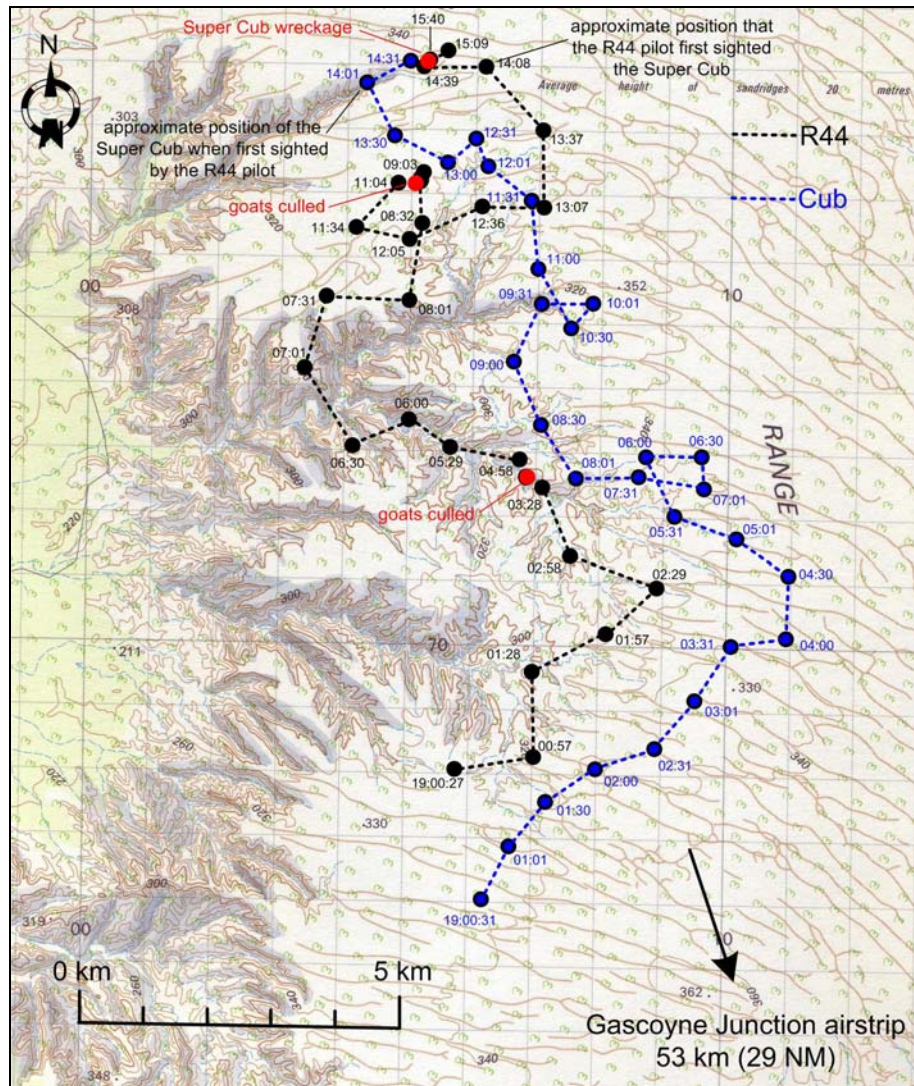
**Figure 2: GPS track data for both aircraft<sup>3</sup>**

The operation proceeded without incident until about 1914, when the occupants of the R44 observed the Super Cub about 2 km away and flying towards them. The Super Cub was slightly offset to their left and at the same height, estimated by the R44 pilot to be about 300 ft above ground level (AGL) (Figure 2). The pilot of the R44 reported that, as the two aircraft approached each other, the Super Cub banked away from the R44 briefly, before resuming wings level flight on an easterly heading.

about the time the R44 passed through south, the Super Cub passed beneath it. The R44 pilot's assessment was that the Super Cub's occupants would have been unable to see the helicopter at that time. The R44 pilot continued the left turn to keep the Super Cub in sight and, while turning through east, observed the right wing of the Super Cub move left underneath the R44 until only the right wingtip was visible. He reported that the right wing then appeared to rise quickly and, in response, he increased the left bank and raised the collective lever<sup>2</sup> in an attempt to remain clear.

- 2 Raising the collective lever increases the main rotor thrust (effectively lift) produced by the main rotor blades.
- 3 Both aircrafts' onboard GPS units recorded their respective aircraft's position at 30 second intervals. The lines between those recorded points approximate the aircrafts' movement and do not accurately reflect any turns by the aircraft – for example, the turn described by the R44 pilot prior to the collision.

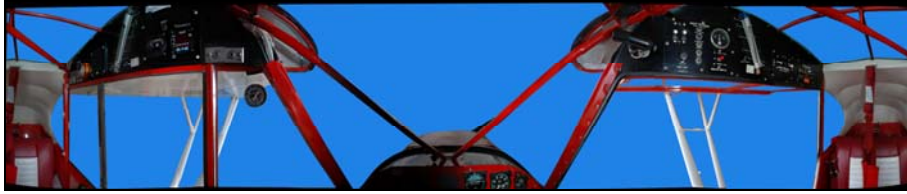
**Figure 12: Field of view from the Super Cub's front seat**

An assessment of the field of view from the Super Cub's front seat cockpit was undertaken by the investigation. That assessment involved taking a series of digital photographs from the Super Cub pilot's approximate eye position,<sup>22</sup> and combining them to form a single, 360 degree panoramic image<sup>23</sup> (Figure 12). The area shown in blue on the panoramic image represents the unobstructed field of view from the front seat of the Super Cub.

A second spotter, who participated in the Kennedy Range cull, described having good peripheral visibility from the rear cockpit of the accident aircraft, with limited visibility towards the front of the aeroplane. He also stated that the metal roof (not visible in Figure 12) obscured his field of view above the aeroplane, and that it extended forward to just above the pilot's head.

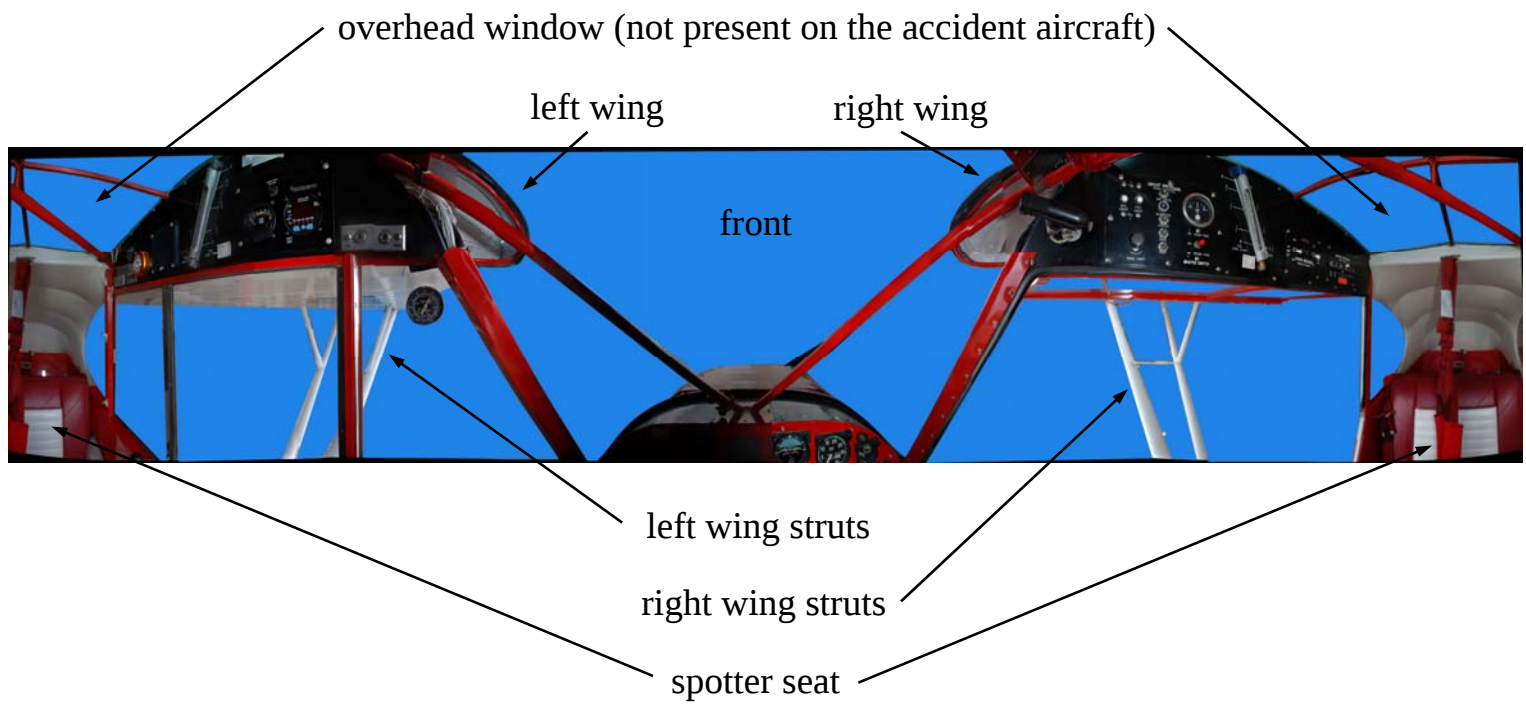
## APPENDIX B: CUB PILOT FIELD OF VIEW

<sup>23</sup> The image was obtained by 'folding out/forward' the 360 degree view, to produce a two dimensional representation of the field of view from the front seat of the aircraft. Refer to Appendix B for more detail.
