Aviation Occurrence Investigation – AO-2008-008

**Engine failure – Jabiru, NT – 11 February 2008**

**VH-VAZ**

**Beech Aircraft Corporation 1900**

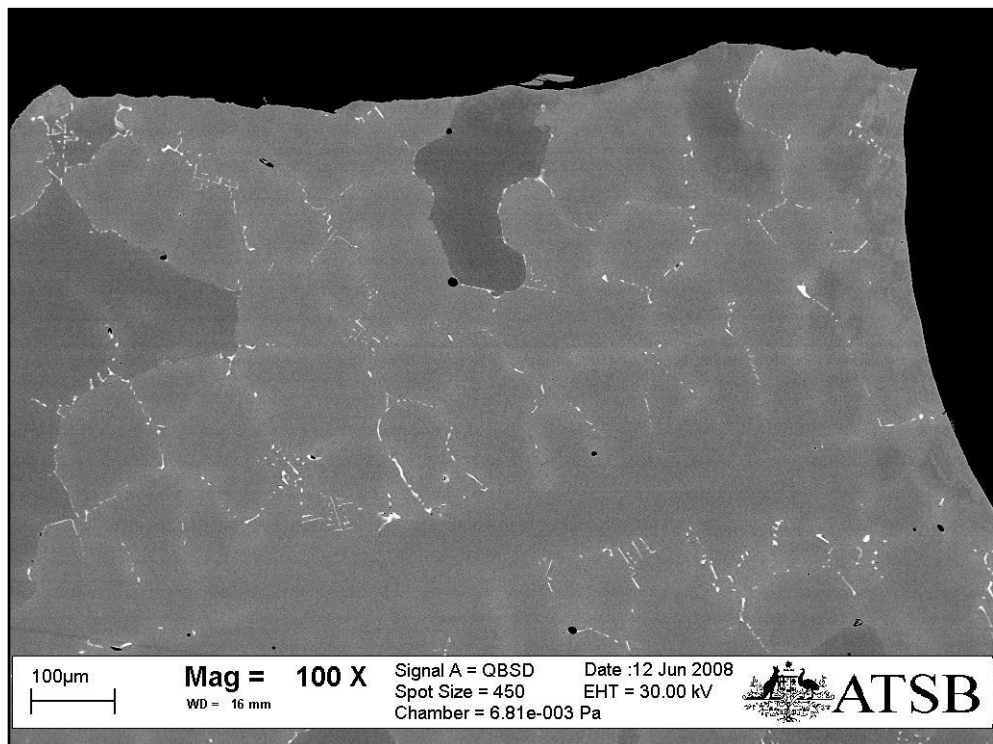
Figure A19: Interdendritic platelets of TCP phase (Laves) – light material

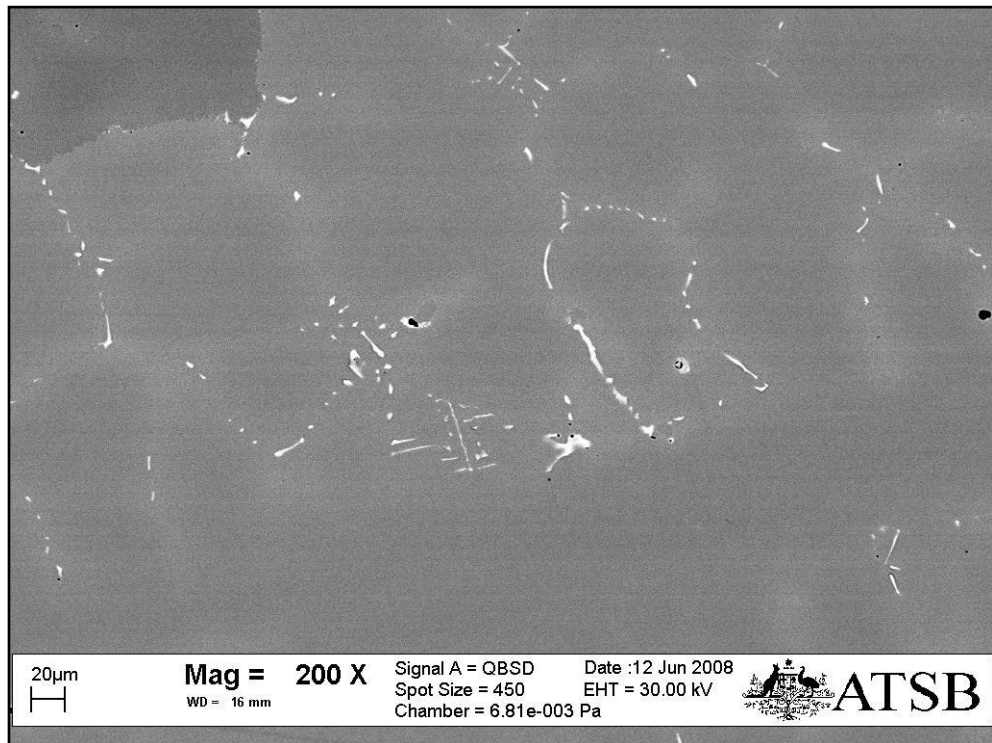
Figure A20: High magnification microstructural view, showing the gamma-prime precipitate (packed cuboids) and carbides / Laves phase (white areas)

Microstructurally, the bulk material presented the expected  $\gamma$ - $\gamma'$  constituents typical of high-temperature superalloys. There was no evidence of creep voiding or microstructural degradation associated with sustained or transient over-temperature operation. The presence of an interdendritic TCP second phase (suspected as Laves) was, however, considered suboptimal from a fatigue and oxidation resistance perspective.

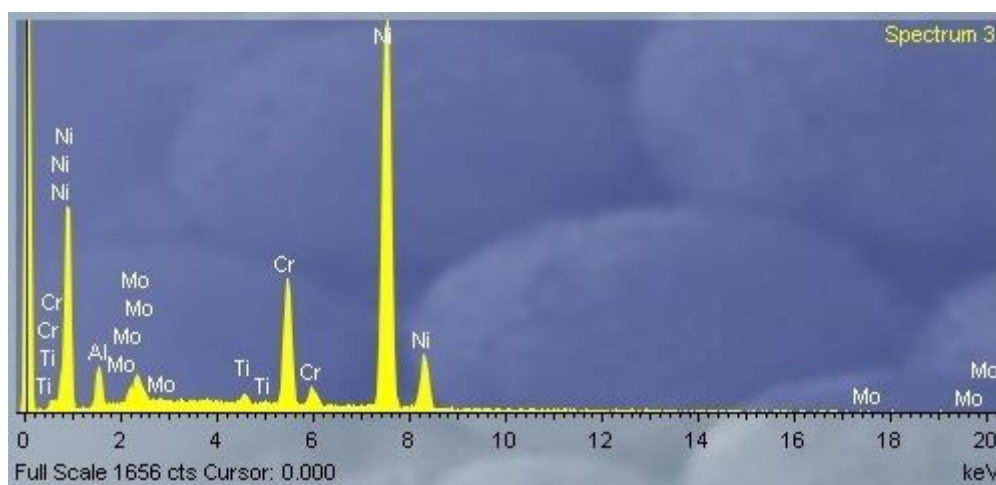
Energy-dispersive x-ray spectroscopy (EDS), conducted on the prepared metallographic sections under the SEM, provided a qualitative indication of the elemental composition of the base metal alloy and the non-metallic inclusion observed microscopically. The base blade alloy presented as a nickel-based superalloy of chromium, molybdenum, aluminium and titanium (Figure A23). The inclusion was predominantly niobium rich, with nickel, oxygen, aluminium, magnesium and zirconium sub-peaks (Figure A24).

**Figure A23:** EDS spectrum of the blade base metal alloy
