ATSB TRANSPORT SAFETY REPORT

Aviation Occurrence Investigation – AO-2007-038

Procedures-related event

Townsville Airport, Qld

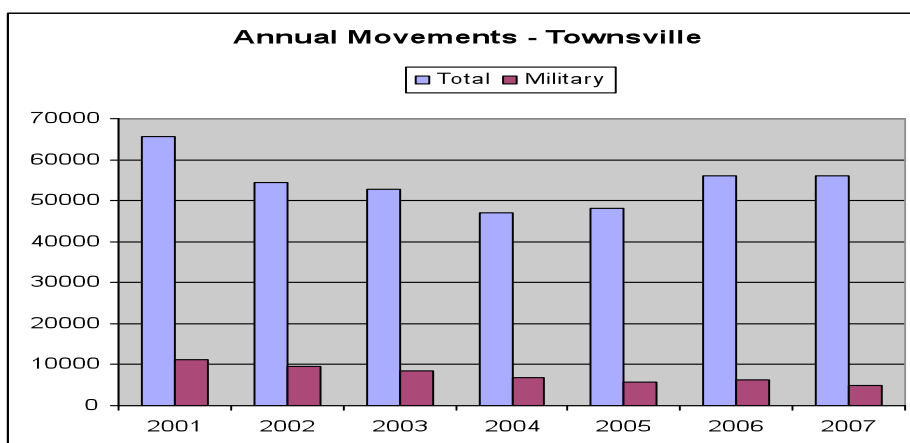
Figure 3: Airport movement data Townsville

Data is collected by Airservices on the number of aircraft movements at Australian Airports. The annual numbers of aircraft movements for Townsville Airport over the period 2001 to 2007 are at Figure 3. Similar figures for Darwin Airport are at Figure 4.

An examination of the aircraft movements at Townsville for 2007 showed that military aircraft accounted for just less than 9% of the total aircraft movements that year.

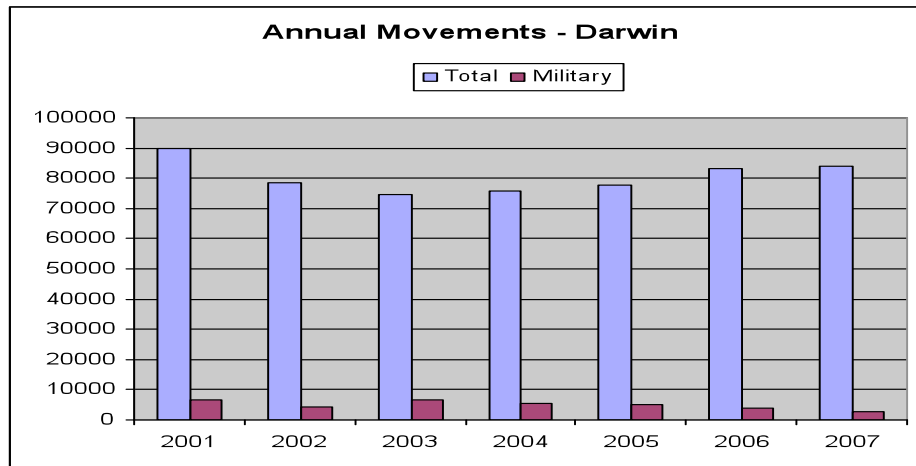
Figure 4: Airport movement data Darwin

An examination of the aircraft movements at Darwin for 2007 showed that military aircraft accounted for just less than 3.5% of the total aircraft movements that year.
