**ATSB TRANSPORT SAFETY REPORT**  
Aviation Occurrence Investigation AO-2007-069  
Final

**Collision with water**  
**Pier 35 Melbourne, Vic.**  
**29 December 2007**  
**VH-MEB**  
**Robinson Helicopter Company R44 Raven 1**

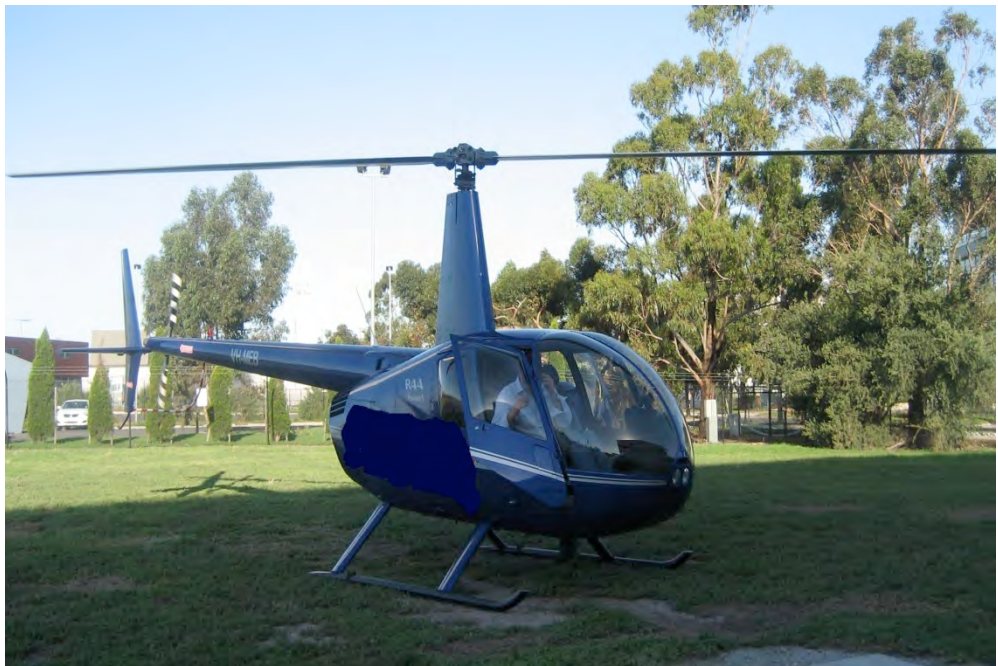
**Figure 1: VH-MEB following the passenger scenic flight**

Following completion of a scenic charter flight, at about 1905 Eastern Daylight-saving Time<sup>1</sup> on 29 December 2007, a Robinson Helicopter Company R44 Raven 1, registered VH-MEB (Figure 1), departed the Pier 35 private helipad, located adjacent to the Yarra River, Melbourne, Vic. on a private flight to return to the operator's base, with two pilots on board.

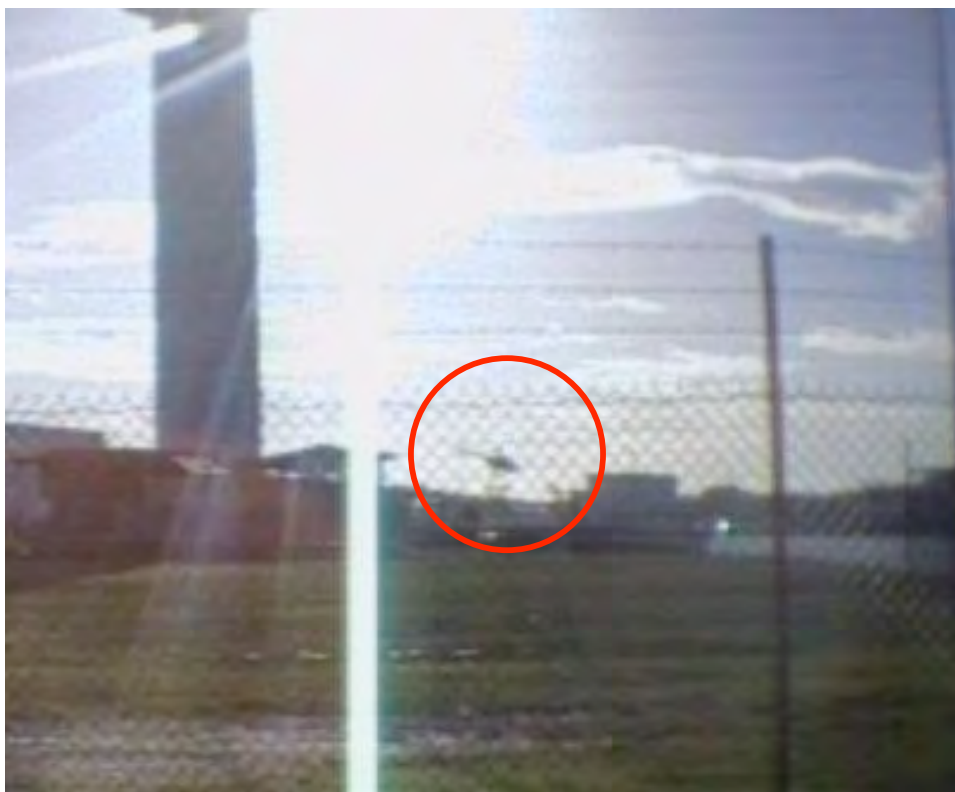
**Figure 3: CCTV video still footage of the helicopter taking off (circled)**

A Port of Melbourne Corporation closed circuit television (CCTV) security camera, recorded the helicopter's flight and impact with the water. The CCTV video displayed the helicopter departing the helipad. The video also recorded that, following the takeoff, the helicopter momentarily lost altitude, yawed counter-clockwise and the main rotor RPM appeared to reduce following takeoff and prior to impact (Figure 3).
