**ATSB TRANSPORT SAFETY INVESTIGATION REPORT**

Aviation Safety Occurrence Report – 200506266

**In-flight breakup**  
**28 km north of Condobolin, NSW**  
**2 December 2005**  
**VH-PYN**  
**Piper Aircraft Corporation PA-31-350**

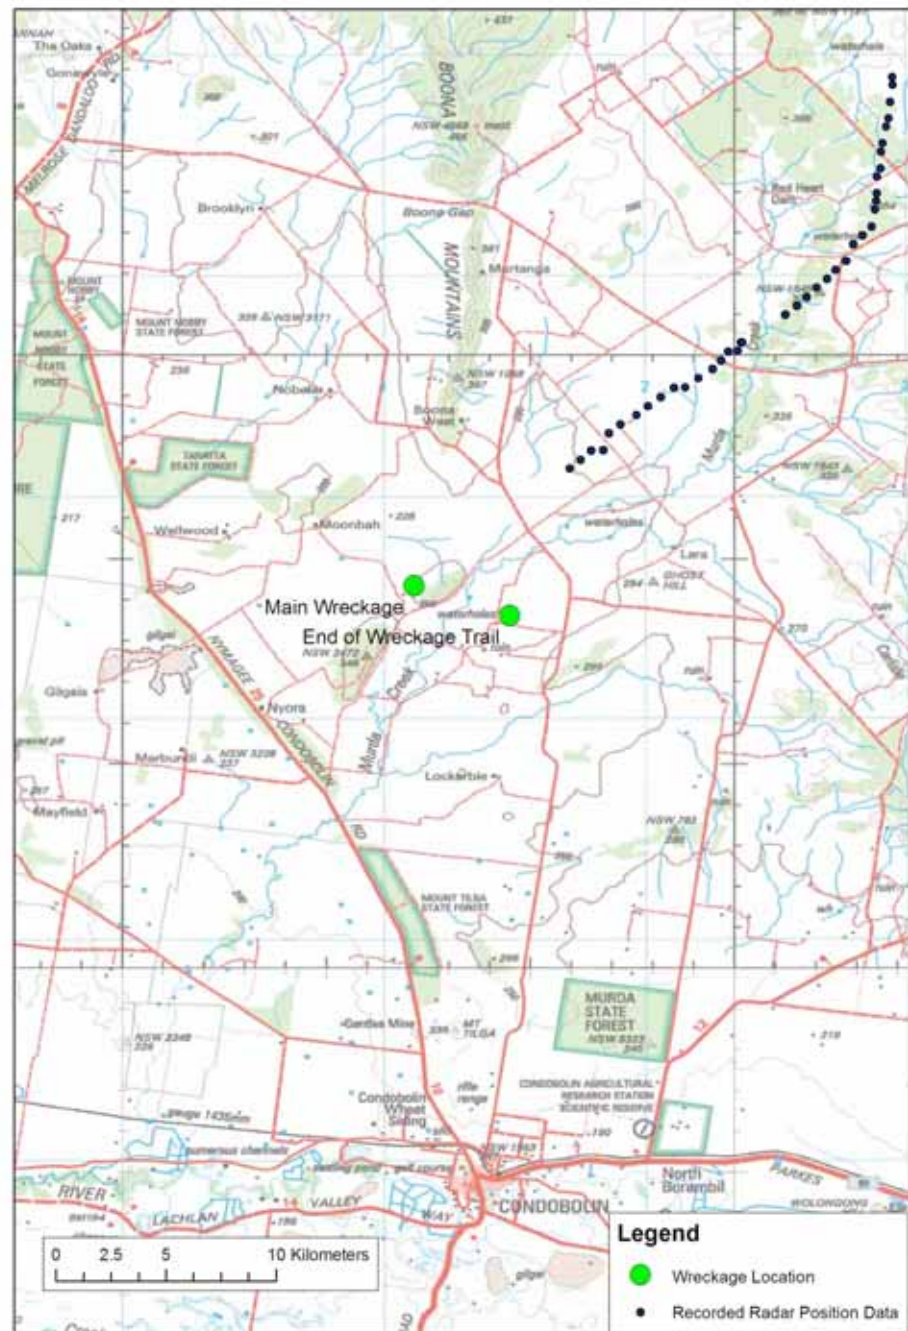
Figure 1: Wreckage location and radar data

2    The radar had a range of 250 NM (463 km) and was 116 NM (215 km) southeast of Condobolin Airport.

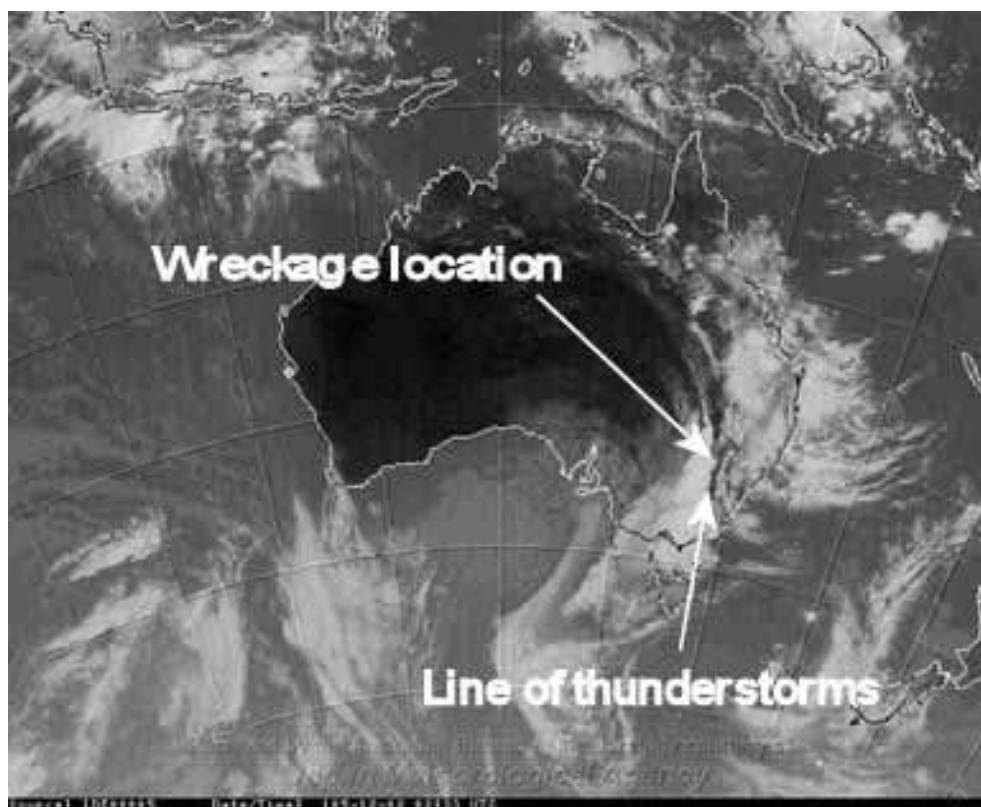
**Figure 3: Infrared satellite image at 1330, 2 December 2005**

The BoM advised in a report on the meteorological situation produced after the accident that an active frontal system was moving east at 15 to 25 kts through New South Wales. Satellite images showed a line of thunderstorms extending from south-central Queensland, through New South Wales, and into Victoria (Figure 3). A line of active thunderstorms visibly marked the front.

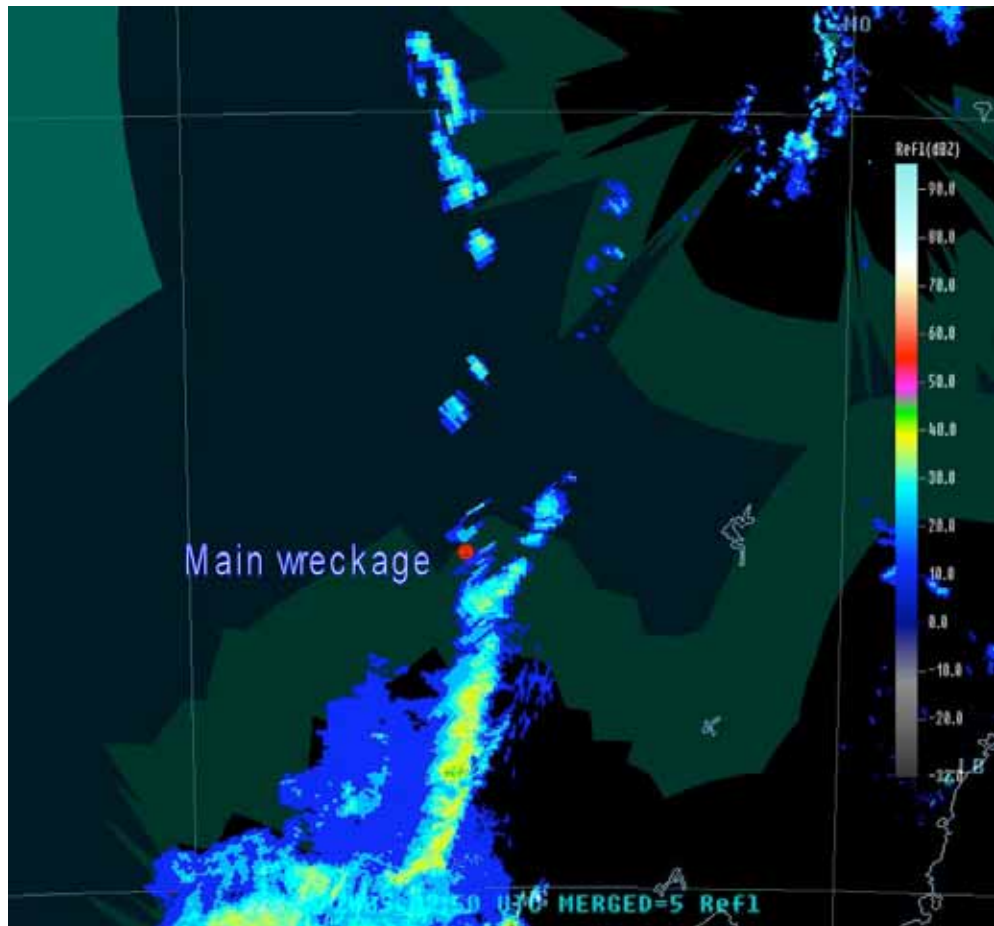
**Figure 4: BoM composite weather radar image at 1350, 2 December 2005 showing the line of thunderstorms in 'Y' configuration.**

Figure 4 shows merged data recorded at 1350 from Wagga Wagga, Captains Flat and Moree weather radars. The red circle (just below and left of centre) indicates the wreckage location. From that position, Wagga Wagga radar was located approximately 261 km to the south-south-east (bottom centre of image) and Moree radar approximately 454 km to the north-east (near top right corner of image).

The BoM advised that, notwithstanding the limited ability of the weather radars to detect storms at distances in the order of 370 km<sup>9</sup>, there were indications in the detail of the images that individual storm cells were located very close to the recorded aircraft location around 1350. Furthermore, it appeared that immediately prior to the accident, the aircraft was likely to have been surrounded on the west, south and east sides (that is, inside the 'Y' depicted in Figure 4) by a large complex of storms.

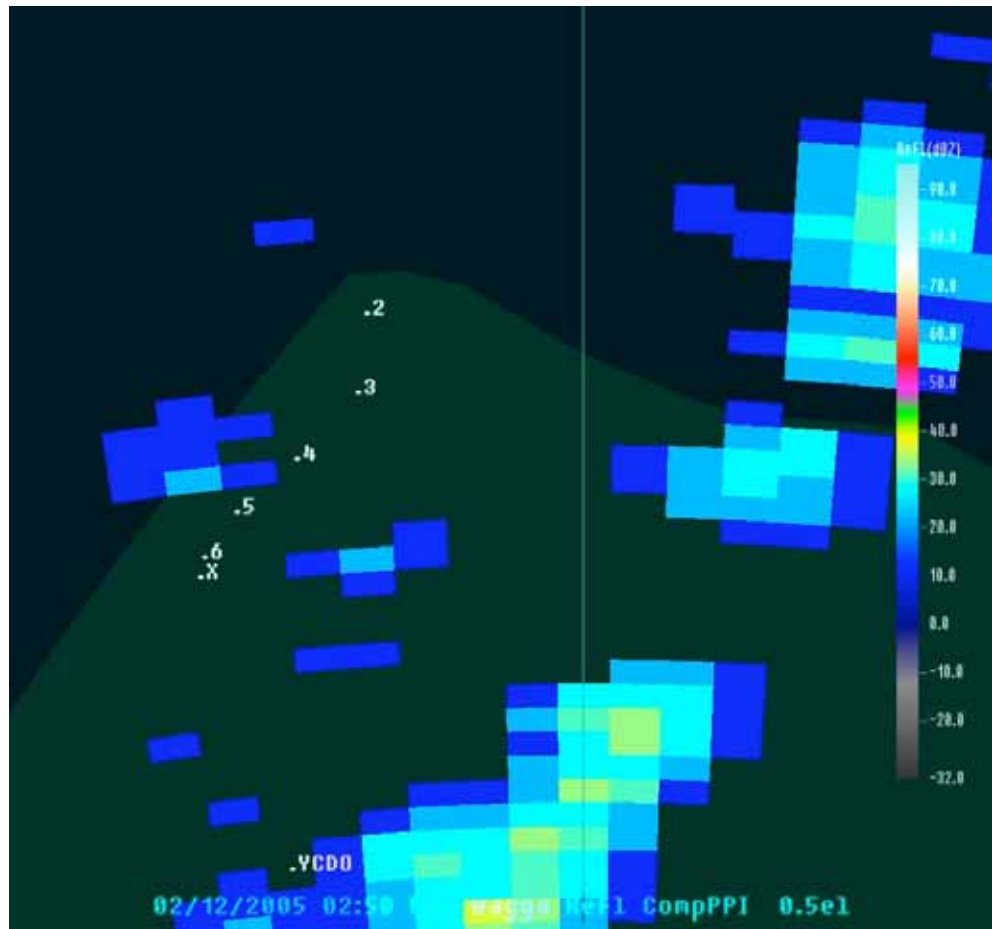
Figure 5: BoM enlarged image from Wagga Wagga weather radar at 1350, 2 December 2005

Figure 5 shows data from Wagga Wagga radar at 1350 enlarged to show detail in the vicinity of the accident site. 'X' marks the approximate position of the aircraft wreckage. The points labelled "2" through to "6" mark approximately the recorded radar positions of the aircraft. 'YCD0' indicates the location of Condobolin Airport. The centre of the radar's beam was 3,050 to 4,260 m (10,000 ft to 14,000 ft) above the ground level where it intersected storms in the vicinity of the accident location.

Analysis of lightning activity data confirmed that between 1349 (when radar contact was lost) and 1352.30 (sufficient time for the aircraft to have travelled about 20 km), lightning activity was concentrated predominantly in two areas; one was more than 8 km west and the other more than 17 km south of a line between the last recorded radar position and the location of the main wreckage. Those areas approximated the areas of precipitation evident on the weather radar images provided by the BoM and which are apparent to the left and right of the aircraft's track in Figure 5. The nearest recorded strike was about 3.5 km from that line.

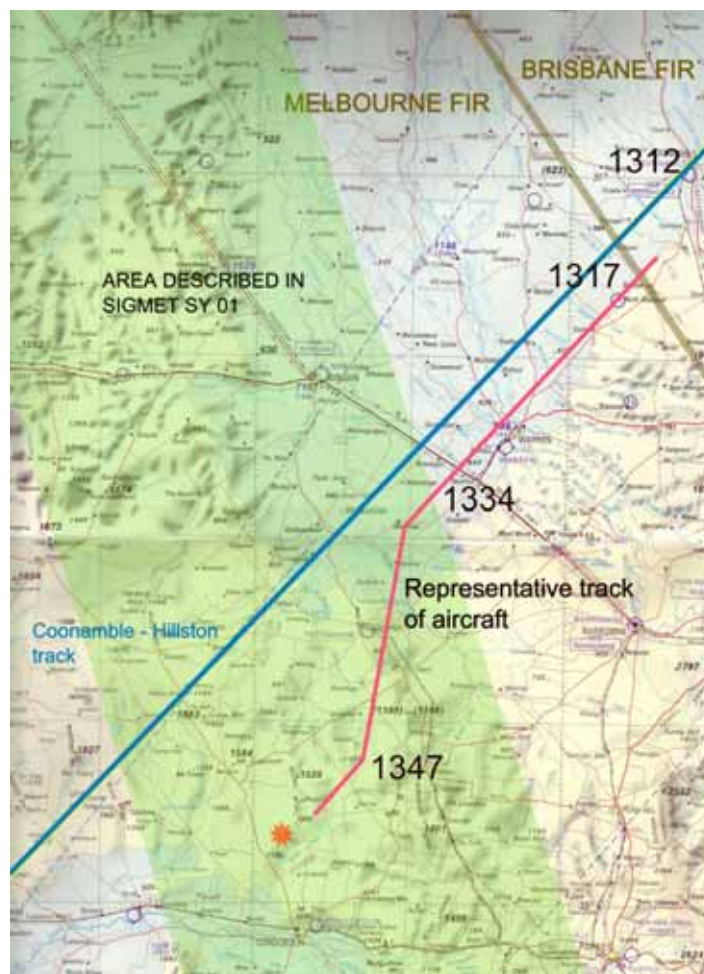
**Figure 15: Key flight information after Coonamble**

Figure 15 depicts key information regarding the flight after the aircraft passed overhead Coonamble. It shows the planned track from Coonamble to Hillston (blue line), and a representation of the actual track taken by the aircraft based on recorded radio and radar data (red line). The local times that the aircraft was at specific locations appear in black. The diagram also shows the Brisbane/Melbourne Flight Information Region (FIR) boundary (brown) and the area described in SIGMET SY01 (shaded green).

Because the area described in SIGMET SY01 fell within the Melbourne FIR, there was no responsibility on the part of air traffic service agencies covering the

Brisbane FIR regarding any hazard alert associated with the SIGMET. Therefore, air traffic control sectors within the Melbourne FIR had the task of assessing the SIGMET and determining any follow-up action. However, because the aircraft was outside 1 hour of flight time<sup>19</sup> of the hazard when the SIGMET was issued, and in accordance with air traffic control procedures, at that time there was no requirement for the information to be passed to the pilot.
