**ATSB TRANSPORT SAFETY INVESTIGATION REPORT**

Aviation Occurrence Report – 200403238 / 200404436

**Abnormal airspeed indications  
En route from/to Brisbane Qld  
31 August 2004 / 9 November 2004  
Bombardier Aerospace DHC8-315  
VH-SBJ / VH-SBW**

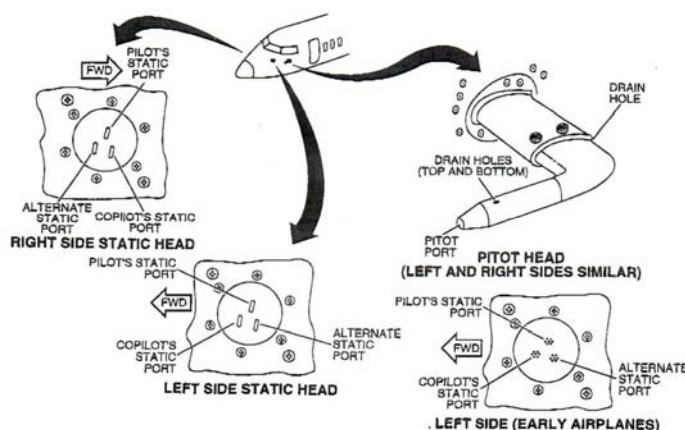
**Figure 5: Location of pitot and static heads**

The static head consists of a plate, flush mounted to the aircraft skin, with ports (or holes) that allow instruments access to the ambient air pressure. Two static heads are fitted to the DHC-8, one located each side of the aircraft nose, see figure 5. Each head has three ports<sup>5</sup> which are connected to the pilot's and copilot's instruments, figure 6 shows the connections.

The pitot head is a tube with a knife edge orifice facing in the direction of flight. Two pitot heads are fitted to the DHC-8, one for each pilot's instruments, and are located each side of the aircraft nose, see figure 5. Each pitot head is connected to the respective pilot's instruments and cannot be switched between pilot in command and copilot. Figure 6 shows the connections.

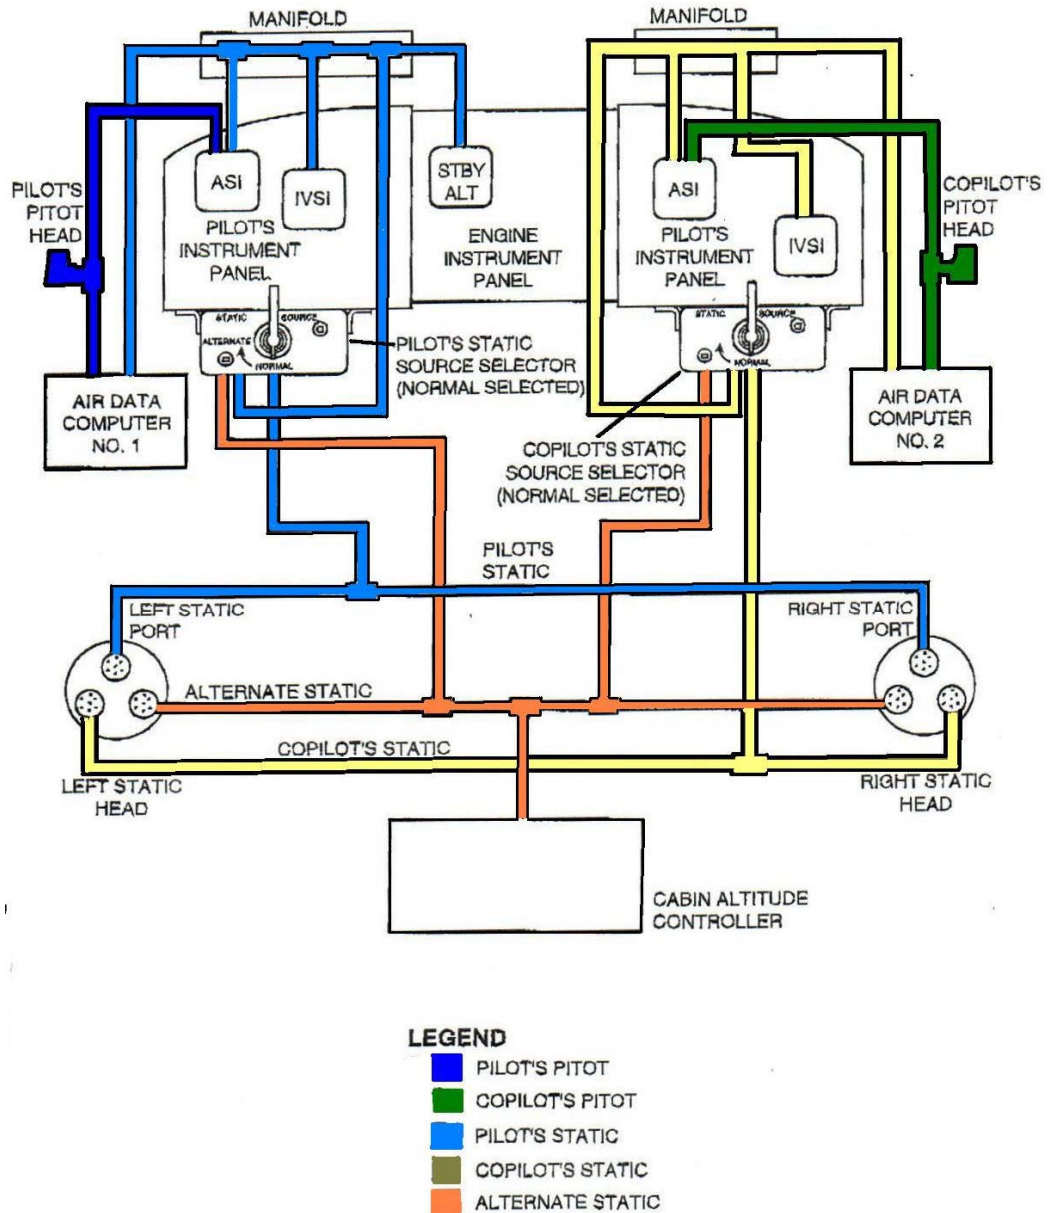
**Figure 6: Pitot and static system configuration**

Figure 6 shows the interconnection of the pitot and static system fitted to the DHC-8. It can be seen that the pitot head is dedicated to the instruments utilised at a flight crew position and cannot be switched. The static system has two ports available to each flight crew and is controlled via selection of a *normal* port or an *alternate* port.

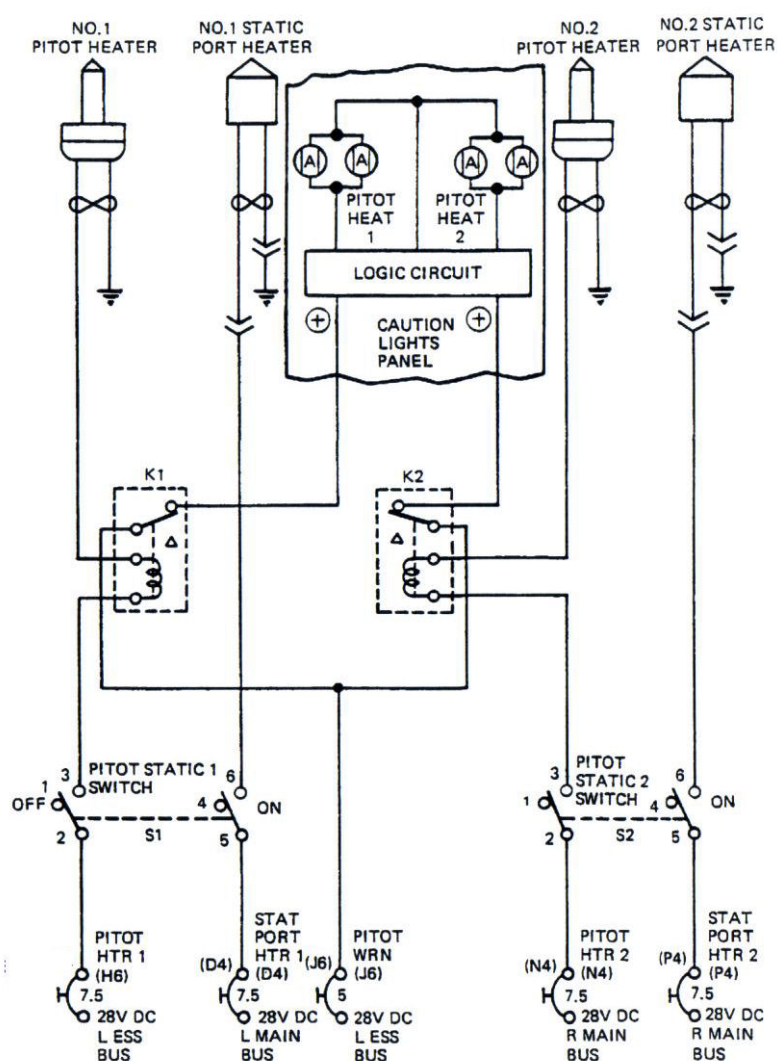
**Figure 7: Pitot Static heating system schematic**

Both the pitot and static heads are fitted with an electrically powered heating element to minimise the effect of ice build up that may block the ports when the aircraft is being operated in moist cold conditions. Each pitot and static head heater is powered by 28V direct current (d.c.) with the pilot's pitot and static head being powered from the left essential buss and the copilot's powered from the right essential buss, see figure 7.

The crew is alerted to the heaters being turned off with a light for each respective system being illuminated. If the pitot heating system is turned on and a heating element fails, the corresponding warning light will also illuminate.
