ATSB TRANSPORT SAFETY INVESTIGATION REPORT  
Marine Occurrence Investigation No. 234  
Final

Independent investigation into the engine room fire on board the  
French Antarctic supply ship

# L'Astrolabe

11 November 2006

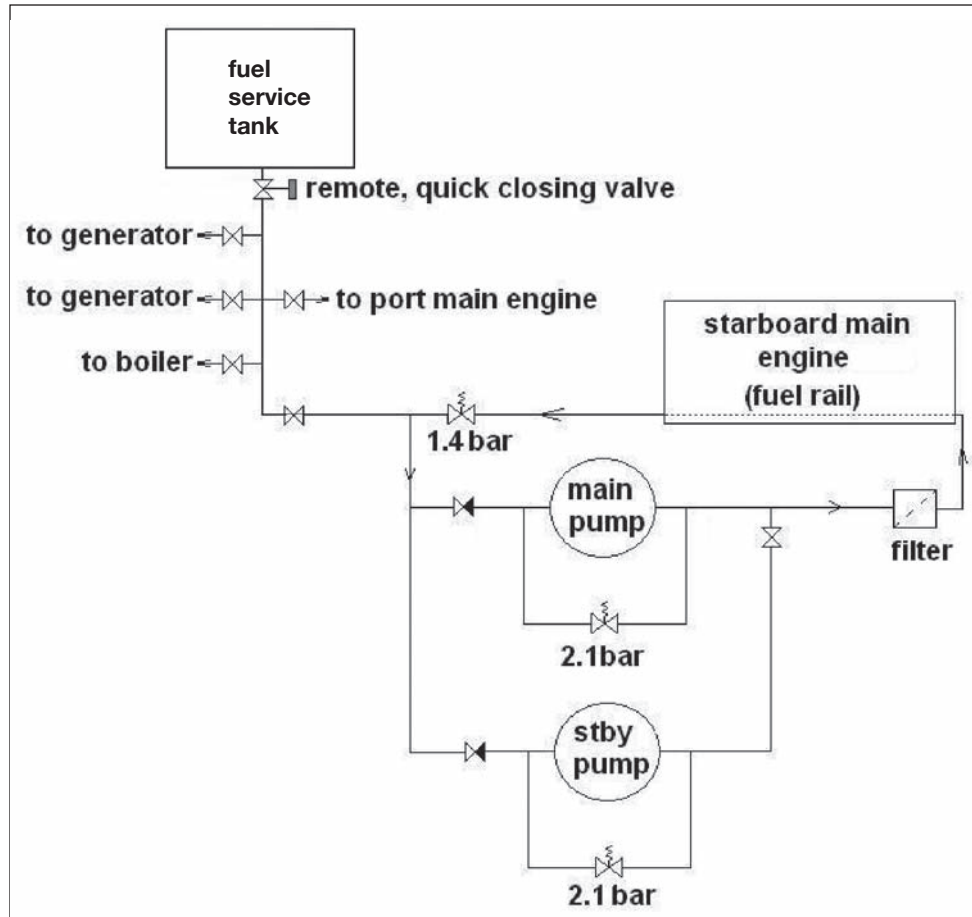
**Figure 2: Fuel system schematic drawing**

Each main engine is fitted with an engine driven main fuel pump. If this pump fails, an electrically driven standby pump can be used to supply fuel to the engine's fuel rail (Figure 2).

There is no discharge valve fitted after the main pump. Therefore, if the standby pump is operated, the main pump's screw down non-return inlet valve prevents the flow of fuel back through the main pump but the main fuel pump's body remains pressurised. If there is a need to remove the main pump and run the engine on the standby pump, a blank needs to be fitted on the main pump's discharge side.

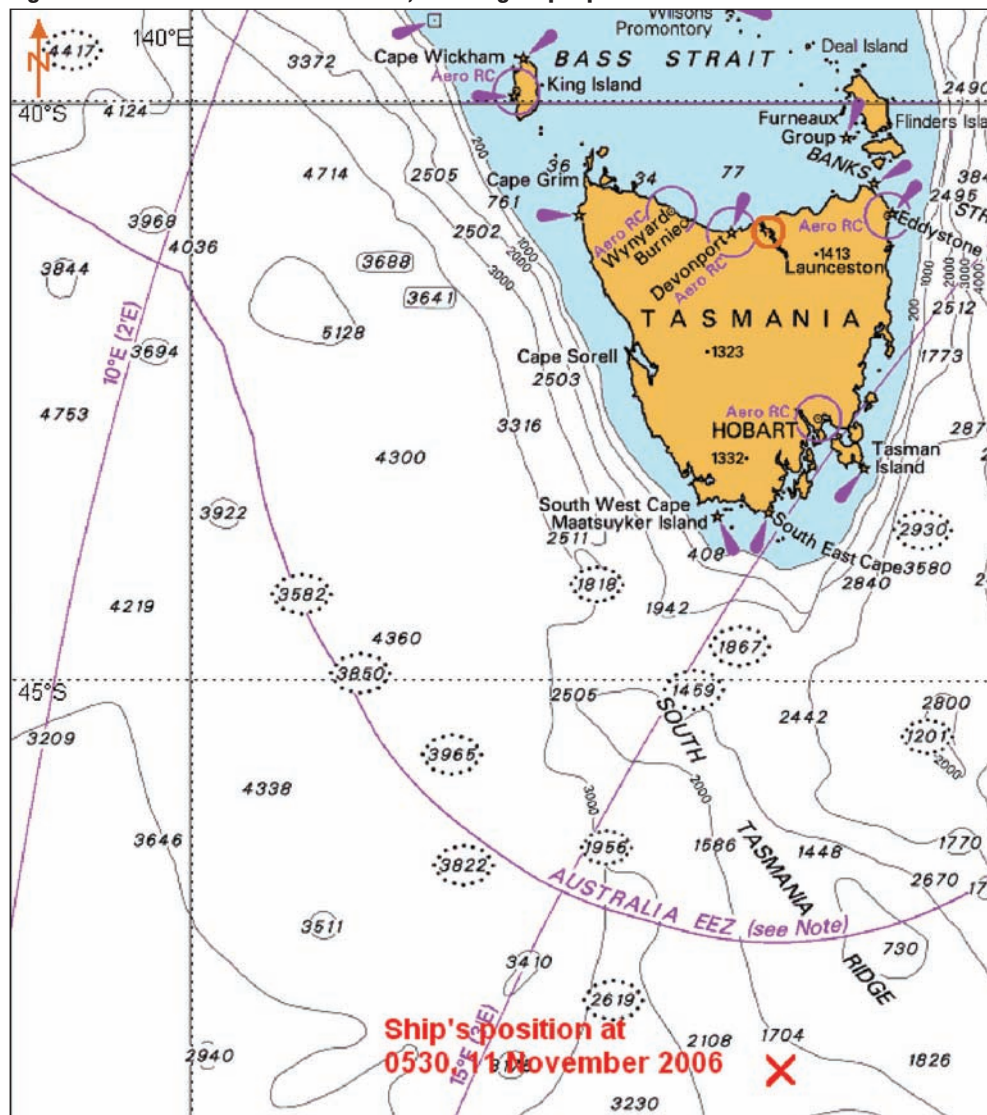
**Figure 5: Section of chart Aus 4074, showing ship's position when the fire occurred**

At 0530, when the ship was still about 320 miles from Hobart (Figure 5), the fire alarm sounded, indicating that an engine room fire detector had activated. The chief mate, who was on watch, instructed the AB to go to the engine room and investigate the reason for the fire alarm.
