ATSB TRANSPORT SAFETY INVESTIGATION REPORT  
Marine Occurrence Investigation No. 208  
Final

Independent investigation into the lifeboat accident and  
fatalities aboard the Hong Kong registered bulk carrier

# Lowlands Grace

at anchor off Port Hedland, Western Australia on  
7 October 2004

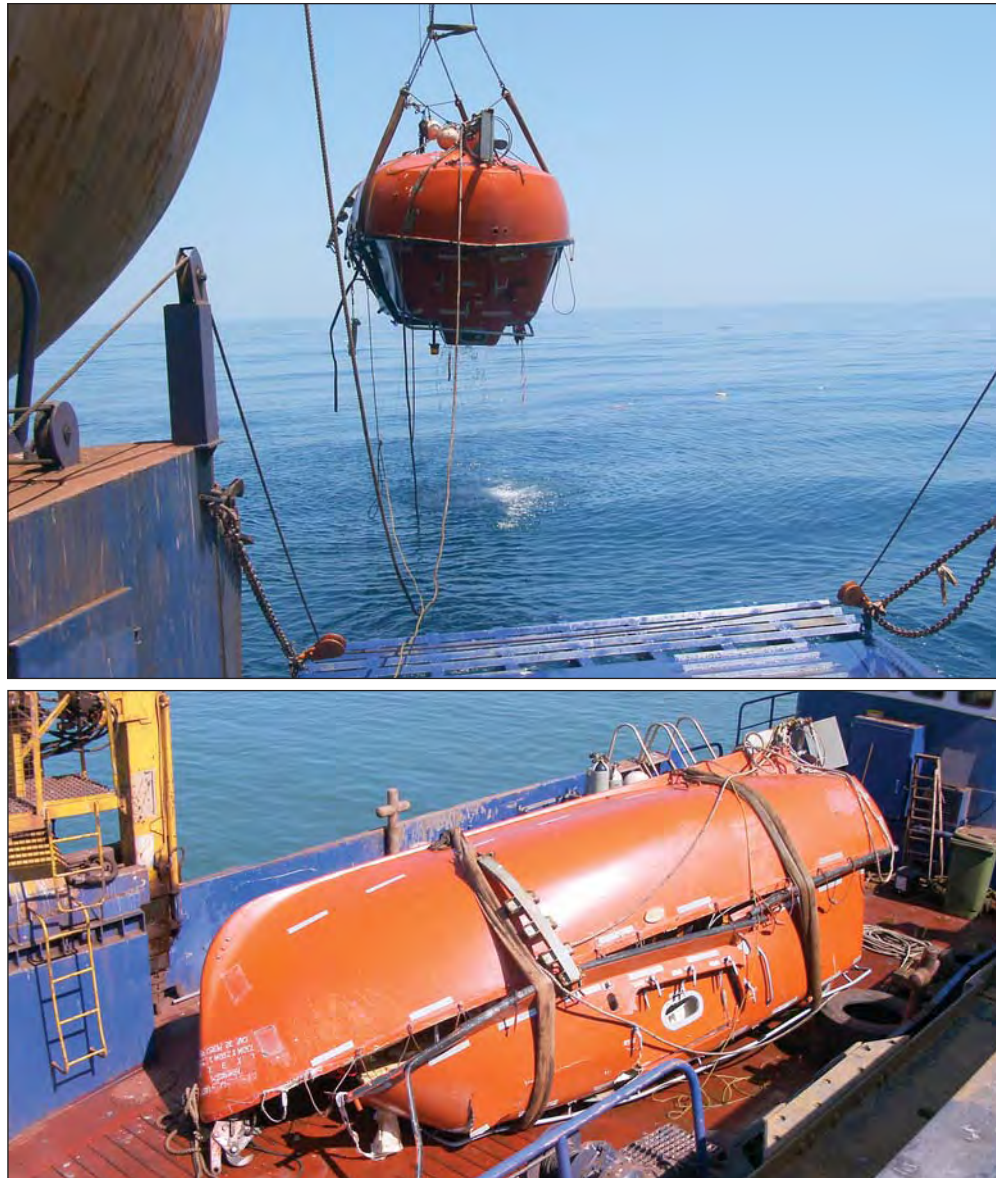
**Figure 11: Port lifeboat being recovered**

On 9 October 2004, investigators from the Australian Transport Safety Bureau (ATSB) arrived on board *Lowlands Grace*, at anchor off Port Hedland, to conduct an investigation into the circumstances of the lifeboat accident. At the time, the port lifeboat was still afloat, upside down, alongside the port side of the ship tethered by painters. Attempts were made during the day of 9 October to recover the lifeboat by righting it and pumping it dry so that it could be towed ashore. These attempts proved to be unsuccessful. The following day another attempt to recover the lifeboat was made by lifting the lifeboat clear of the water using slings passed around the boat, which were then attached to the lifeboat davit falls. This attempt was successful and the lifeboat was loaded on board a small landing barge for transport to a shore facility in Port Hedland (Figure 11).

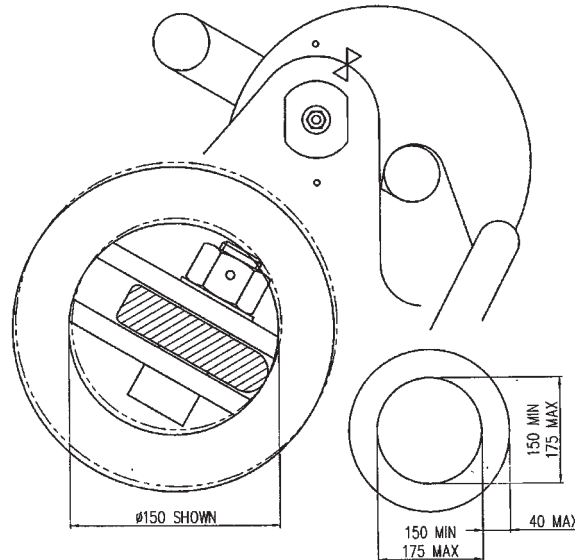
**Figure 22: Lifeboat manufacturer's recommended suspension ring**

The suspension ring specified by the on-load release manufacturer for 5 tonne Titan on-load release systems is a circular ring with a minimum internal diameter of 150 mm and a maximum internal diameter of 175 mm. This ring is sized to ensure that in circumstances similar to those which occurred on *Lowlands Grace* the suspension ring will clear the main pivot pin and thus not form a lever to increase opening forces on the hook (Figure 22). Had *Lowlands Grace*'s lifeboat davits been fitted with the suspension rings stipulated by the on-load release manufacturer, there would have been significantly less opening force applied to the forward hook and it may not have failed and opened under load.

5 – Tonne 'Titan' gear recommended ring size shown in detail.  
Minimum ring size, showing clearance over hook pivot pivot pin

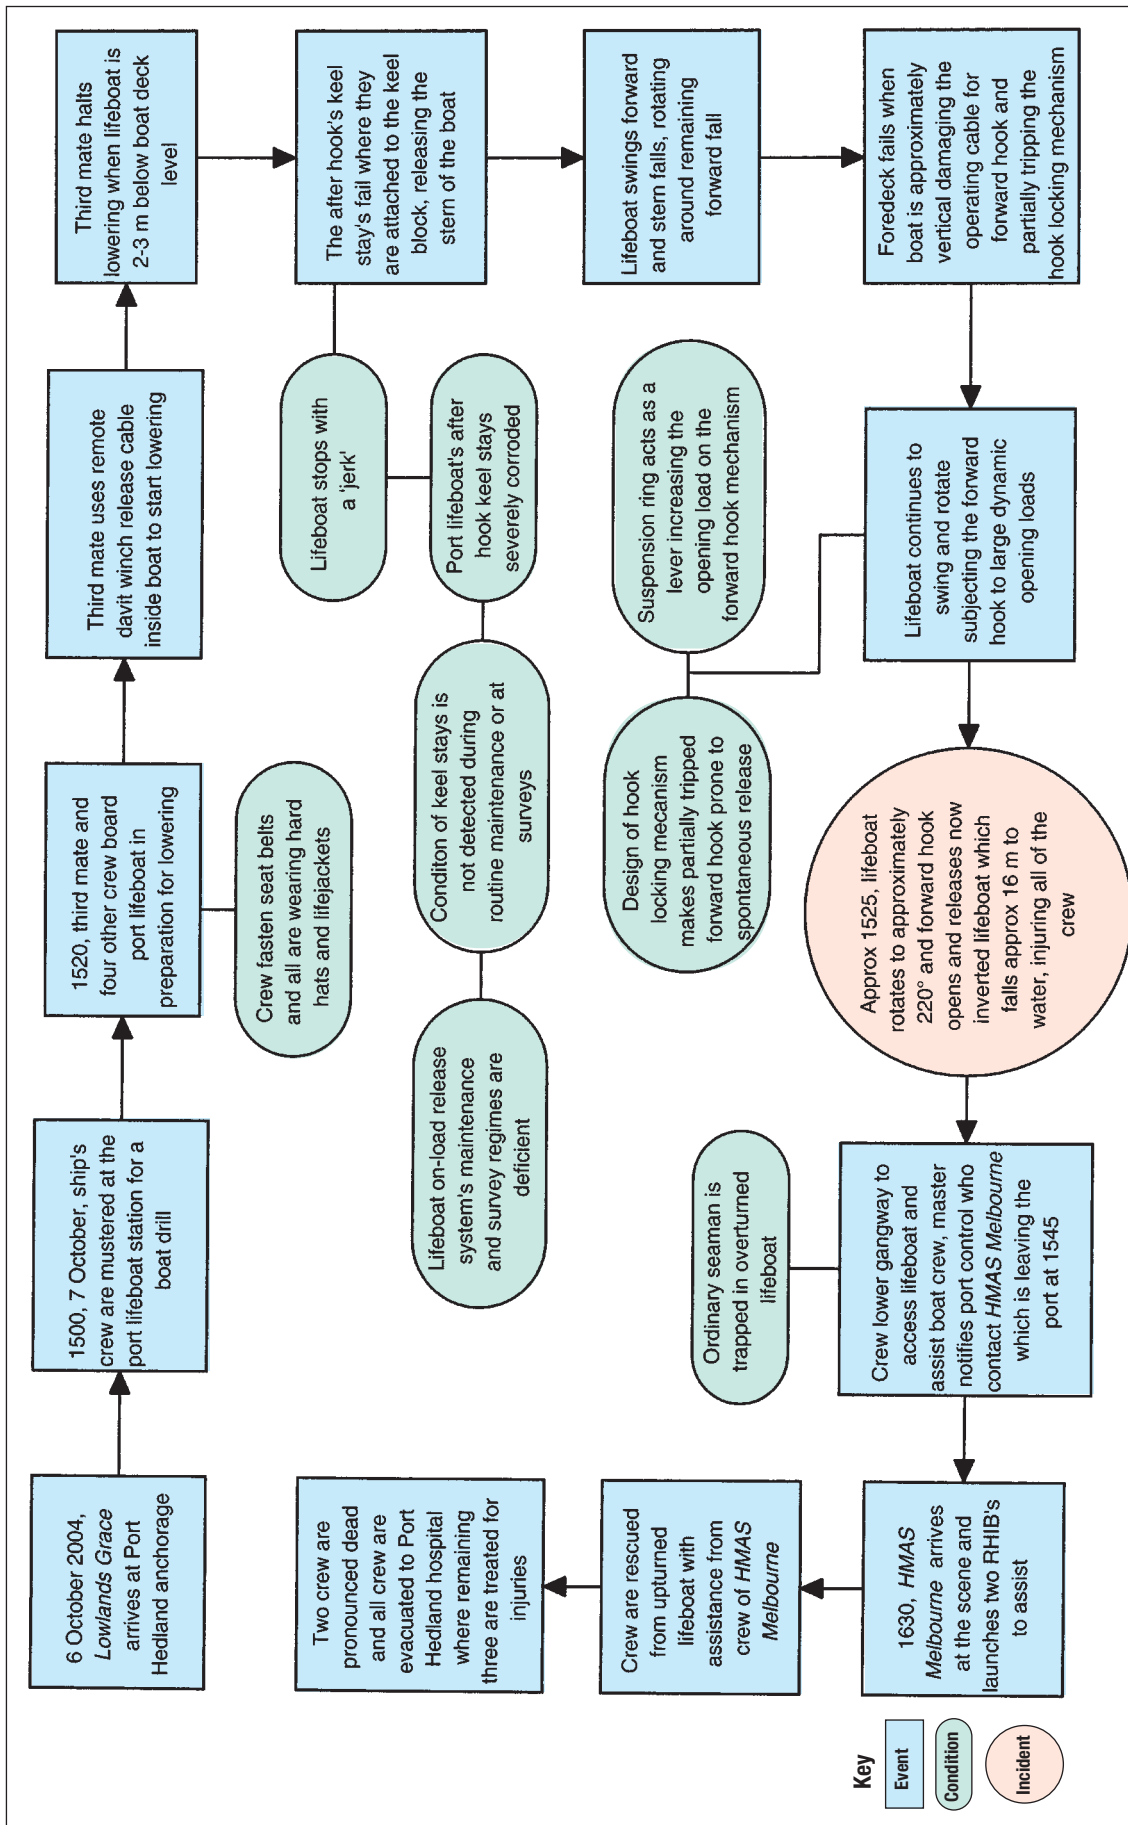
Figure 24: *Lowlands Grace's* Events and causal factor chart

While the *Lowlands Grace* incident is somewhat different due to the failure of the foredeck, the design issue vis-a-vis the cam release pin is still implicated. While the possibility that other designs of on-load release systems would also have failed in the circumstances cannot be ruled out, had *Lowlands Grace*'s port lifeboat been fitted with a system utilising a more positive method of locking the hooks, it is possible that the severe consequences of the accident could have been avoided.
