MARINE SAFETY INVESTIGATION

REPORT 178

Independent investigation into the contact with the
number two coal loader at Port Kembla, NSW,
by the Bahamas flag bulk carrier

SA Fortius

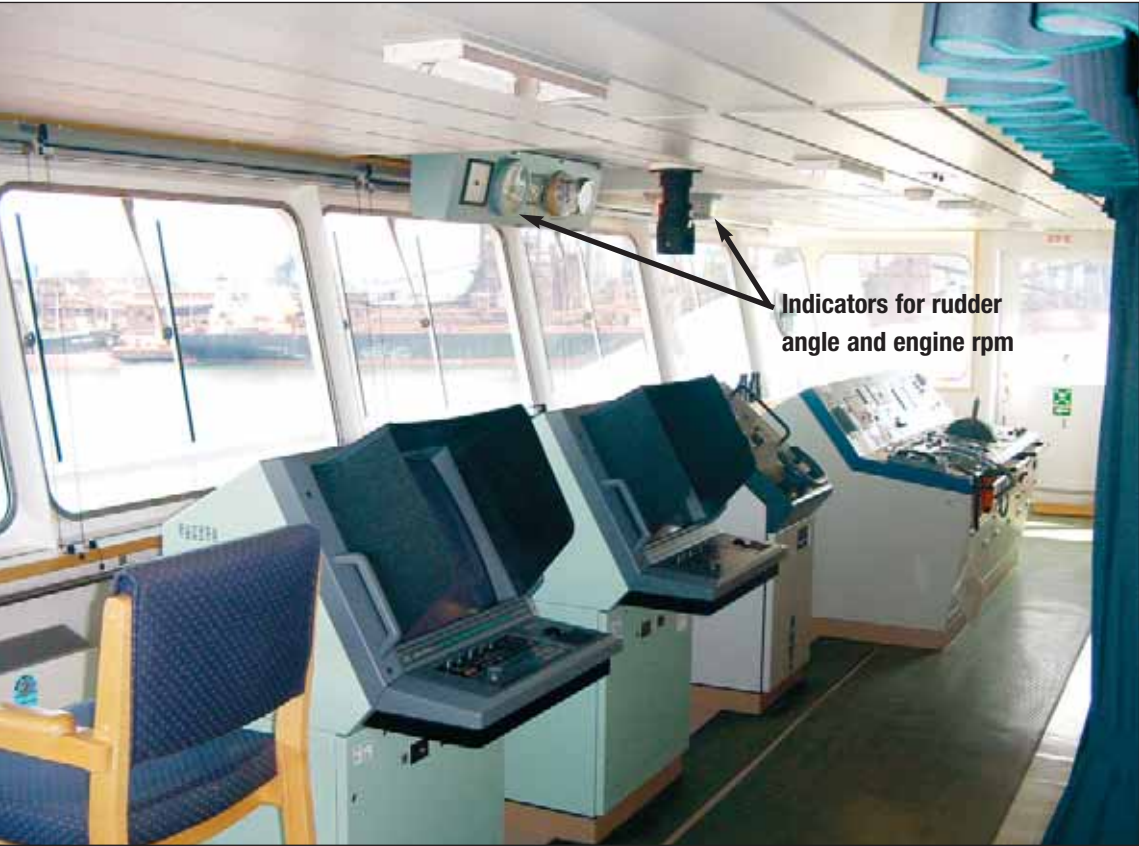
FIGURE 7:
SA Fortius wheelhouse

The Master states that the pilot moved from the wheelhouse to the port bridge wing when the turn was started on a heading of 310. The pilot was accompanied by the Master, both of them remaining on the port bridge wing throughout, until the vessel was actually berthing after the incident.

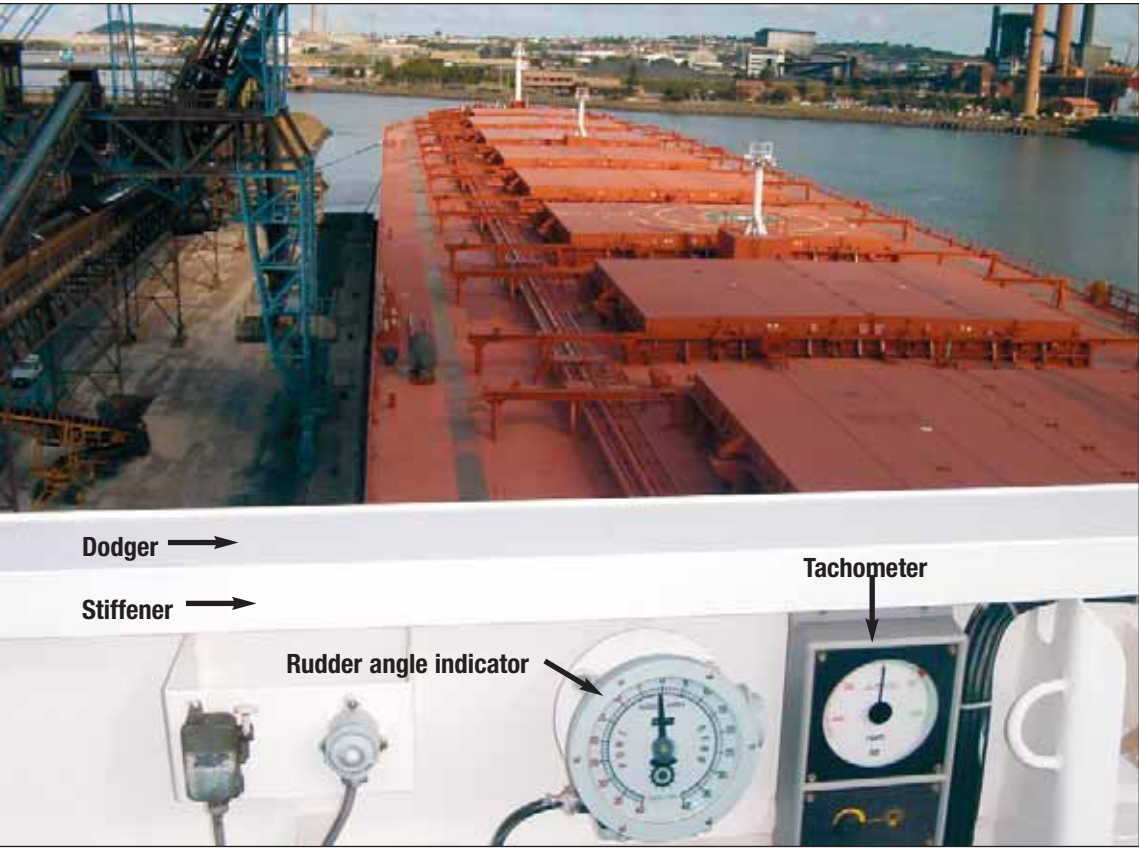
FIGURE 8:
SA Fortius looking forward from port bridge wing

However, the harbour master, who was at the grain berth, noticed that *SA Fortius* seemed closer to the general purpose berth than was normal. He went to the adjacent multi-purpose berth at about the time that contact was made with number two coal loader. From the dock side he could see the pilot, but stated that he could not see the master.

If port rudder had been applied after the pilot left the wheelhouse, and he did not notice the indicator on the bridge wing, then the port wheel would probably have made little, if any, difference to the rate of turn. The pilot provided a statement that it was his experience and that of other pilots in Port Kembla, that once a rate of turn to starboard had been established on low ahead engine revolutions, applying full port rudder had no effect for at least 30 seconds.

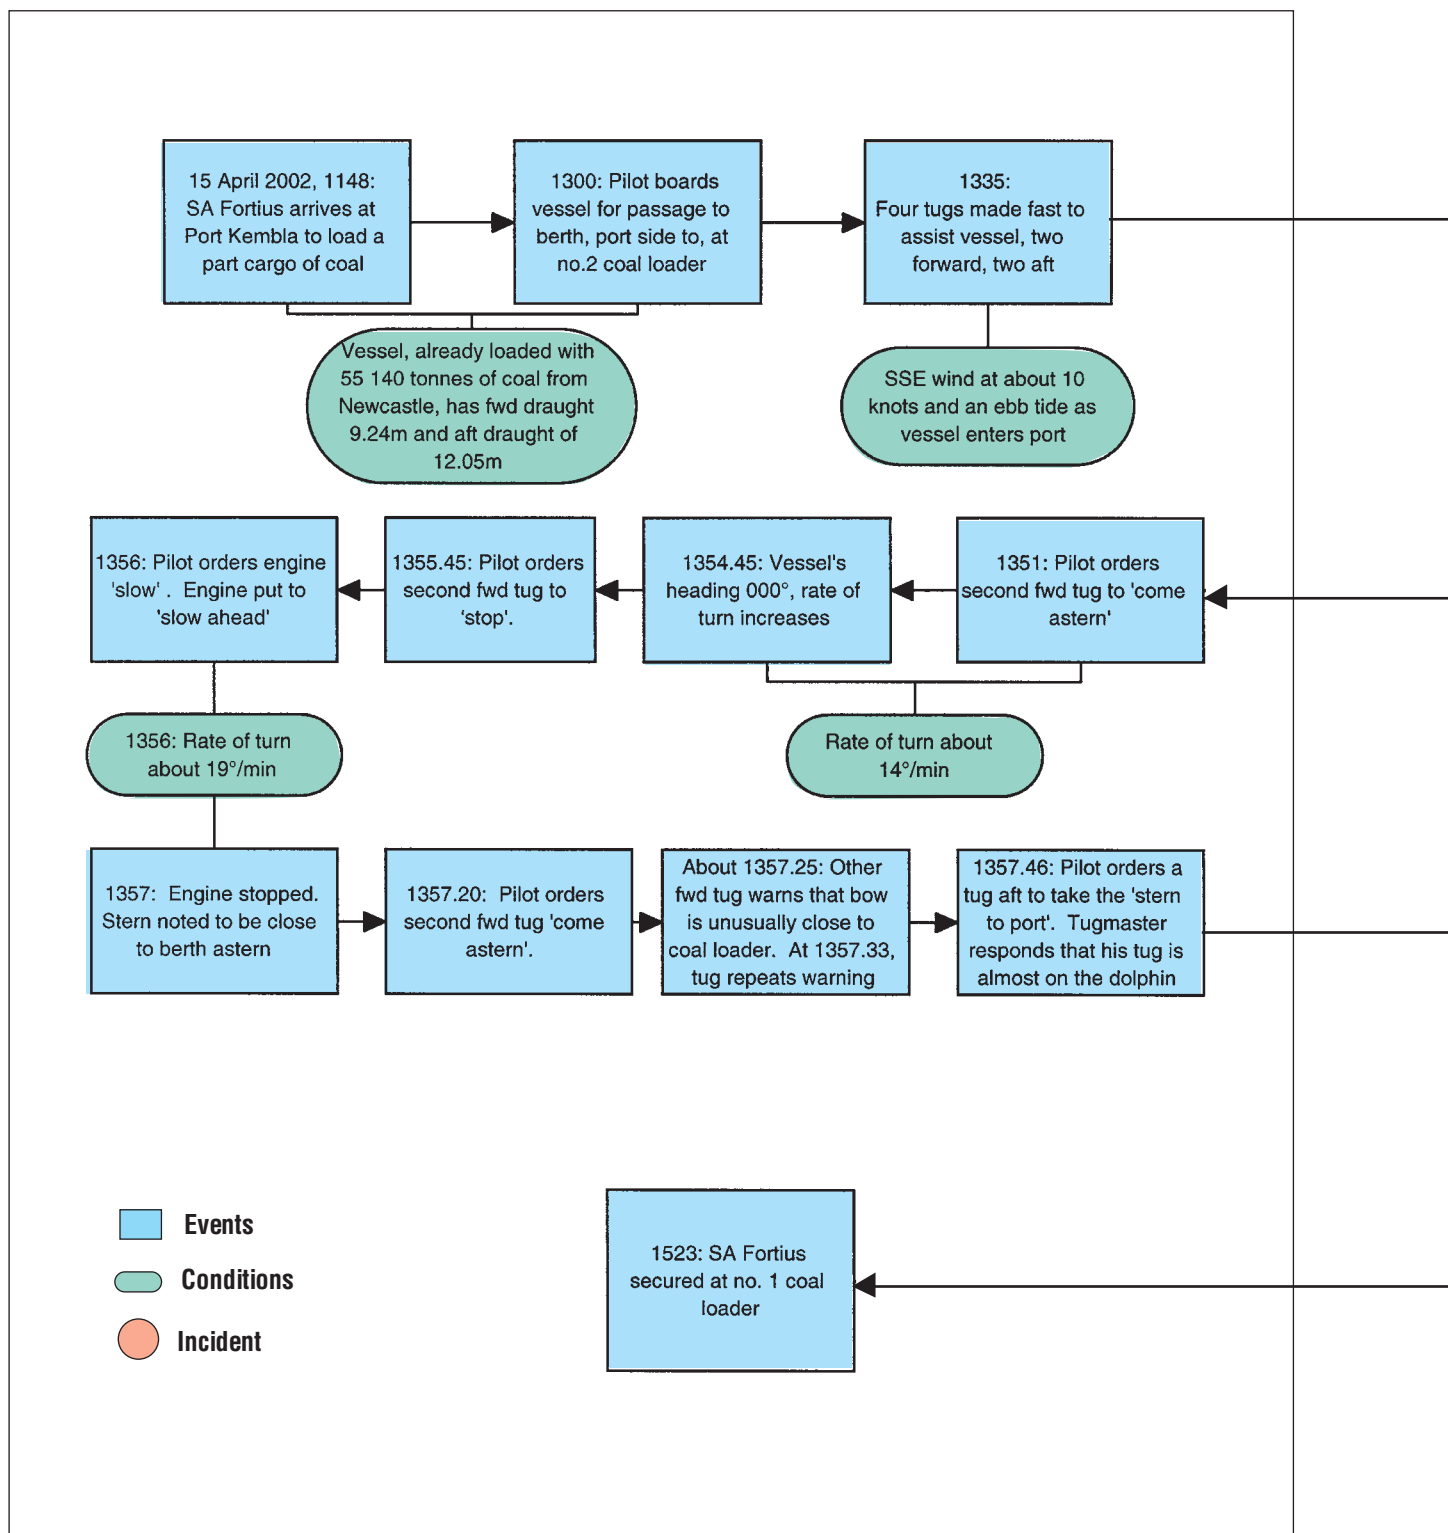
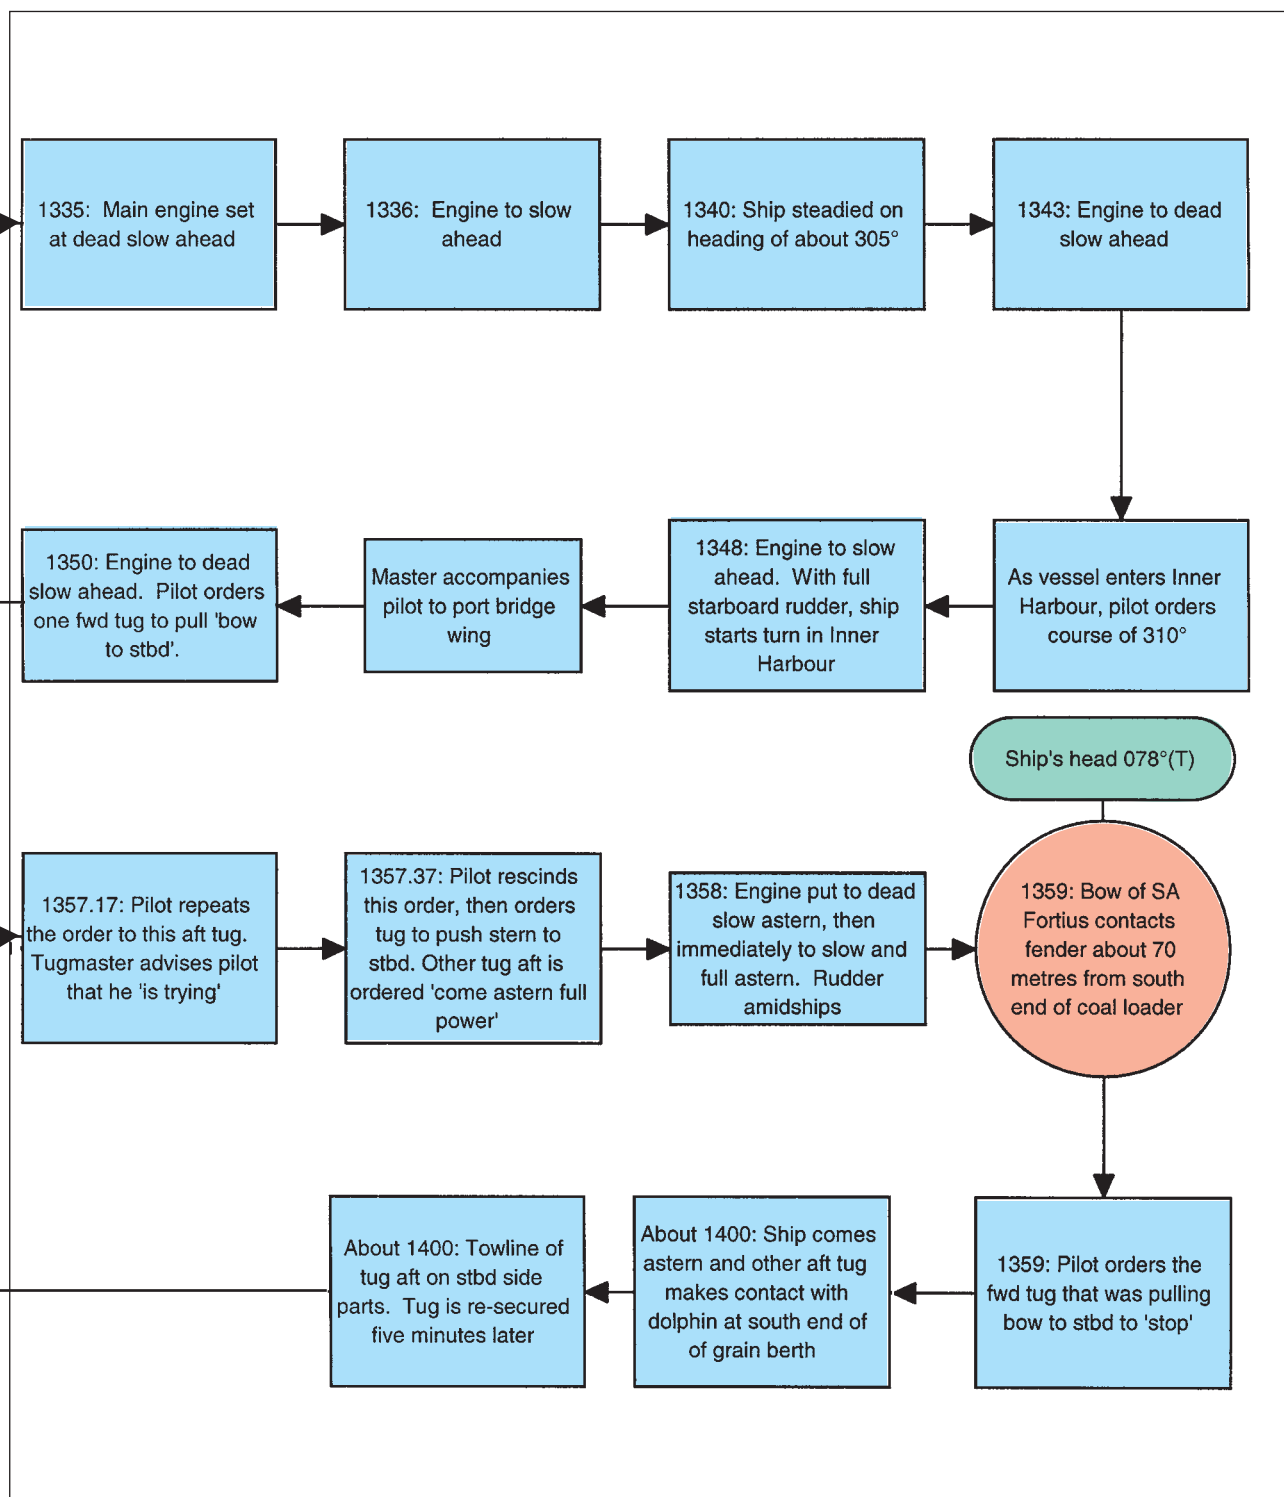
SA Fortius Events and causal factors chart

These conclusions identify the different factors contributing to the incident and should not be read as apportioning blame or liability to any particular individual or organisation.
