MARINE SAFETY INVESTIGATION  
REPORT 155

Independent investigation into the collision  
involving the Chinese bulk carrier

**Hai Teng**  
and the Australian recreational vessel  
**Chester**

east of Mooloolaba, Queensland  
on 19 March 2000

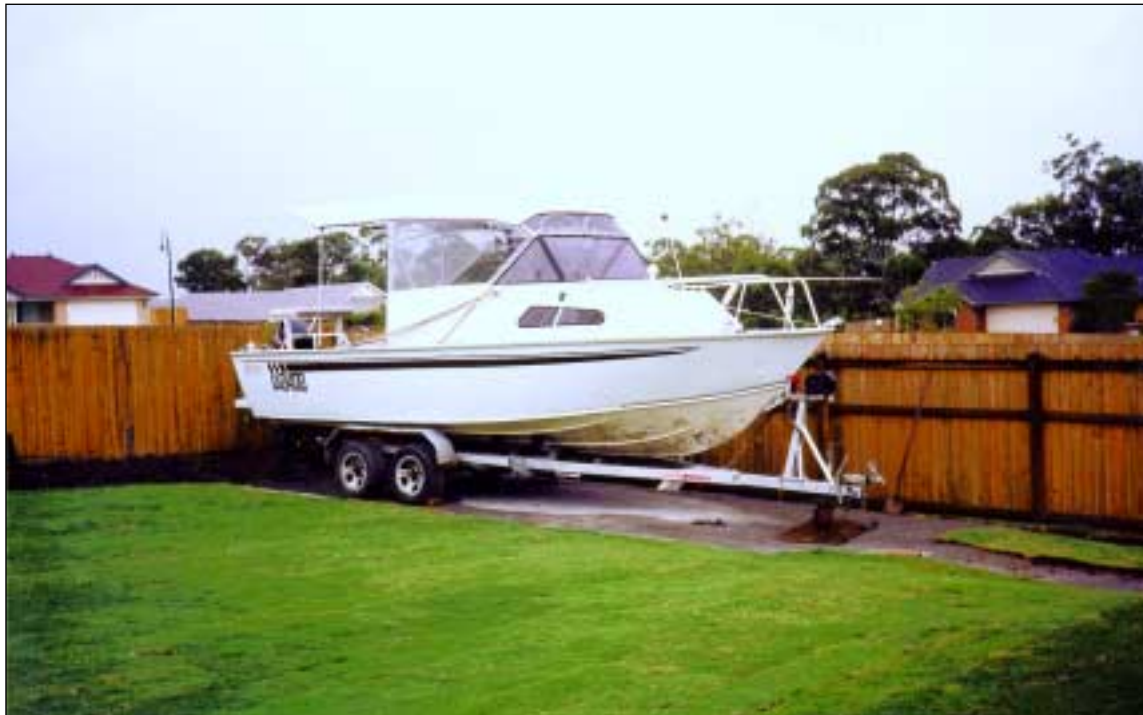
**FIGURE 2:**  
*Chester*

He checked the craft for damage and saw that the fairlead for the moorings and anchor rope was bent though it was still serviceable. There was also a smear of black paint on the starboard rail of the craft.
