MARINE SAFETY INVESTIGATION

REPORT 152

Independent investigation into the
steering gear failure
on the Australian flag motor vessel

Warden Point

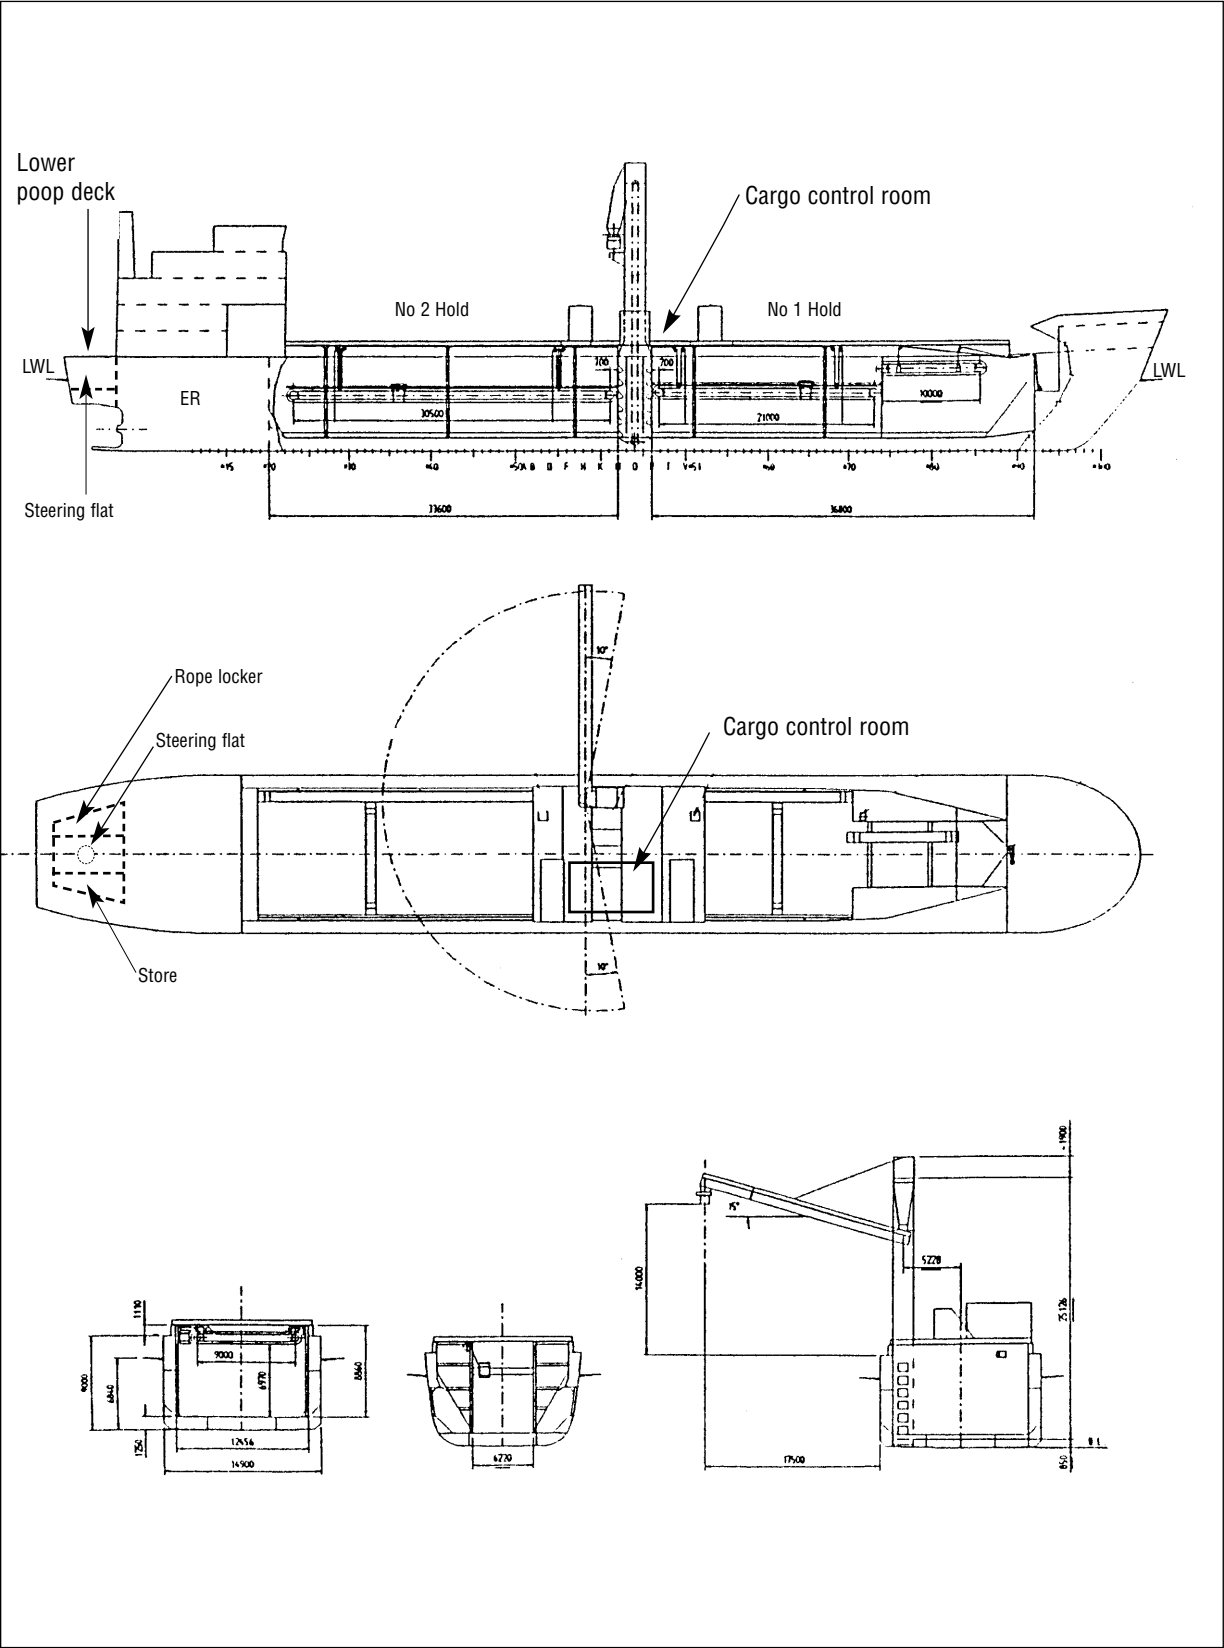
FIGURE 2:
Warden Point general arrangement of holds and self-unloading system

The vessel has two cargo holds, each hold has a width of 12.53 m and a depth of 6.79 m, number 1 hold is 36.8 m long and number 2 hold is slightly shorter at 33.6 m in length (fig. 2). The cargo self-unloading system consists of PLC (programmable logic controller) controlled transverse and longitudinal scraper conveyors in each hold, which feed a bucket elevator located on the port side between the holds. The cargo is then discharged overboard to the reception facility via a slewing boom conveyor fed from the top of the bucket elevator. The cargo system control gear is located between the two holds in a cargo control room. There are inspection windows in the bulkhead between the cargo control room and the

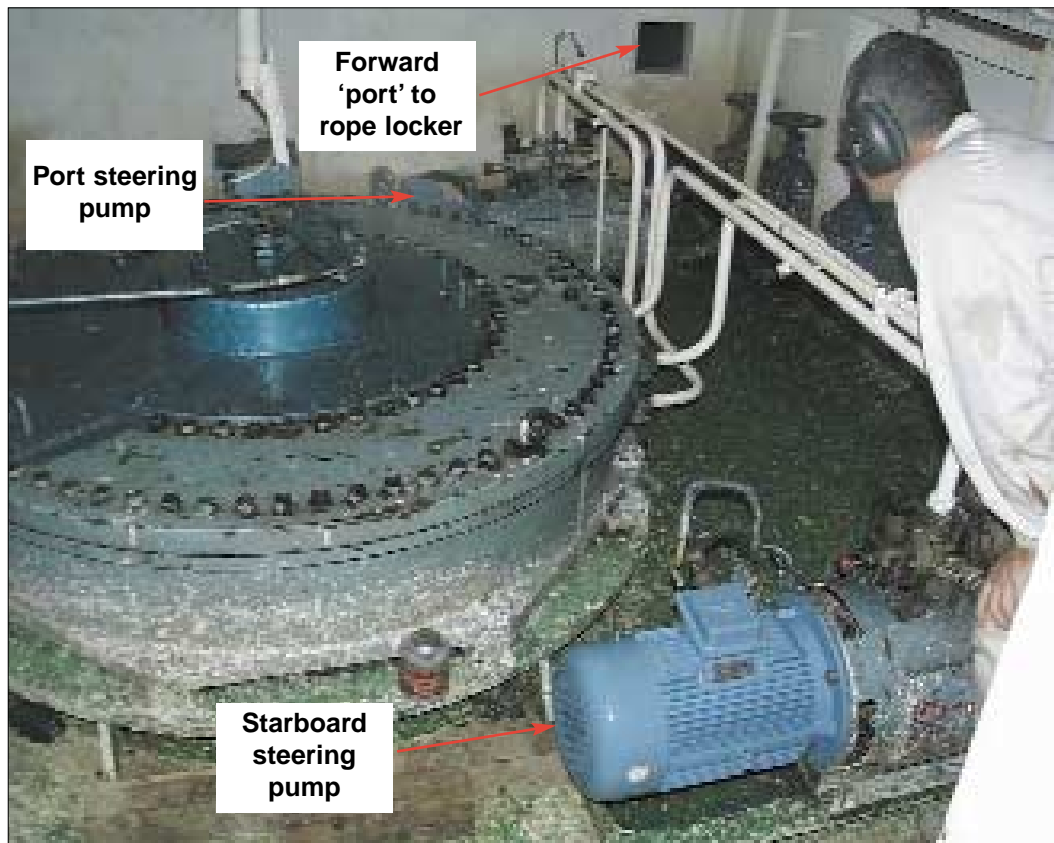
FIGURE 3:
Warden Point's steering flat

Warden Point is fitted with a rotary vane steering system manufactured by A.S Tenfjord Mek.Verkested (fig.3). The system consists of two fixed displacement hydraulic pumps driving the rotary vane 'rudder motor' (hydraulic rudder actuator) via integral, solenoid actuated, hydraulic directional control valves, and independent piping. The steering pumps are mounted horizontally 100 mm above the deck, on the forward side of the 'rudder motor'. When operated alone, each pump is capable of meeting the requirements of class with regard to the speed of rudder actuation. The usual shipboard procedure is to run a single pump when en route and both pumps for any pilotage. The steering gear has three modes of operation; automatic from the bridge when the autopilot is engaged, non-follow-up steering when hand steering from the bridge, and emergency steering effected by manually operating the directional control valves on the steering pumps in the steering flat.

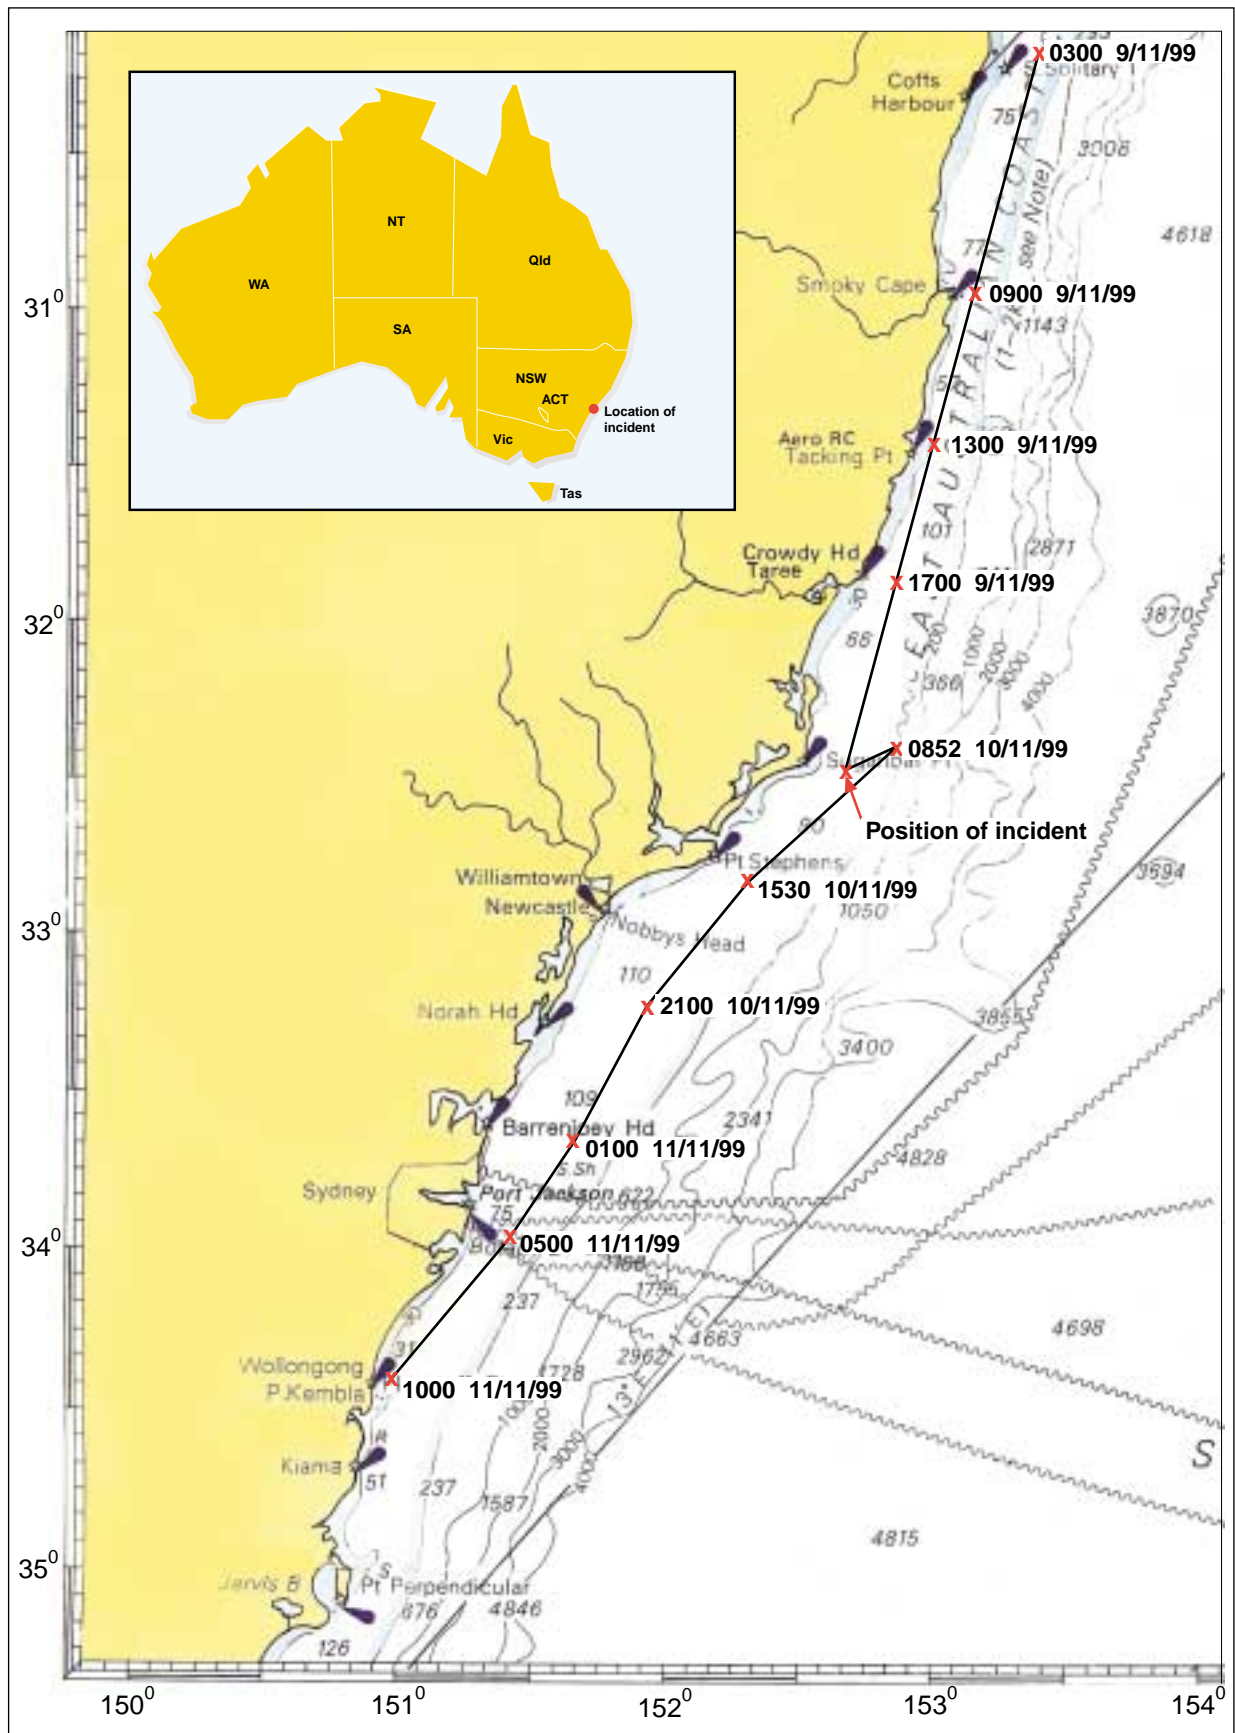
FIGURE 5:
Warden Point's approximate track 9,10,11 November 1999

Warden Point's approximate track for 9, 10, 11 November is shown in figure 5. The events and causal factors chart for the incident is reproduced in figure 8.
