**Commonwealth and
New South Wales
joint investigation into
the contact damage sustained
by the Barbados
flag bulk carrier
MV Claudia
at Bass Point,
New South Wales
on 16 December 1998**

Navigation Act 1912
Navigation (Marine Casualty) Regulations
joint investigation into the contact damage sustained
by the Barbados flag bulk carrier
MV Claudia
at Bass Point, New South Wales

Published: July 1999

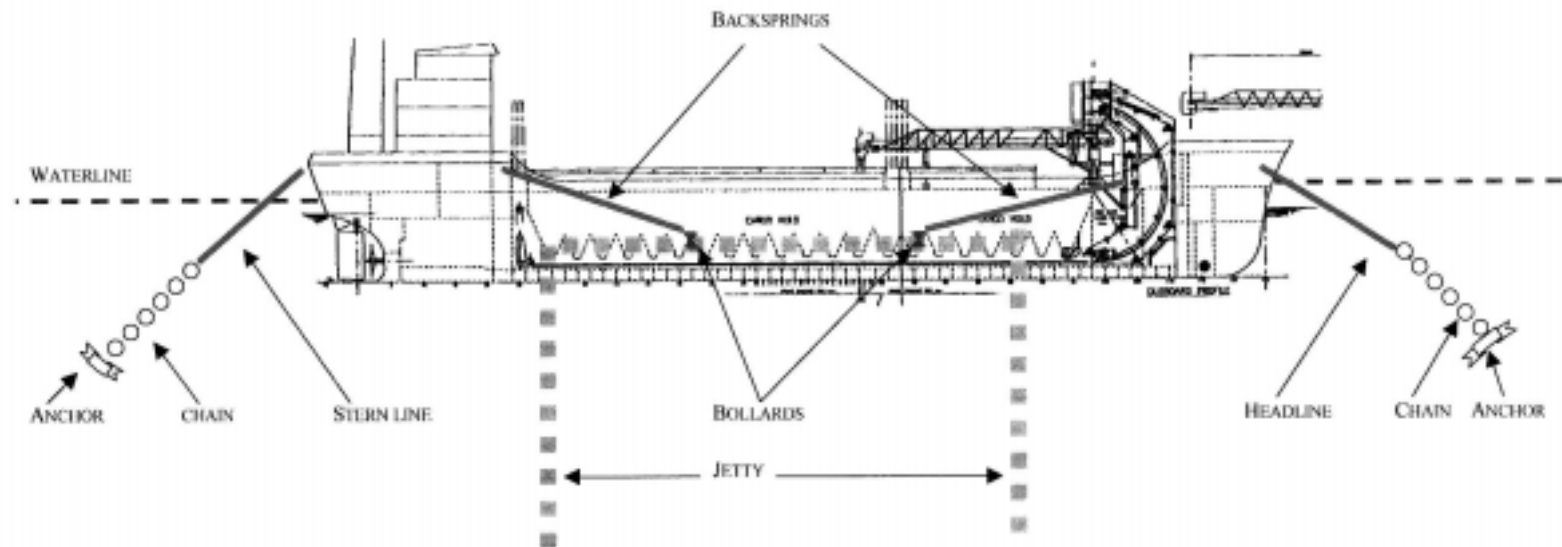
Figure 4

MV Claudia

mooring arrangements namely, that the vessel would be secured alongside the jetty with a headline and forward spring and a stern line and after spring. The vessel provides the two springs which are secured to bollards on the jetty and the quarry provides the head and stern lines which are secured to a ground tackle arrangement consisting of mooring anchors and chains. (See figure 4)

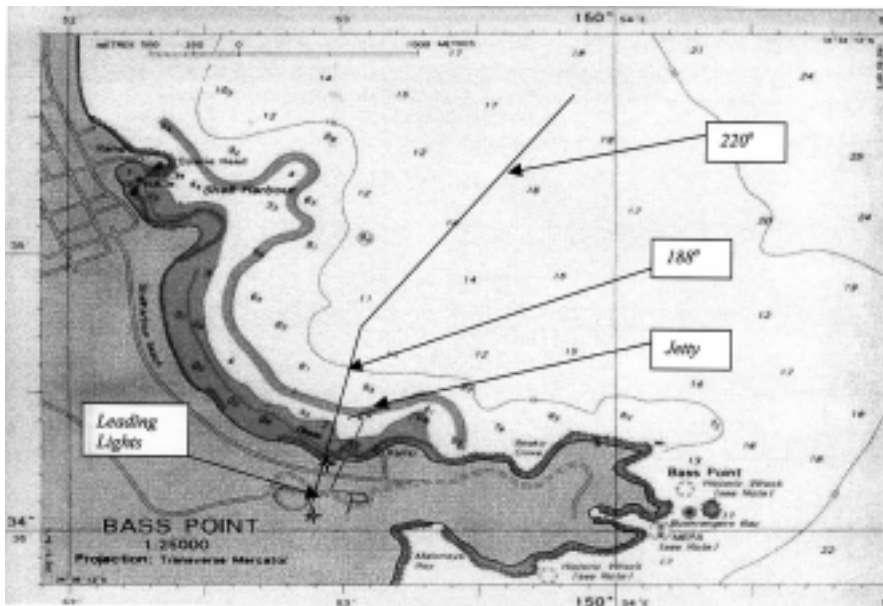
Extract of chart showing approach courses
Figure 5

The typical approach courses for the vessel to berth starboard to are shown at figure 4.
