ATSB TRANSPORT SAFETY INVESTIGATION REPORT  
Rail Safety Investigation 2005/003  
Final

**Shunting Accident  
Regency Park, South Australia**

02 February 2005

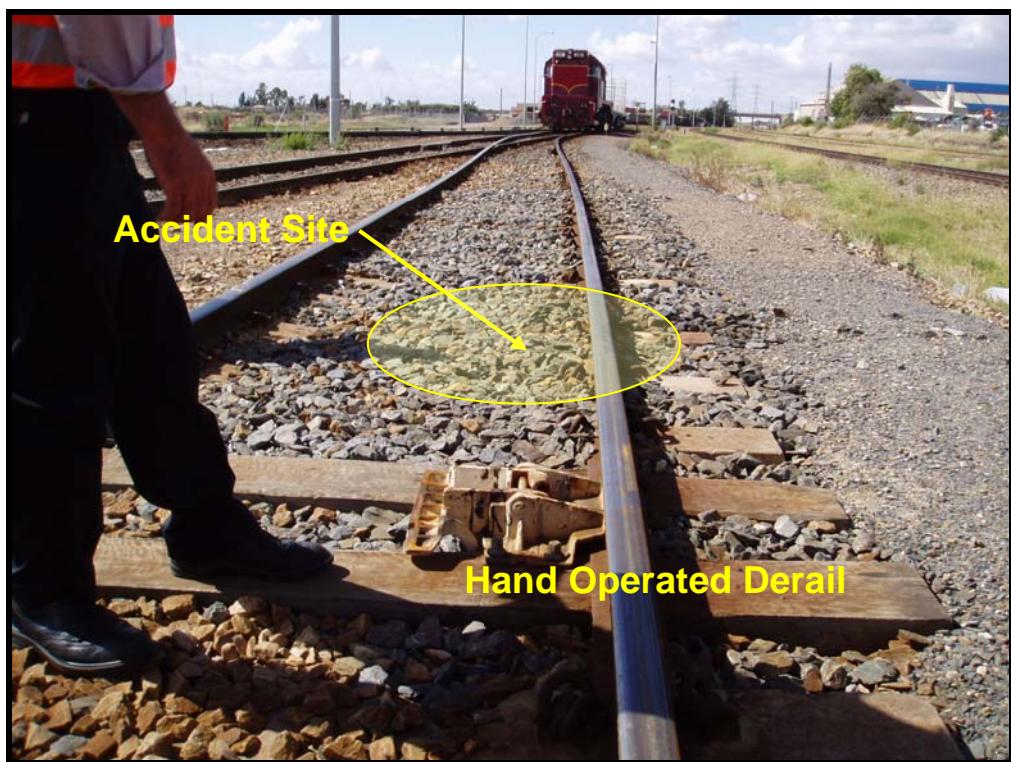
**FIGURE 3. Locomotive T345 at entrance to ‘marshalling loop’**

Due to the length of trains and the constraints of the overall yard layout, SCT shunting operations work through the PN/SCT ‘common interface area’ before gaining access to a 500 metre long ‘marshalling loop’. The entrance to the ‘arrival/departure road’ and the ‘marshalling loop’ is protected by hand operated derails. (Fig. 3)

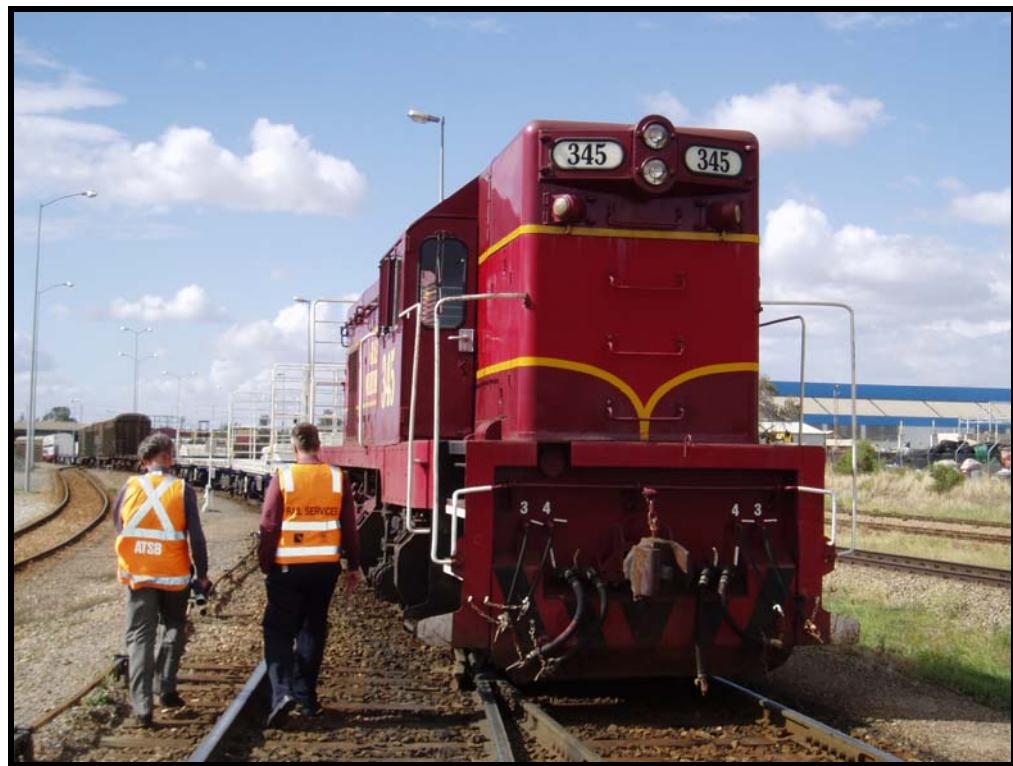
**FIGURE 4. T345, Locomotive involved in accident.**

An examination of the general condition of locomotive T345 and the nine wagons in the rake through visual inspections of the running gear components; including bogies, braking system, and mechanical structure did not identify any issues that would have had any direct or indirect causal effect on the accident.

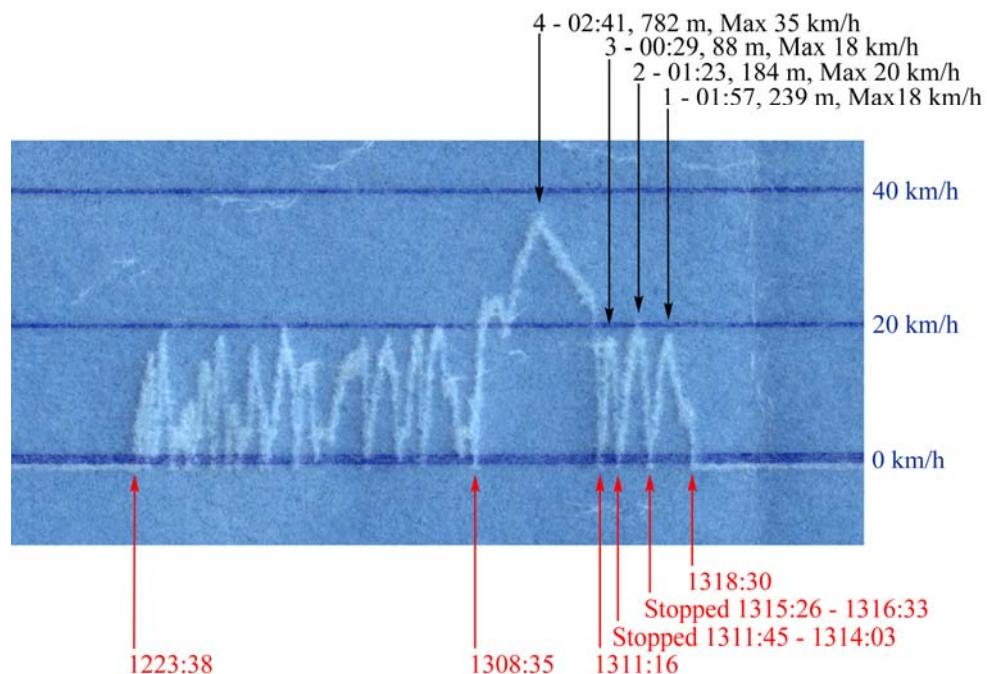
**FIGURE 5. T345, Hasler recorder data (locomotive data logger).**

An examination of SCT's security video<sup>12</sup> and the locomotive chart log was used in reconstructing the sequence of events leading up to the accident. A review of the chart log (Fig. 5) shows that T345 had been driven at speeds significantly in excess of that prescribed in SCT's operating procedures. Although this is not considered a factor in this accident it is concluded that robust auditing of prescribed safety practices may have been an effective mechanism in reinforcing a culture that promotes safety.

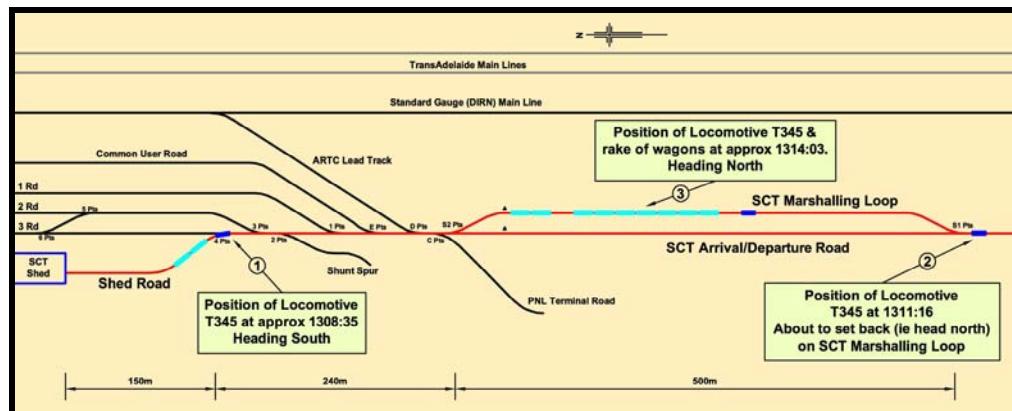
**FIGURE 6. Sequence of shunt movements (See Appendixes, Fig. 15 for large scale plan)**

At 1308:35, the shunter uncoupled the last two remaining wagons. The shunter then joined the driver in the cab before T345 headed south, (Fig. 6) through the PN/SCT common interface area. It proceeded along the 'arrival/departure road' where it travelled to the far end of the loop, clear of points, S1.

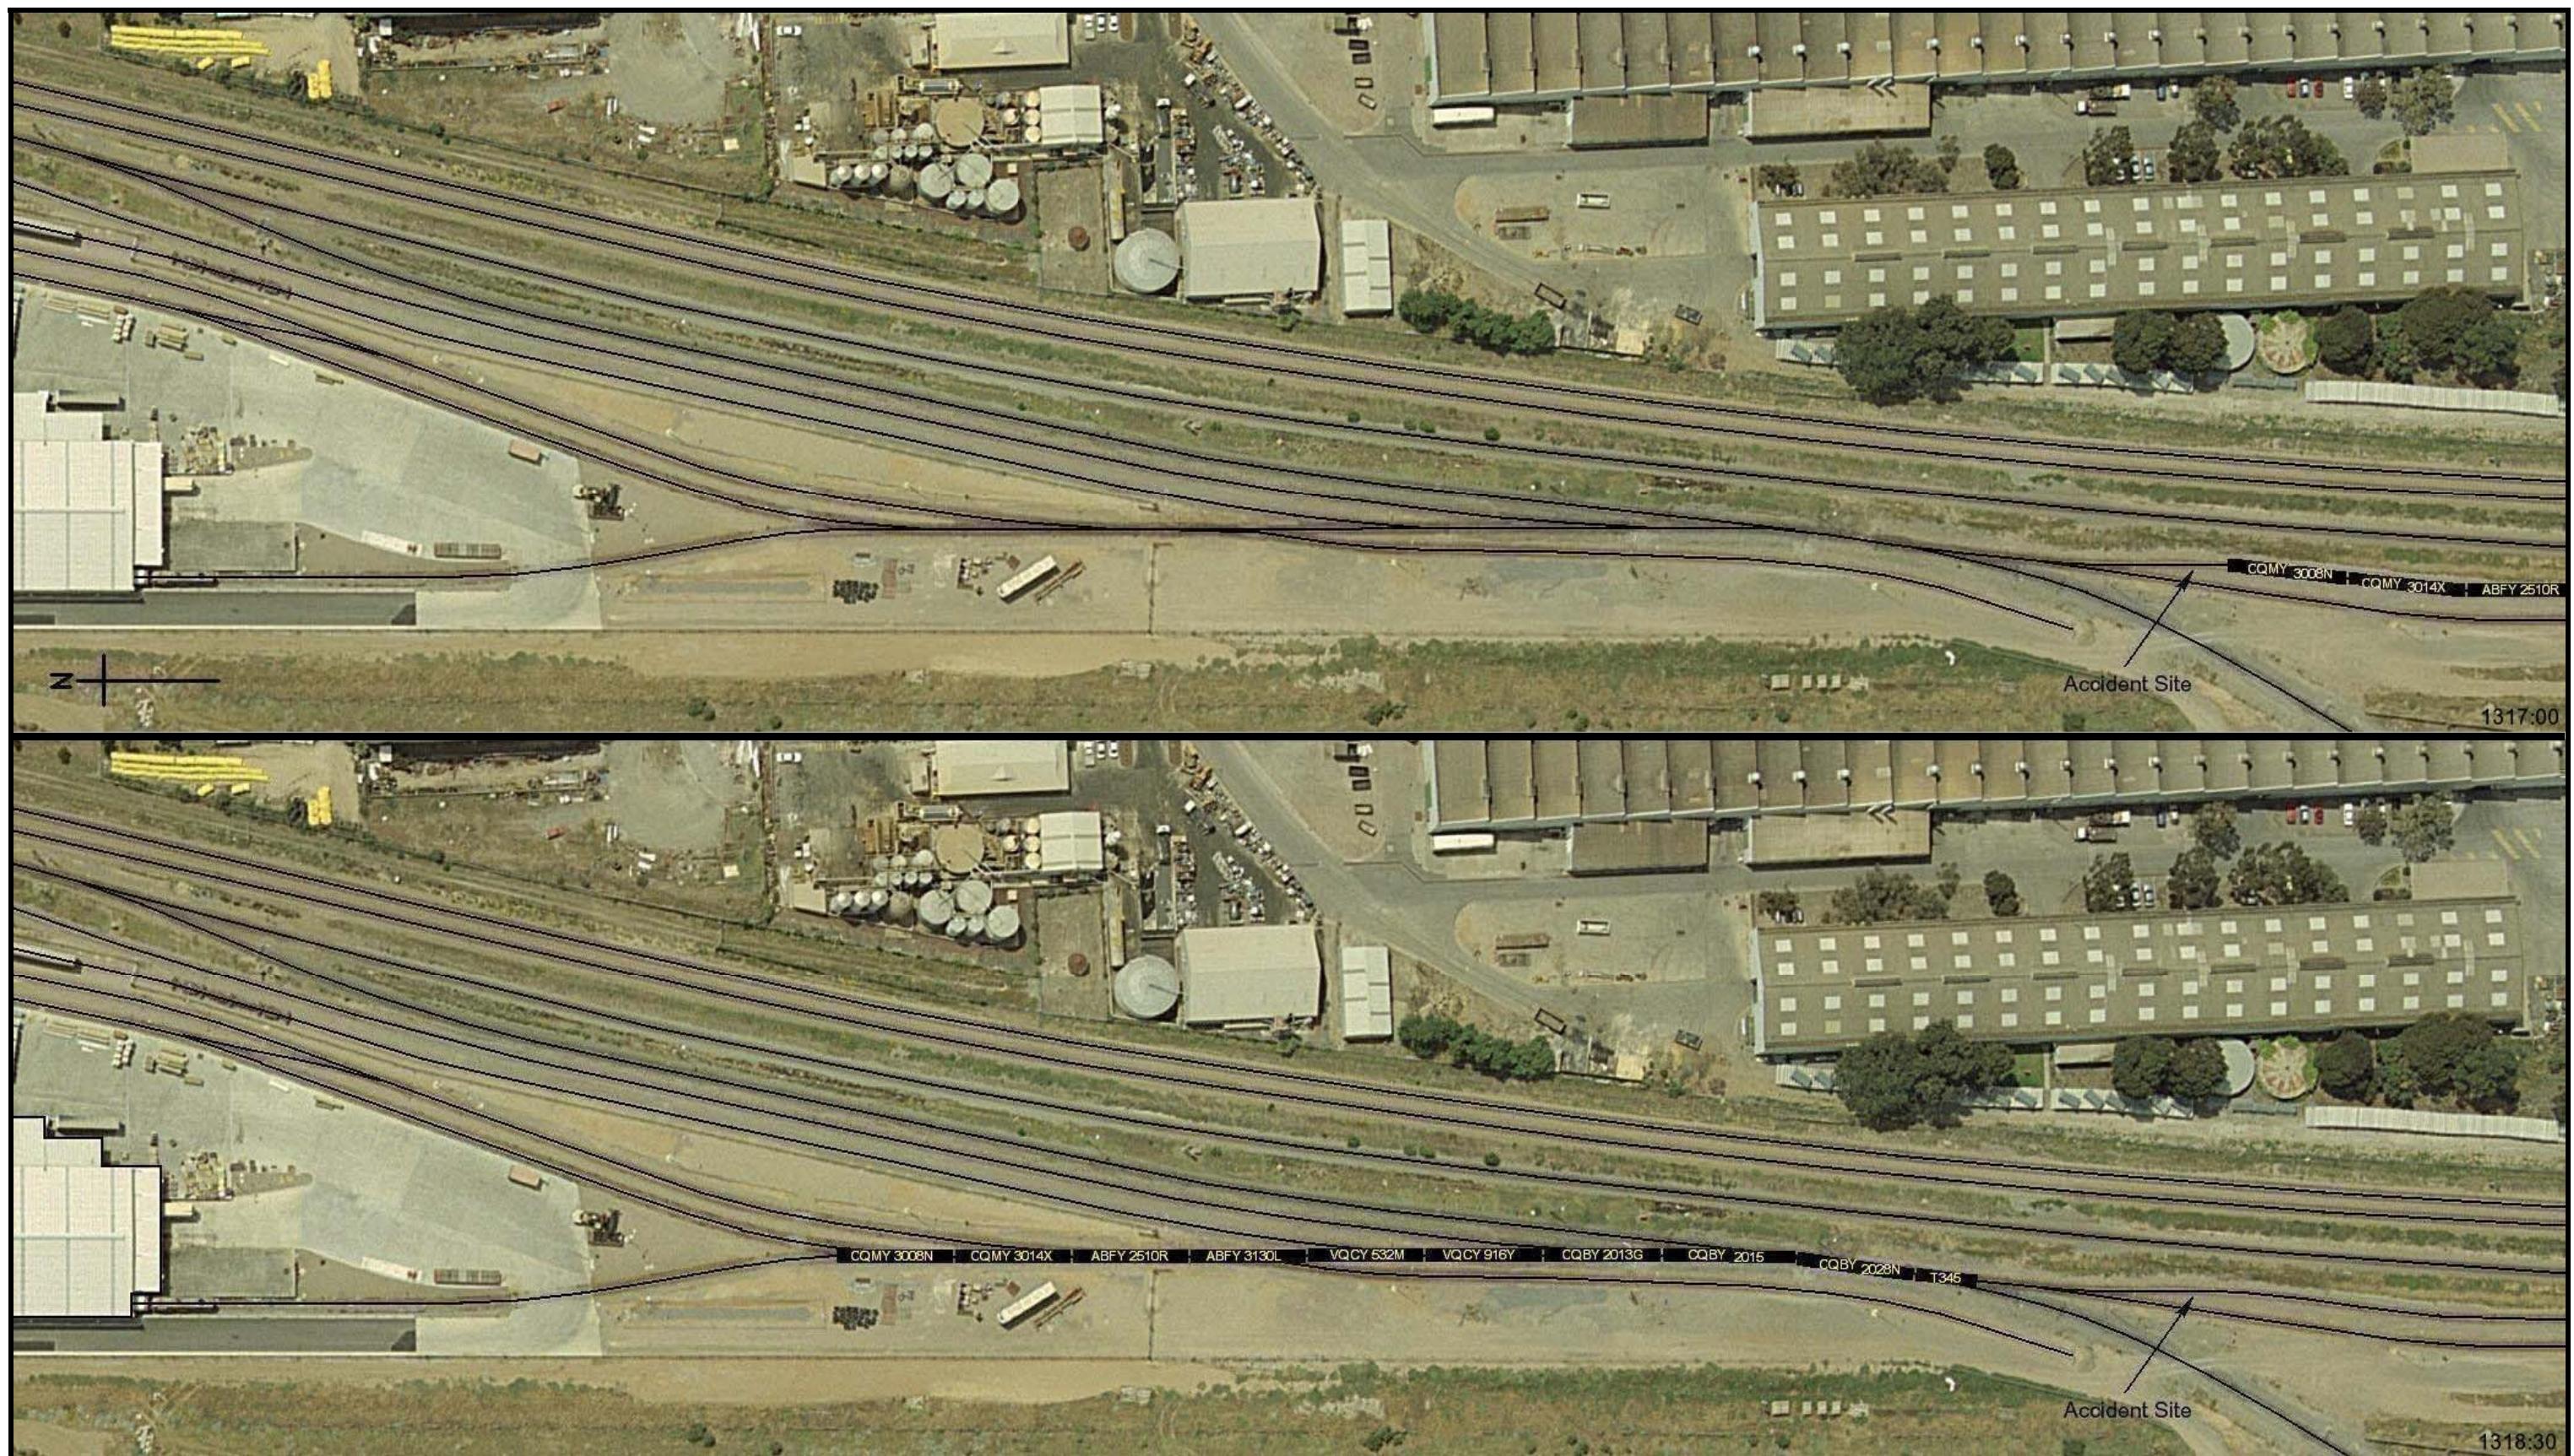
FIGURE 19 & 20. Site layout SCT yard showing position of T345 and rake of wagons at 1317 and 1319.

Fig. 19 & 20 - aerial view of SCT Yard showing the position of T345/wagons for the shunt movement just prior to and post accident.
