DEPARTMENTAL INVESTIGATION
INTO THE LOSS
OF THE BOW SECTION
OF THE GREEK REGISTERED
MOTOR TANKER

KIRKI

THE SUBSEQUENT FIRE,
EVACUATION OF THE CREW
AND SALVAGE OPERATION
FROM
20 JULY 1991 TO 23 AUGUST 1991

REPORT 33

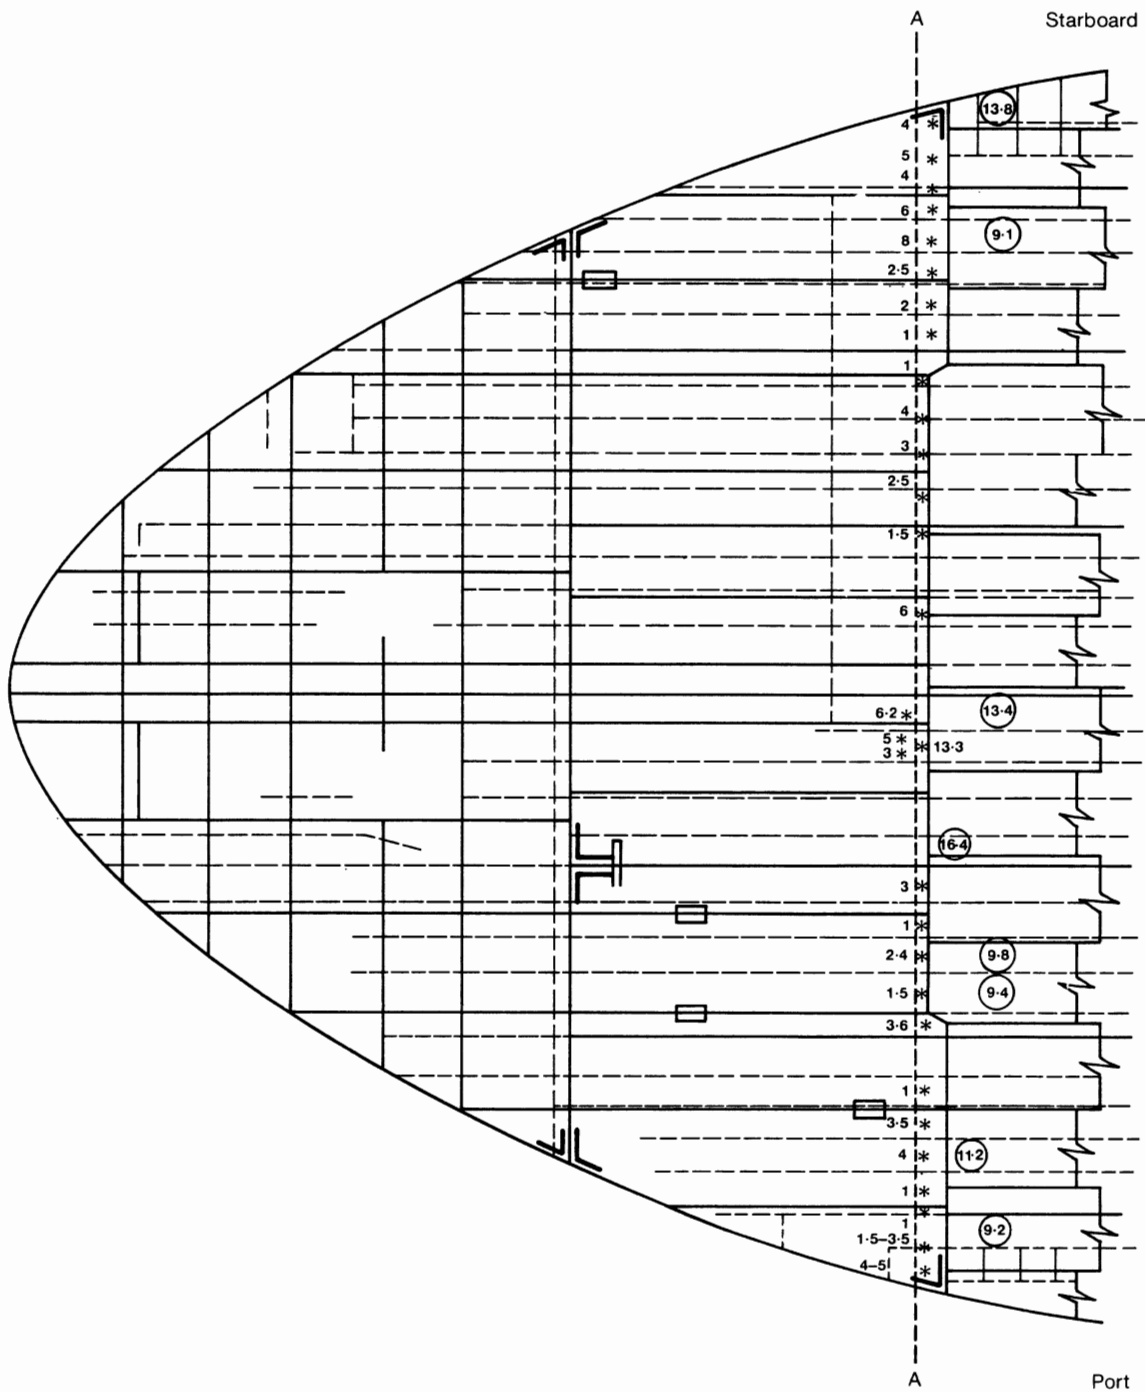
'*' measurements by calliper 23 July 1992

○ Ultrasonic readings taken on 11 August 1991

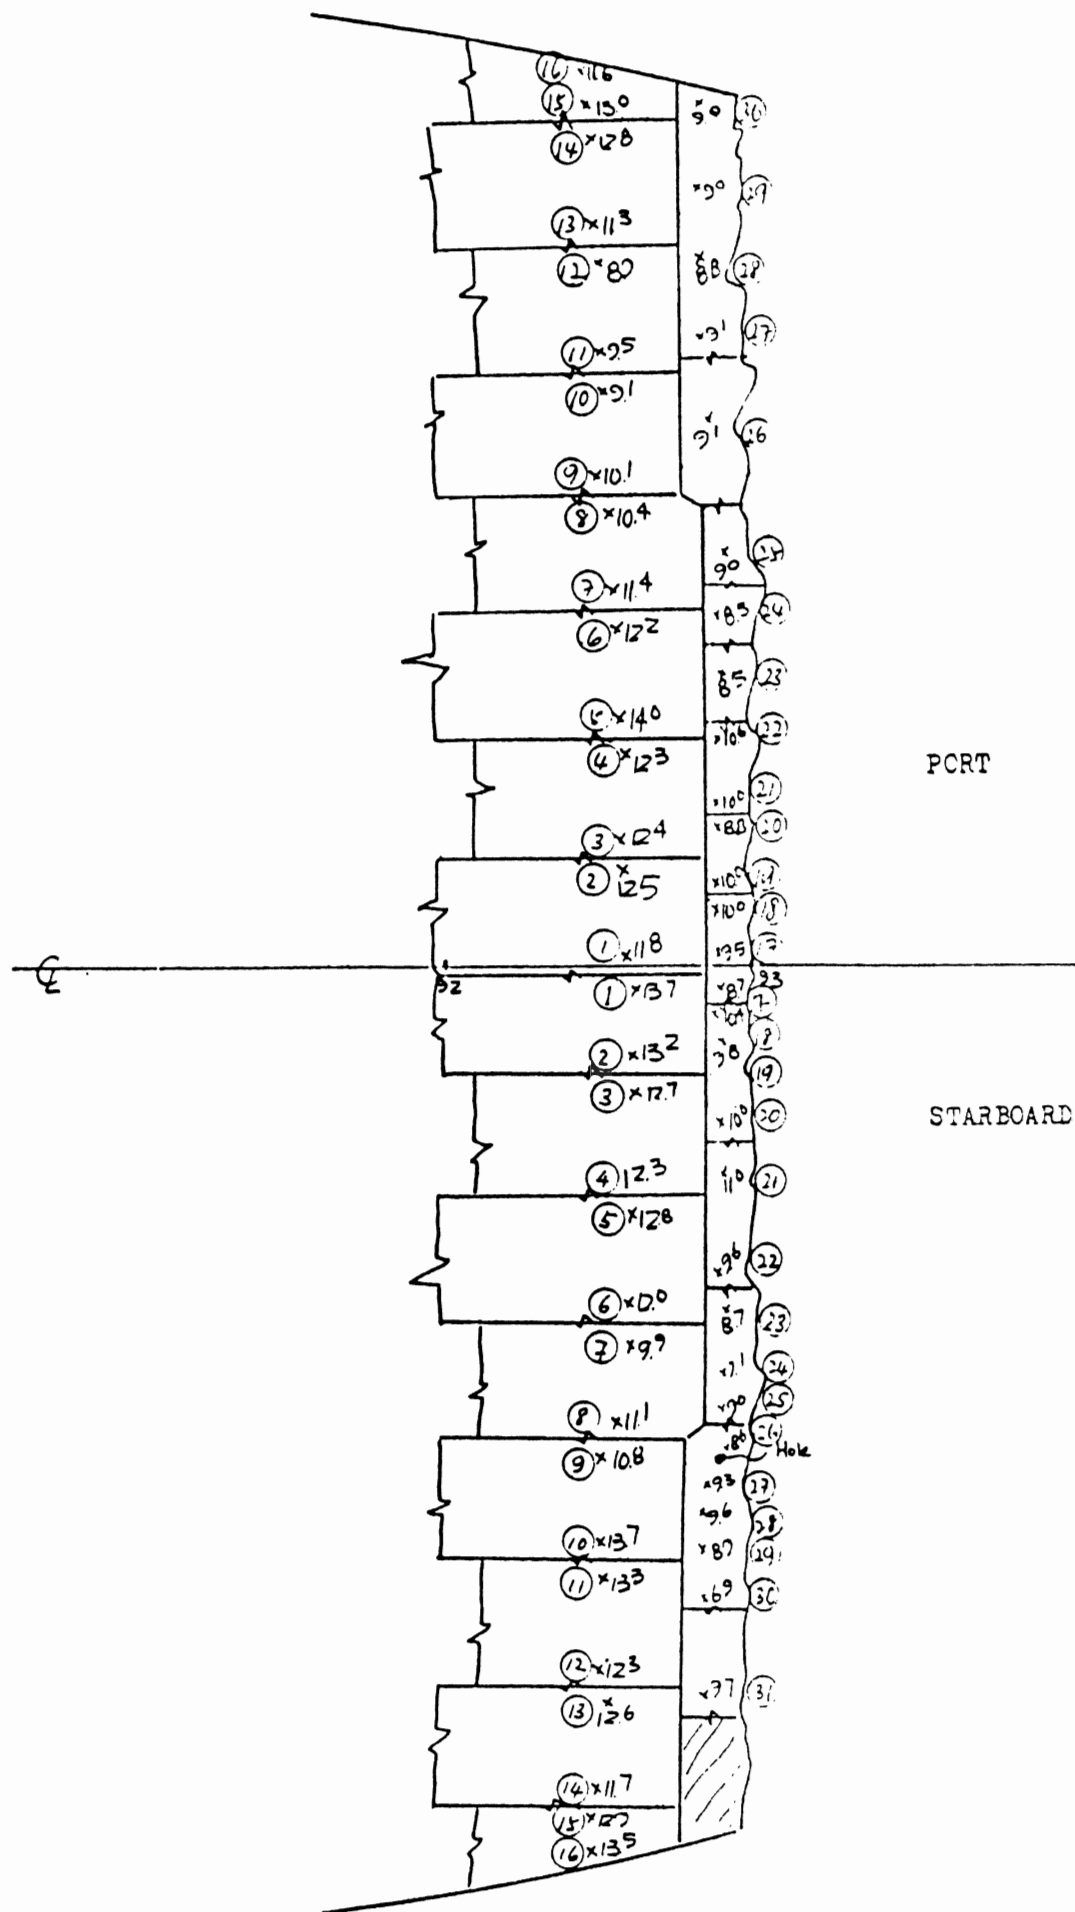
Subject : MAIN DECK PLATING BETWEEN FRS 92/93

PORT				STARBOARD			
PLATE NO	ORIG	THK	DIMINUTION	PLATE NO	ORIG	THK	DIMINUTION
/READING	THK	GAUGED	mm %LOSS	/READING	THK	GAUGED	mm %LOSS
1		11.8		1		13.7	
2		12.5		2		13.2	
3		12.4		3		12.7	
4		12.3		4		12.3	
5		14.0		5		12.8	
6		12.2		6		12.0	
7		11.4		7		9.9	
8		10.4		8		11.1	
9		10.1		9		10.8	
10		9.1		10		13.7	
11		9.5		11		13.3	
12		8.9		12		12.3	
13		11.3		13		12.6	
14		12.8		14		11.7	
15		13.0		15		12.9	
16		11.6		16		13.5	
17		9.5		17		8.7	
18		10.0		18		10.4	
19		10.0		19		9.8	
20		8.8		20		10.0	
21		10.0		21		11.0	
22		10.6		22		9.6	
23		8.5		23		8.7	
24		8.5		24		7.1	
25		9.0		25		9.0	
26		9.1		26		8.6	
27		9.1		27		9.3	
28		8.8		28		9.6	
29		9.0		29		8.9	
30		9.0		30		6.9	
				31		9.7

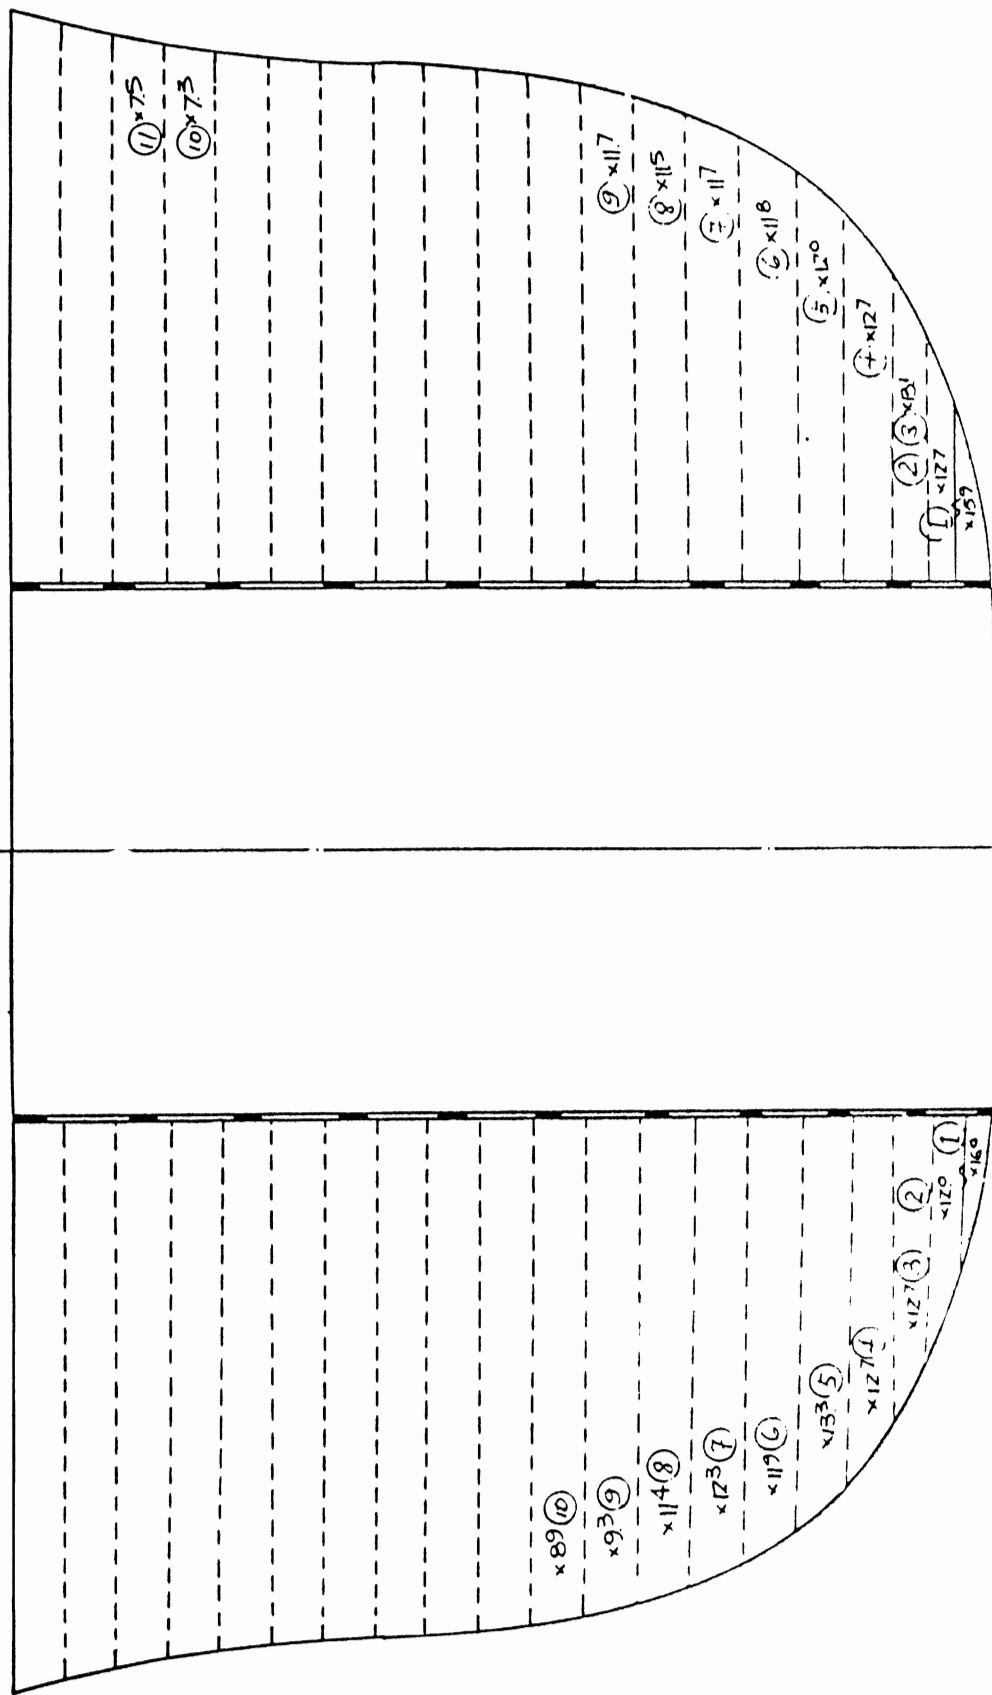
SUBJECT TRANSVERSE BULKHEAD AT FRAME 93

PORT				STARBOARD			
PLATE NO	ORIG THK	THK GAUGED	DIMINUTION mm %LOSS	PLATE NO	ORIG THK	THK GAUGED	DIMINUTION mm %LOSS
/READING				/READING			
CENTRE BRACKET							
1		18.5		1		15.0	
2		20.2		2		17.6	
3		-		3		15.3	
4		27.5		4		18.8	
5		-		5		-	
6		15.7		6		14.1	
7		15.6		7		13.5	
8		15.1		8		14.8	
9		13.0		9		14.2	
10		-		10		-	
11		19.4		11		22.2	
12		18.3		12		-	
13		17.7		13		21.0	
14		18.0		14		17.2	
15		23.6		15		21.0
