**ATSB TRANSPORT SAFETY REPORT**  
Rail Occurrence Investigation – 2007/001  
Final

# **Level crossing collision Back Creek, New South Wales**

10 March 2007

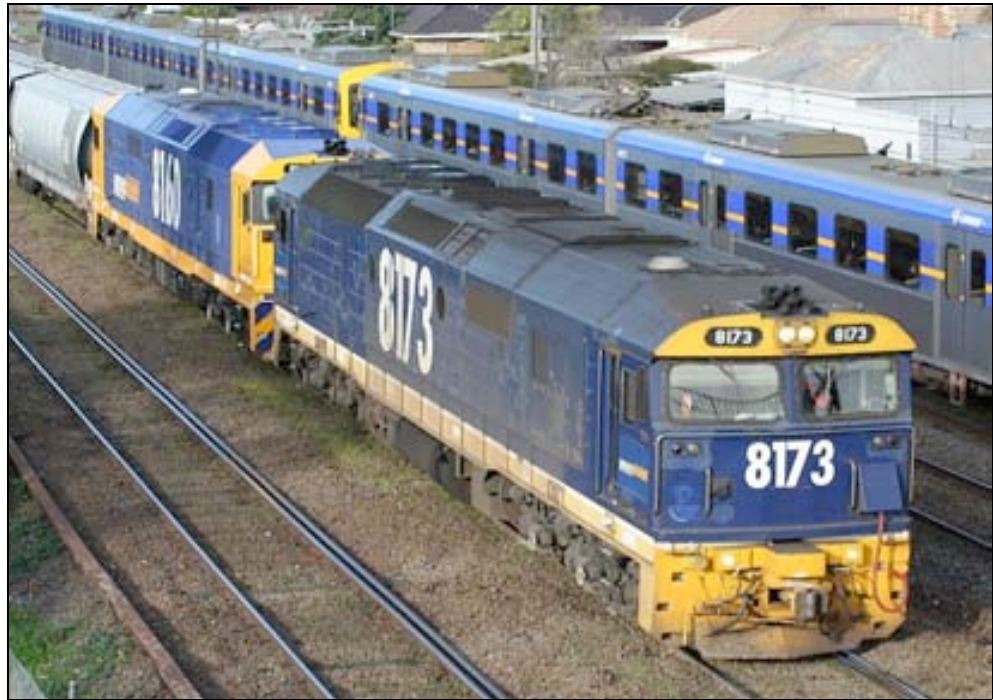
Given the proximity of the locomotive to the Back Creek Road level crossing in the seconds before the collision, the locomotive would have been the dominant feature in the landscape and it would have been easy to see in the clear conditions regardless of its colour, had the semi trailer driver been looking in its direction.

**Figure 13: 'Sister' locomotive 8173 painted in same livery as 8147**
