ATSB TRANSPORT SAFETY REPORT  
Aviation Occurrence Investigation AO-2009-030  
Final

Wirestrike  
24 km NNE of Albury Aerodrome  
New South Wales  
23 June 2009  
VH-CAP  
Bell Helicopter Company 206B  
JetRanger III

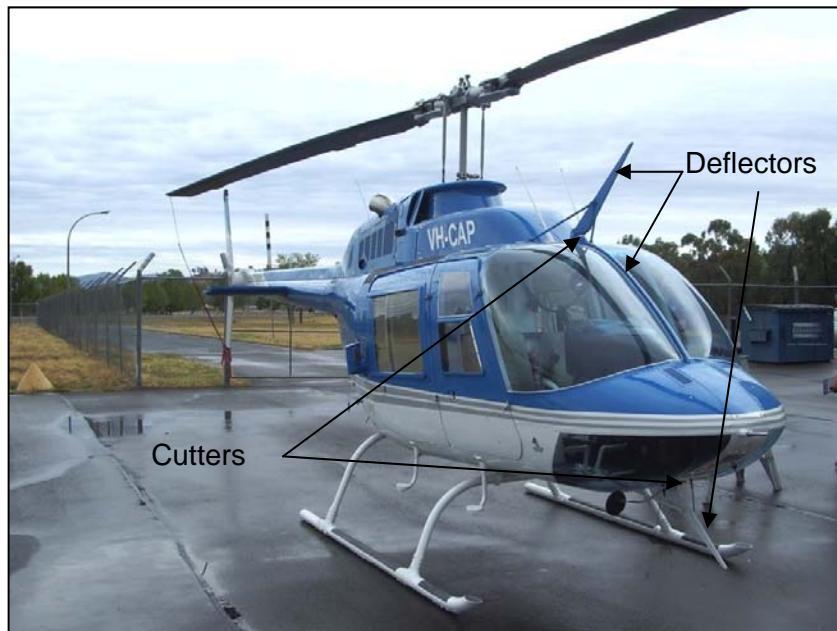
**Figure 2: VH-CAP without chemical spray equipment fitted**

The Bell 206B-3 is a five-seat, single main and tail rotor-equipped helicopter that is powered by a gas turbine engine, and equipped with skid-type landing gear. The accident aircraft was fitted with chemical spray equipment and a wire-strike protection system (WSPS) (Figure 2).

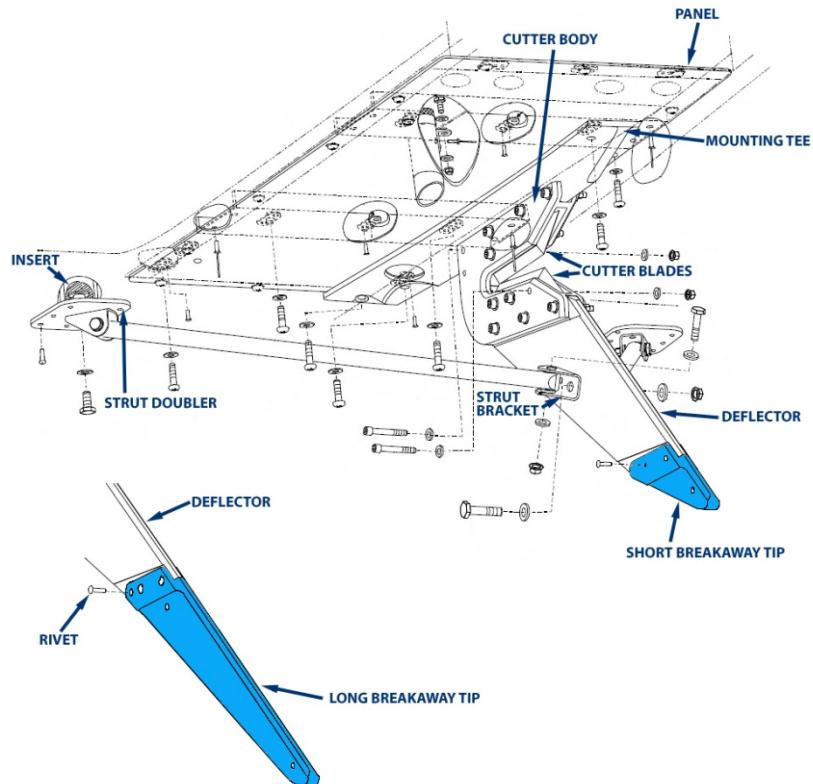
**Figure 3: Lower cutter assembly**

The lower deflector was fitted with a breakaway tip that was riveted to the lower cutter assembly (Figure 3). The rivets were designed to shear in the event of ground contact to prevent damage to the helicopter. The length of the breakaway tip varied depending on whether the helicopter was fitted with high or low skids. CAP was equipped with high skids and the long breakaway tip.
