**ATSB TRANSPORT SAFETY REPORT**  
Aviation Occurrence Investigation AO-2008-014  
Final

**Midair collision**  
**10 km NE of Wee Waa, New South Wales**  
**26 February 08**  
**VH-CJK, Air Tractor 502**  
**VH-ATB, Air Tractor 502B**

Midair collision – 10 km NE of Wee Waa, New South Wales - 26 February 2008 - VH-ATB, Air Tractor Inc. 502B and VH-CJK, Air Tractor Inc. 502

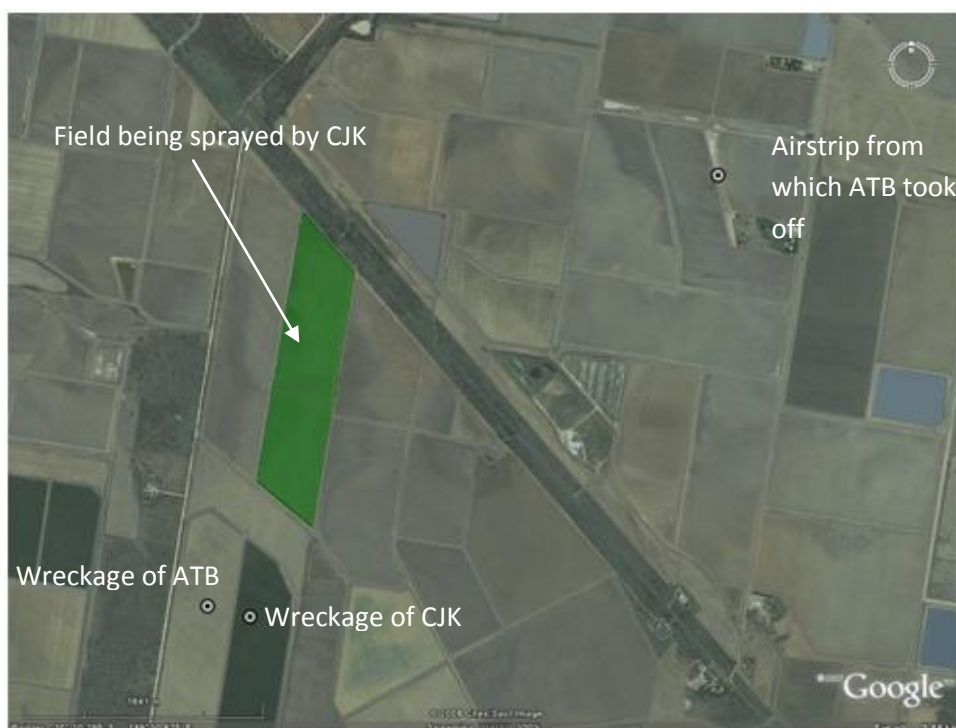
**Figure 1: Satellite image of accident location**

At a location just south of the field that was being sprayed by CJK (about 9 km north-east of Wee Waa township), the two aircraft collided in mid air, and crashed into adjacent fields (Figure 1). The pilot of ATB was seriously injured and the aircraft was seriously damaged<sup>2</sup> by collision forces with the other aircraft, ground impact, and a post-impact fire. The pilot of CJK was fatally injured and the aircraft was seriously damaged by collision forces and by ground impact. It did not catch fire.

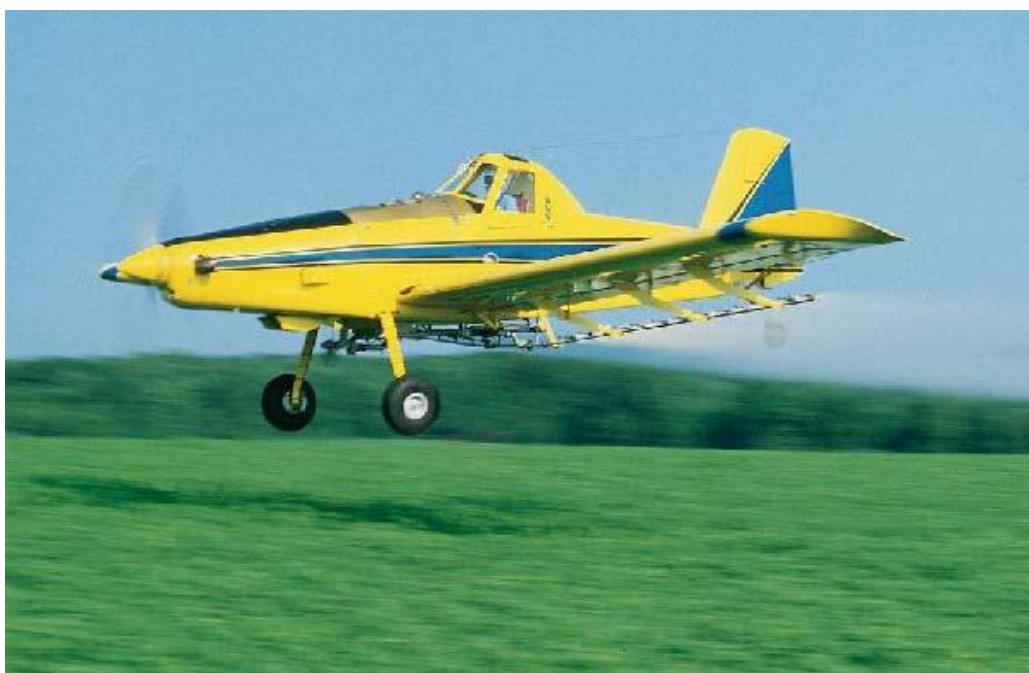
**Figure 2: Air Tractor Inc. 502 aircraft similar to ATB and CJK**

Both aircraft were single-seat agricultural aircraft that were manufactured in the United States (US) by Air Tractor Inc. The AT 502 (Figure 2) and AT 502B were powered by a single Pratt and Whitney Canada PT-6A-15AG turboprop engine, which was rated at 680 shaft horsepower (shp) (maximum continuous power) and drove a three-blade Hartzell propeller.

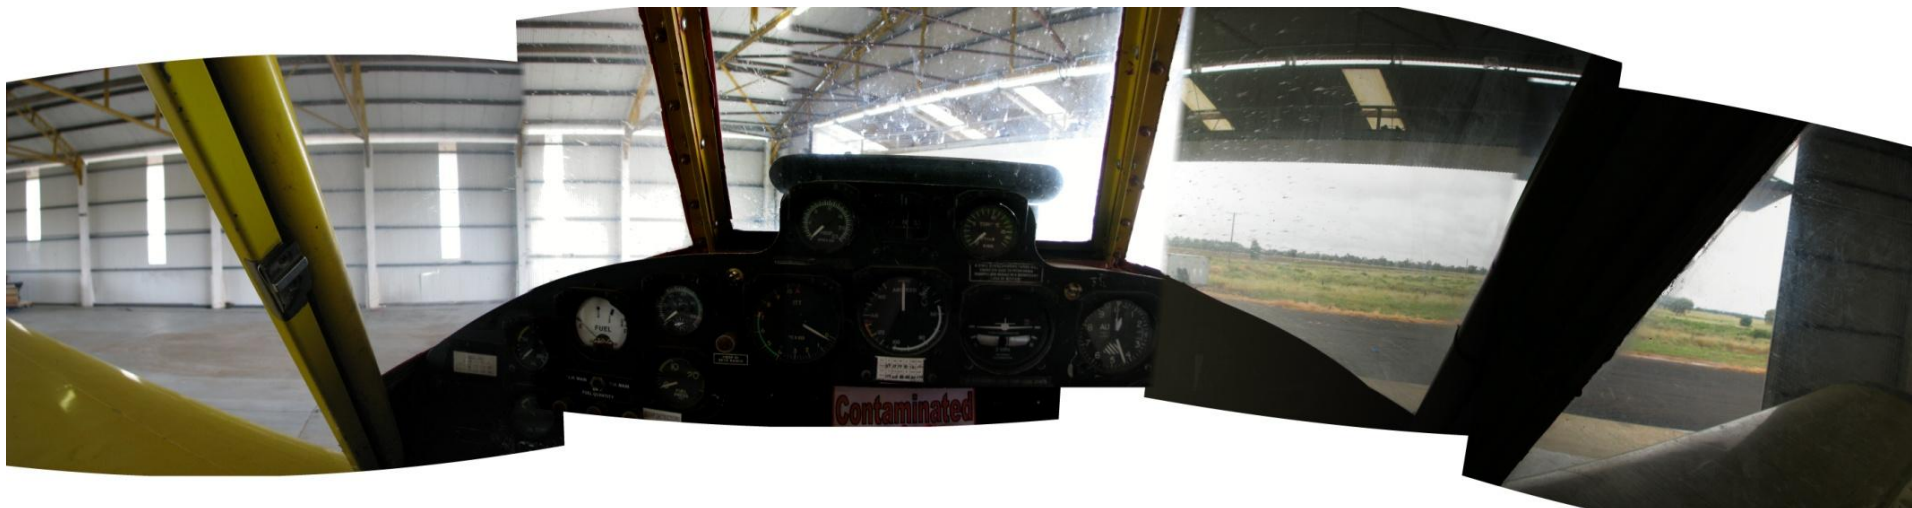
**Figure 3: View from Air Tractor cockpit**

Cockpit visibility from an Air Tractor 502 provided an almost 360° view for the pilot and the raised, mid-fuselage cockpit (a design feature typical of most agricultural aircraft) afforded a pilot a good forward view. Pilots reported that even in a climb attitude, the nose of the aircraft would not obscure the horizon. Either side of the aircraft's nose, the forward view was unobstructed to the leading edge of each wing (Figure 3).
